# Role of Surface Finishing on Pitting Corrosion of a Duplex Stainless Steel in Seawater

N. Ben Salah-Rousset, M.A. Chaouachi, and A. Chellouf

Localized corrosion of duplex UNS S32550 stainless steel in seawater was investigated in the laboratory and in field trials for several surface finish conditions: polished, ground, and sandblasted. Electrochemical data obtained by polarization curves showed that the smoother, polished surface had better characteristics (higher pitting and protection potentials) than the ground or sandblasted surfaces. However, despite its high degree of roughness, the sandblasted surface was the most resistant in field conditions, exhibiting the lowest number of sites attacked. Internal compressive stresses created by sandblasting seem also to have an "unsensitizing" effect on sensitized zones that exist in cast steel (due to repairs of mold defects), reducing its susceptibility to microbiologically influenced corrosion (MIC). Such stresses are not generated in polished or ground surfaces, and localized MIC attack can occur.

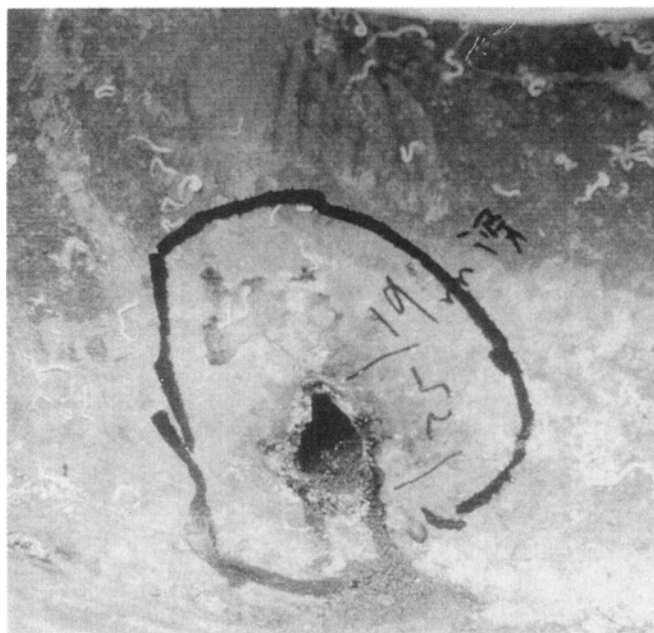
**Fig. 1** Morphology (a) and actual dimensions (b) of localized corrosion attacks of duplex stainless steel as seen on the discharge bowl of the circulating pump

The addition of nitrogen to second-generation duplex stainless steels ensures an  $\alpha/\gamma$  ratio of 50:50, which improves localized corrosion resistance by lowering  $\alpha/\alpha$  sensitive grain boundaries (Ref 4, 5). However, pitting corrosion in duplex UNS S32550 has occurred, especially in the impeller and discharge bowl parts of the pumps. Pit morphology is shown in Fig. 1.

Pit morphology was characterized by a small surface opening and a large subsurface cavity associated with localized deposits of corrosion products (Fig. 8), similar to those observed on the discharge bowl of the circulating pump (see Fig. 1). This type of pit has been reported by other authors on austenitic stainless steels when microbiologically influenced corrosion (MIC) occurred (Ref 12, 13). It is certain that our tests involved MIC since they were conducted in seawater. These same authors have observed that MIC occurred in combination with SCC and/or sensitized structures. This can explain two fundamentals of our work:

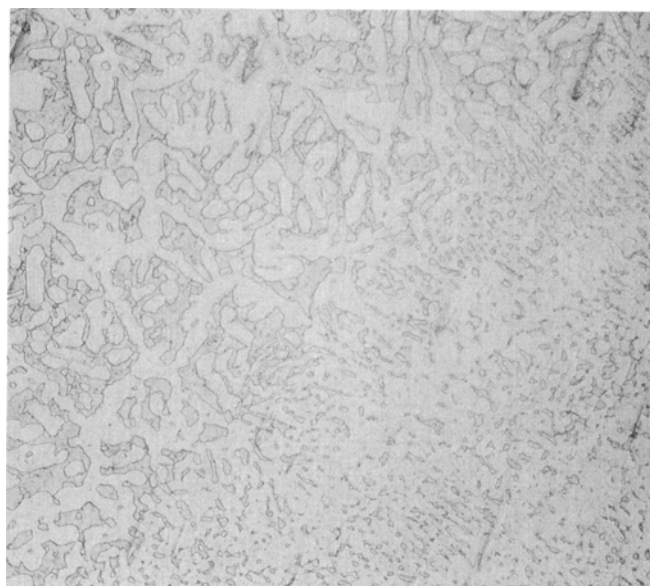
**Fig. 2** Microstructure of the duplex stainless steel (ferrite + austenite). (a) Base metal ( $\alpha/\gamma = 0.5$ ). 250 $\times$ . (b) Interface of the base metal and the repaired zone ( $\alpha/\gamma > 0.5$ ). 100 $\times$

The steel had been water quenched from 1100 °C after molding. Samples used for this study contained repairs of mold defects. Welded and heat-affected zones identified by optical microscopy are shown in Fig. 2. The approximate roughness factor was identified for each surface finish condition (Table 2).

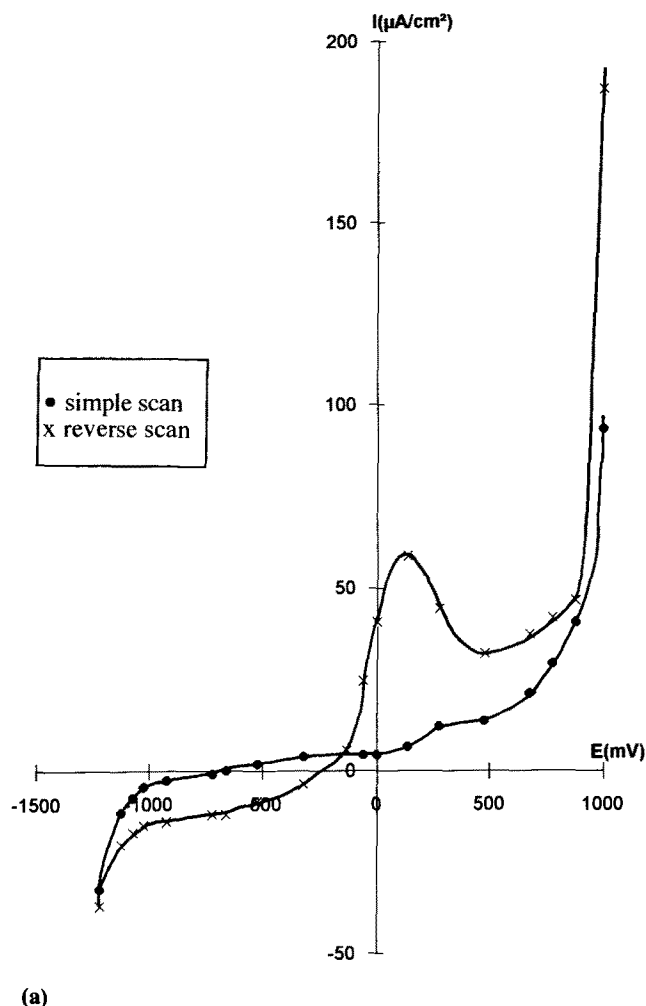
**Fig. 6** Cyclic polarization curves for the sandblasted surface of duplex stainless steel in synthetic (a) and natural (b) seawater

Cyclic polarization curves obtained for each surface finish in synthetic and natural seawater are shown in Fig. 4 to 6. Data obtained from these plots are summarized in Table 4.

Sandblasted and ground surfaces had comparable  $E_{\text{pit}}$  and  $E_{\text{prot}}$  values in synthetic seawater. However, in natural seawater the sandblasted surface seemed to act worse despite its less active corrosion potential ( $E_{\text{corr}}$ ). In addition, it exhibited an active zone in the polarization curve ( $I_{\text{corr}} \sim 70$   $\mu\text{A}/\text{cm}^2$ ).

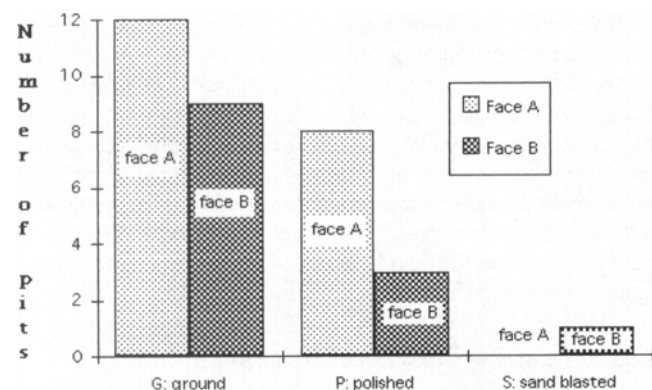
**Fig. 7** Number of pits (depth  $\geq 0.5$  mm) versus surface and flow rate (A and B) conditions

Results of the field trial are summarized in Table 5 and Fig. 7. The histogram (Fig. 7) shows how many pits up to  $0.5$  mm deep each sample exhibited in faces A and B.
