The Structure and Deformation Behavior of Zinc-Rich Coatings on Steel Sheet

S.R. Shah, J.A. Dilewijns, and R.D. Jones

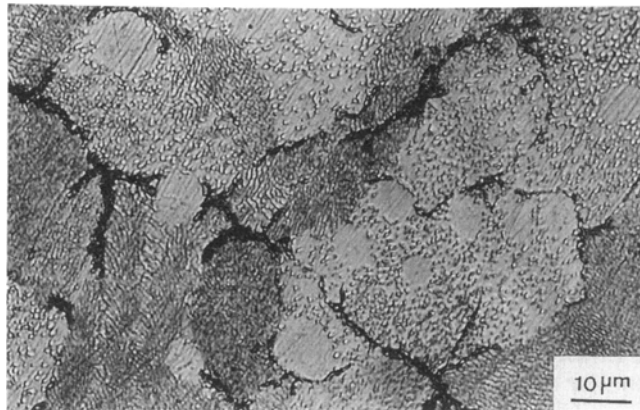
Fig. 1 (a) Galvanized—surface topography. (b) Galfan GF8—surface microstructure. (c) Galfan GF20—surface microstructure. (d) Galvalume—surface topography. (e) Galvalume—transverse microstructure

ple also shows an increased number of zinc-rich primaries (Fig. 1c) than other Galfan coatings. It shows a stronger basal texture than the thicker GF23 coating.

Coating GF20 behaved differently than coatings GF8, GF15, and GF23. Surface rumpling indicated that plastic deformation was again taking place, but the most important factor was the large number of grain boundary dents (Fig. 1c). These provided preferential sites for crack nucleation, as is shown by extensive grain boundary cracking at higher strains (Fig. 4). Intragranular cracks were also observed, but at lower strain levels than in coatings GF8, GF15, and GF23. This is a result of secondary basal cleavage in the higher number of zinc-rich primaries in this coating. The formation of twins prior to cracking was also observed, together with some intergranular cracks at a lower level of strain (Fig. 7a).

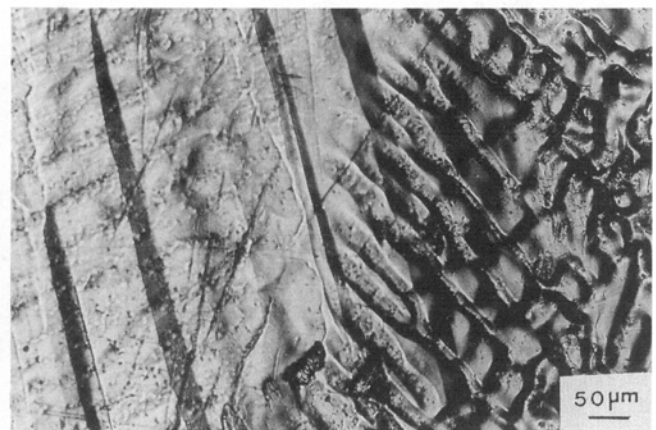
deformation of regular spangle galvanized coating occurred primarily by twinning at low levels (<5%) of tensile strain. Twins are seen in Fig. 3(a) and (b) in both flat and ridged regions, and they are also evident in the transverse sections (Fig. 3c, d). Grain boundary separation increased with strain and probably initiates at the smallest strains.

Fig. 3 Deformation of galvanized coating; twin formation at 4% strain in (a) shiny and (b) shiny and frosty spangle. (c) and (d) Transverse sections showing cracks within zinc layer at 10% and twin at 20% strain, respectively. (e) and (f) Cracks at grain boundary and along the ridges and intragranular cracking at 10% and 20% strain, respectively

Figure 3 shows typical examples of surface topographies (a, b, e, f) and transverse sections (c, d) of deformed samples. The

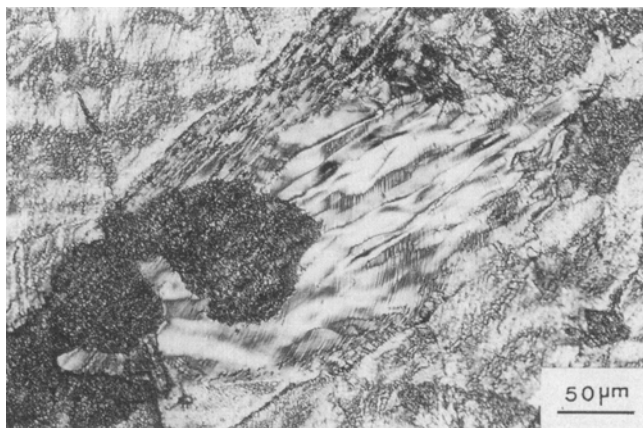
Fig. 5 Surface of GF15 coating at 15% strain under (a) normal and (b) polarized light

Two types of behavior were observed. In coatings GF8, GF15, and GF23, the first stage of deformation was plastic flow accommodated by slip and twinning. Figure 4 shows the deformation behavior over the strain range between 5 and 30%. Virtually no cracking was observed at low levels of strain. Evidence of plastic deformation is the extensive surface rumpling (Fig. 5) and the fine slip lines observed under polarized light (Fig. 5b). At higher strains, intragranular cracks were evident (Fig. 4), but there was also evidence of plastic flow without cracking. The formation of twins in the zinc primaries within the eutectic matrix at 60 to 80° to the tensile axis was observed at 5% strains (transverse section in Fig. 6a). Figure 6(b)

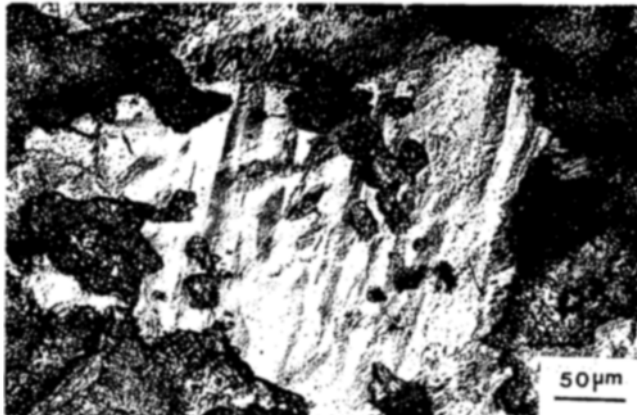
The size of twins in Galfan appears to be related to the initial grain size. In the larger grain size coatings (e.g., GF8 and GF15), coarser twins were observed (Fig. 7b). The larger grain size coatings also contained less basally oriented grains, as shown in Table 2. These results are in agreement with previous findings (Ref 7) that in galvanized coatings, the localization of twinning strain is less extensively developed with a larger grain size than with a small grain size under the same conditions. In

Fig. 7 Twin formation at surfaces of (a) GF20 and (b) GF15 coatings at 5% strain. Optical micrographs using polarized light

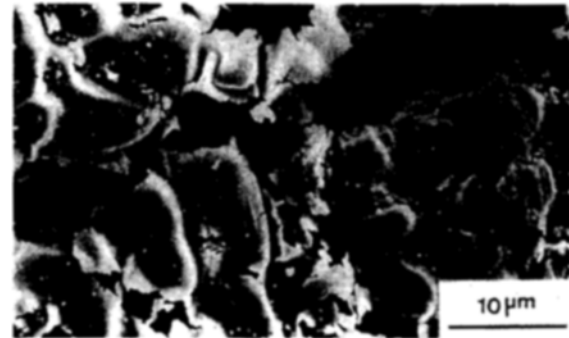
The use of SEM confirmed that cracking could be nucleated at low strains in the brittle interdendritic zinc-rich regions (Fig. 8). These cracks grow as plastic strain increases (Fig. 8b). This region, which consists of zinc-rich β -particles within the eutectic structure, is associated with the $(10\bar{1}1)$ orientation. It is therefore possible that some plastic deformation occurred prior to cracking.

Cracks could also be nucleated by shrinkage voids (e.g., Fig. 8a).

A fourth, less significant, mechanism for coating failure is the formation of cracks in large aluminum dendrites at higher strains (Fig. 8b).

Fig. 8 (a) and (b) Deformed surfaces of Galvalume coating at 10% and 20% strain, respectively. SEM micrographs. (c) Transverse section of Galvalume coating at 10% strain

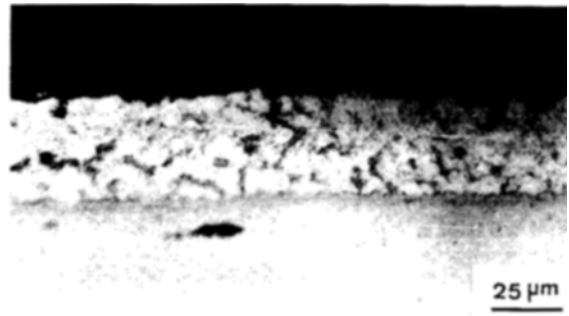
(c)

Silicon flakes in the coating were also identified as sites for crack nucleation (Fig. 8c), in accordance with a previous observation (Ref 19). However, the severity of this form of cracking can be reduced if the silicon flakes are finely dispersed in the coating during solidification.
