# Localized Swelling of Fe-Cr-Ni Alloy Rollers in High-Temperature Applications

A. Prasad, S.K. Sen, S. Varadrajan, and S. Jha

**Keywords** Fe-Cr-Ni Alloy, localized swelling, oxidation, void formation

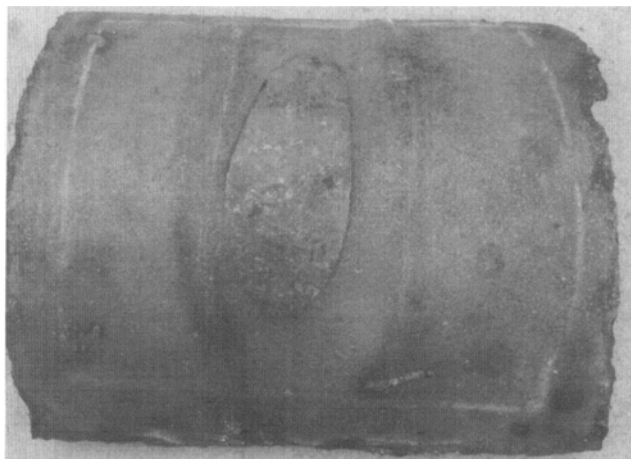
Fig. 1 Outer surface of the used roller

The outer and inner surfaces of the used roller are shown in Fig. 1 and 2. Swelling can be seen in the middle portion of Fig. 1. Optical micrographs of the unswelled and swelled portions of the used roller material are shown in Fig. 3(a) and (b), respectively. Both these micrographs show the presence of voids and coarse carbides. It is evident from the micrographs that the carbide size is bigger in the unswelled portion while the void density is significantly higher in the swelled portion. The preferential location of carbides and voids in both cases is along grain boundaries.

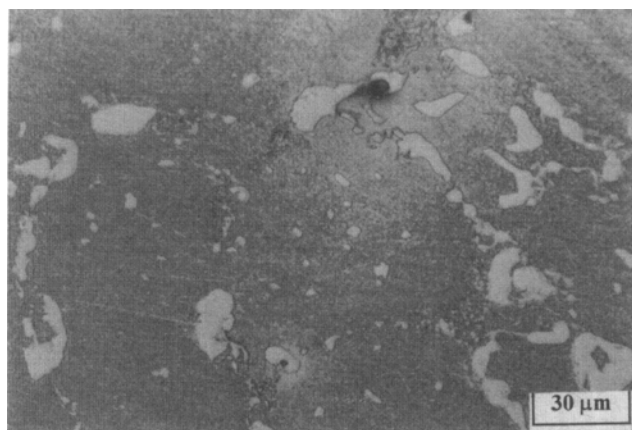
Fig. 3 Optical micrographs of used roller material. (a) Unswelled portion. (b) Swelled portion

The presence of coarse carbides in the unswelled portion (Fig. 3a) is the result of prolonged use at high temperature. Similar findings have been reported for nickel- and iron-base superalloys (Ref 3) and nickel-chromium alloys (Ref 4). During the long exposure of the material to oxidizing atmosphere at high temperature in the normalizing furnace, the coarse carbides are likely to undergo oxidation reaction, provided that oxygen from the flue gas can penetrate the roller material.
