Sliding Wear Response of a Lead-Tin Bronze: Influence of the Counterface Material Characteristics

J.P. Pandey and B.K. Prasad

Observations were made of the dry sliding wear behavior of a lead-tin bronze against different counterface materials (stainless, EN8, and EN24 steels) over a range of applied pressures and speeds. The study showed that, in addition to sliding speed and pressure, the characteristics of the counterface materials greatly control the wear response of the bronze. The results were further substantiated by the characteristics of the wear surfaces, subsurface regions, and debris particles generated during the tests.

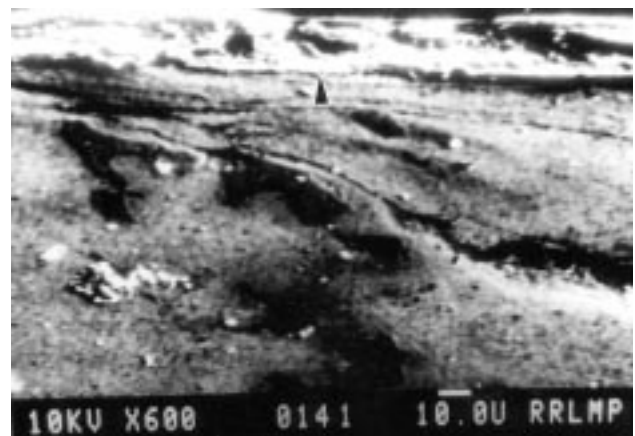
The subsurface regions of the bronze at different speeds and pressures are shown in Fig. 6. Note that to a considerable extent subsurface cracks were generated in the specimens tested at 0.42 m/s even at minimum applied pressures (Fig. 6a). The degree of cracking increased with pressure at this speed (Fig. 6b). The regions marked A are in the process of being detached to form wear debris. Limited flow of material in the direction of sliding was also observed near the wear surface.

Microcracking in the subsurface regions decreased to some extent at 1.26 m/s at low pressures (Fig. 6c), whereas the extent of plastic deformation was marginally greater at higher pressures (Fig. 6d and e) when compared with specimens tested at 0.42 m/s. The flow of microconstituents, including lead particles, is noticeable at the 1.26 m/s sliding speed (Fig. 6c and d).

Fig. 6 SEM micrographs of the subsurface regions of the bronze alloy at different sliding speeds and pressures when tested against the EN24 steel disk. (a) 1.0 MPa at 0.42 m/s. (b) 5.0 MPa at 0.42 m/s. (c) 1.0 MPa at 1.26 m/s. (d and e) 15.0 MPa at 1.26 m/s. Regions marked A in (a) and (b) are in the process of being detached from the wear surface. Arrows in (c) and (e) indicate microcracks.

At 0.42 m/s, chipping of material led to the generation of physically visible flaky debris. As a result, the specimens lost proper contact with the disk (Ref 12) due to the microcracking tendency of the bronze alloy (Fig. 5b, 6a and b) imparted by lead.

At the higher sliding speed of 1.26 m/s, the microcracking tendency of the bronze was suppressed to a limited extent and the degree of plastic deformation increased (Fig. 5e and 6e). This caused lower wear rates at this speed (Fig. 3), also evident from the higher degree of frictional heating (Fig. 4b) and finer debris formation (Fig. 7e).

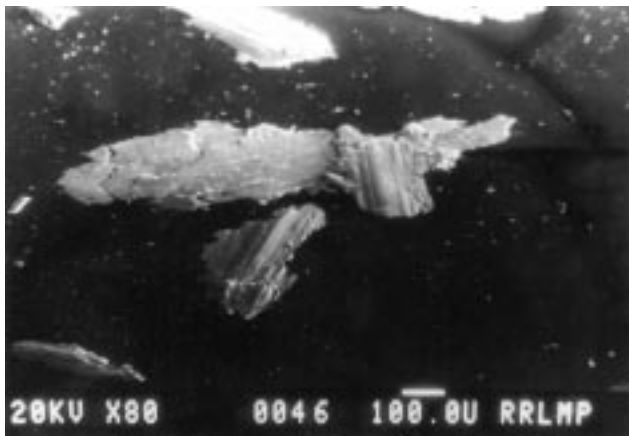
Debris particles from the bronze specimen when tested against the EN24 steel disk at different sliding speeds and pressures are shown in Fig. 7. At 0.42 m/s, the debris was flaky and quite large at low pressures (Fig. 7a), further increasing in size at higher pressures (Fig. 7b and c). In fact, in the latter case the debris was much coarser than shown, and also revealed the presence of microcracks. Interestingly, the debris size shrank considerably at a sliding speed of 1.26 m/s, especially at higher pressures (Fig. 7e); however, at lower pressures and the same speed (Fig. 7d), debris size was similar to that formed at 0.42 m/s.

Fig. 7 SEM micrographs of the wear debris of the bronze alloy at different sliding speeds and pressures when tested against the EN24 steel disk. (a) 1.0 MPa at 0.42 m/s. (b and c) 5.0 MPa at 0.42 m/s. (d) 1.0 MPa at 1.26 m/s. (e) 15.0 MPa at 1.26 m/s. Arrows in (b) and (c) indicate microcracks.
