Corrosive Wear Behavior of 2014 and 6061 Aluminum Alloy Composites

S.K. Varma, S. Andrews, and G. Vasquez

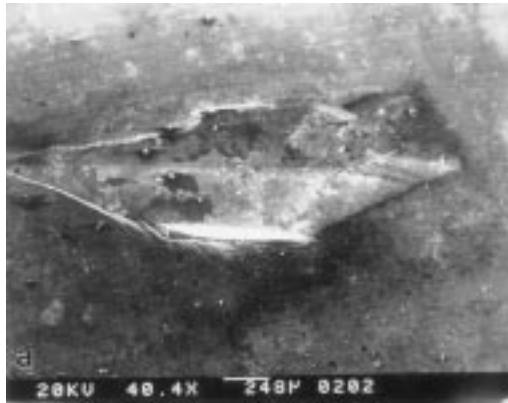
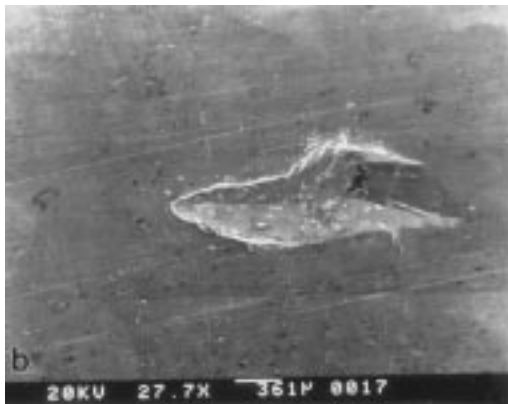
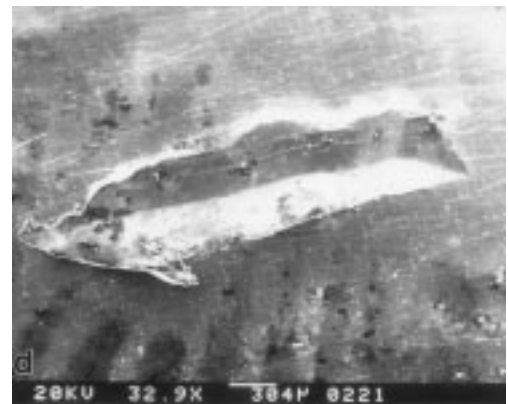
Fig. 3 Typical morphologies developed after impact scratching the electrodes of 2014 aluminum alloy, which have been solutionized at 540 °C for (a) as-received condition, (b) 5, (c) 10, and (d) 20 h

Figures 1 and 2 show the morphologies that were developed in 6061 aluminum alloy in monolith form and reinforced with 0.1 VFAP, respectively, when subjected to impact scratches in the electrolytic cell. The scratches are shown for the as-received condition and for samples that were solutionized for 5, 10, and 20 h at 540 °C. It can be readily seen that due to the larger grain size at longer solutionizing time, the area of the scratch increases. Almost identical behavior was observed for 2014 aluminum alloy in the monolithic form and reinforced with 0.1 VFAP, as shown in Fig. 3 and 4.

Another important observation to be noted from Fig. 1 to 4 is the presence of large amounts of pits in composites reinforced with 0.1 VFAP. The relative concentration of the pits is small for the monolith in both alloys. This may be due to the consequences of different mechanisms of corrosion occurring in the monoliths and the composites and is discussed in the “Conclusions.”

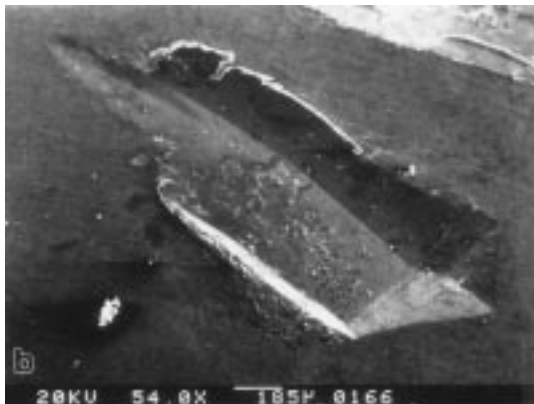
Fig. 4 Typical morphologies developed after impact scratching the electrodes of 2014 aluminum alloy reinforced with 0.1 VFAP, which have been solutionized at 540 °C for (a) as-received condition, (b) 5, (c) 10, and (d) 20 h
