Drilling of Graphite/Bismaleimide Composite Material

M. Ramulu, P. Young, and H. Kao

Drilling study of graphite/bismaleimide composite material was conducted by using different cutter materials (high-speed steel, carbide, and polycrystalline diamond) and drill geometries. It was found that polycrystalline diamond tools outperformed all other tools in terms of minimal surface damage, delamination, and fiber pullout. The drilling forces exerted in machining graphite/bismaleimide were recorded by using a dynamometer, and the morphology of drilled surfaces was evaluated with surface profilometry and optical and scanning electron microscopy. The drilling characteristics were evaluated in terms of cutting forces, tool wear, and surface morphology.

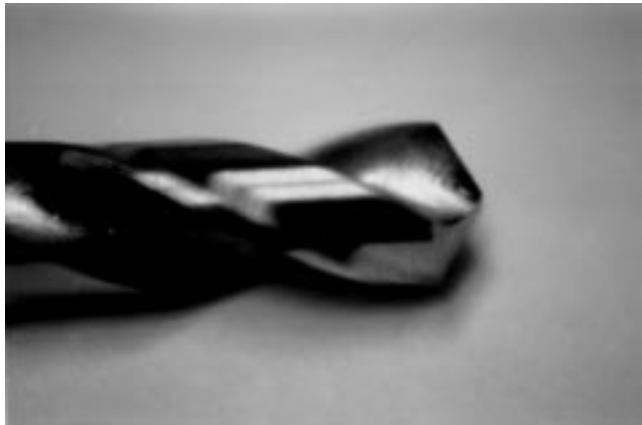
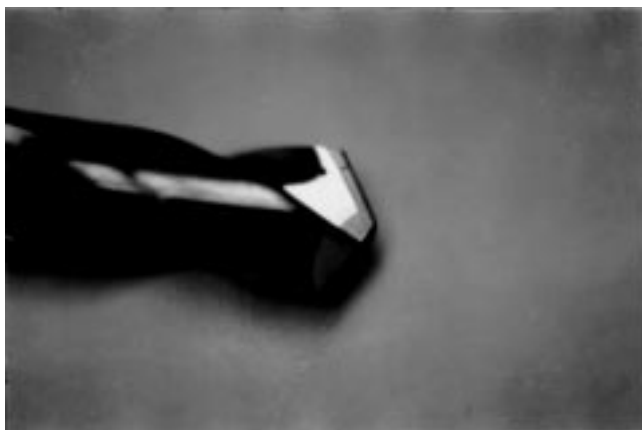
Fig. 1 Drilling tools. (a) High-speed steel (HSS) drill. (b) Carbide Dagger drill. (c) Polycrystalline diamond (PCD) drill

types, namely high-speed steel (HSS), carbide, and polycrystalline diamond (PCD). Drill geometries are listed in Table 1 and shown in Fig. 1.

Tools used included three types of drills. The specialized drill types were chosen because they are currently in use by many major aerospace manufacturers. The HSS drill is the typical drill used for mild steels and is readily available through many different suppliers. The Dagger (also known as four-flute tapered, straight flute drill/reamer; Grobet USA, Carlstadt, NJ) drill design differs in that it has primary, secondary, and tertiary cutting zones, with the first zone being much like that of a small conventional drill. The second cutting section increases the hole size from the diameter of the small tip to that of the third cutting zone by engaging the workpiece with four cutting edges. The third cutting area is a four-flute reamer, which finishes the hole to the desired diameter. The PCD drill is a four-facet drill with a true cutting point at the tip of the drill. The four facets meet at the very tip of the tool to engage cutting action rather than extrusion as with typical geometry, cam-relief ground drills.

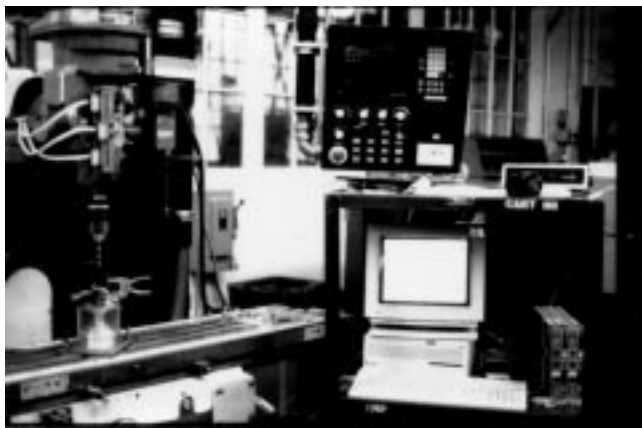
Fig. 3 Actual setup of machining apparatus. (a) Testing setup. (b) Drill dynamometer and drilled specimen

A schematic of the test setup can be seen in Fig. 2, and the actual setup of machining of the test apparatus is shown in Fig. 3(a), with a close-up of the dynamometer setup in Fig. 3(b). The summary of experimental conditions is listed in Table 2. The system was designed to accommodate a drilling dynamometer, which was equipped with strain gages. This cylinder of aluminum was fitted with two sets of strain gages, which were aligned to be independently sensitive to torque and thrust forces applied to the dynamometer. Two amplifiers were used

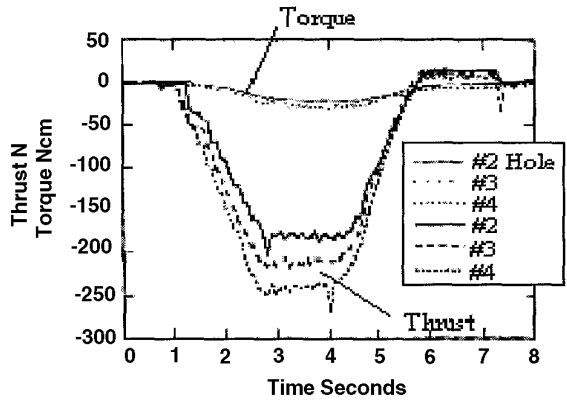
Fig. 5 Drilling forces at 2720 rpm and 0.028 mm/rev. (a) HSS drill. (b) Carbide Dagger drill. (c) Polycrystalline diamond drill

Thrust force and the torque recorded for the holes drilled at constant cutting conditions of 0.028 mm/rev feed and a speed of 2720 rpm by HSS, carbide, and PCD tools are shown in Fig. 5. Figure 5(a) shows the penetration of the drill tip into the workpiece at the time of approximately 1.2 s and full engagement of the cutting edges at 2.5 s. The tool tip penetrates the workpiece at 4.5 s followed by a quick decrease in the thrust force as more of the length of the cutting edges passes the final ply of the composite. At 5.5 s the tool is no longer cutting but is still traversing through the workpiece, with the helical flutes or grooves of the drill imparting a pulling force on the workpiece. This can be seen as a positive thrust force from 5.5 to 7.5 s at which the tool is rapidly retracted out of the work, resulting in no net forces.

The torque can be seen to reach its maximum at the point when the tip of the tool passes through the last ply, with subsequent cutting action taking place on less than the entire cutting edge of the drill. The maximum thrust force can be seen to occur approximately 0.1 s after the tool engages the workpiece, or at a hole depth of 0.130 mm. The torque can be seen to fail to return directly to zero after the penetration of the drill tip in the work. This might be due to the very fine chips and dust from the specimen being forced upward through the drill flutes. These

small Gr/Bi chips and dust become wedged between the tool and workpiece, therefore continuing to induce a torque force after the cutting action has finished.

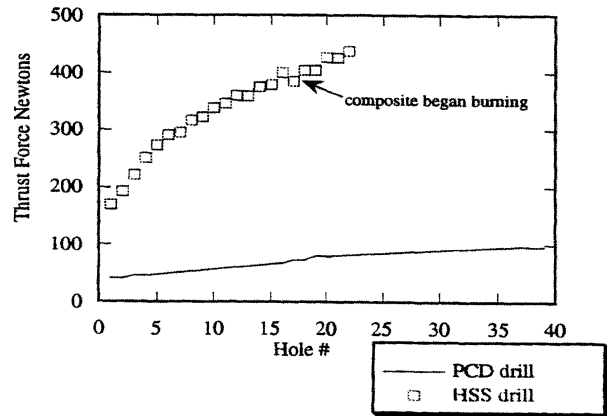
Fig. 6 Thrust force versus number of holes drilled, 2720 rpm and 0.028 mm/rev

Figure 6 shows the thrust force measurements made in drilling Gr/Bi material. Holes were drilled at the constant cutting conditions of speed 2720 rpm and feed 0.02794 mm/rev for the HSS and PCD drills. Increase of thrust force can be seen to be insignificant for the PCD tool when compared to the thrust force increase in HSS tool. The HSS drill induced thrust forces initially of around 150 N with subsequent holes producing

thrusts of 450 N. Burning of the composite occurred during the drilling of the 15th hole and continued during each subsequent hole, until the HSS drill failed after 20 holes. The PCD drill, however induced only 50 N on its first hole and less than 100 N after drilling 40 holes. After drilling 40 holes, a PCD drill induced one half the thrust force of a new HSS drill. It is not surprising that the PCD drill has the highest hardness of any of the tool materials, and consequently it best resisted wear.
