# Optimum Me-DLC Coatings and Hard Coatings for Tribological Performance

Y.L. Su and W.H. Kao

**Keywords** hard coating, Me-DLC, tribology

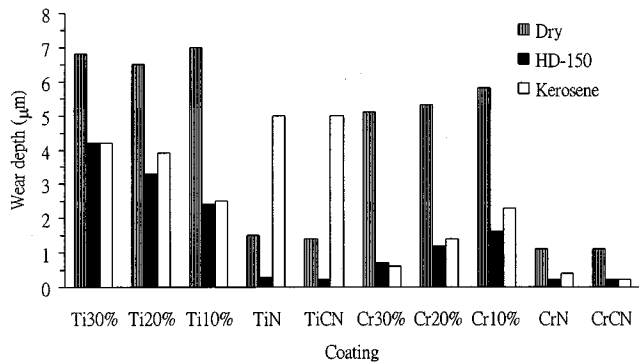
**Fig. 6** Wear depth of coating disks against steel ball under dry and lubricated conditions (Ti30% stand for  $Ti_{30\%}$ -C:H, Cr30% stands for  $Cr_{30\%}$ -C:H, etc.)

tions, both display a very poor wear resistance under kerosene-lubricated condition. Coatings of TiN and TiCN even possess a deeper wear depth under kerosene-lubricated condition than under dry condition. The tribological behavior of a steel ball sliding against TiN and TiCN coatings under kerosene-lubricated condition displays a special wear mechanism.  $Cr_{x\%}$ -C:H coatings possess a better wear resistance than  $Ti_{x\%}$ -C:H coatings under lubricated conditions. Under dry conditions, however,  $Cr_{x\%}$ -C:H coatings become severely damaged, even wearing through to the substrate. On the other hand, both CrN and CrCN coatings reveal an excellent wear resistance under

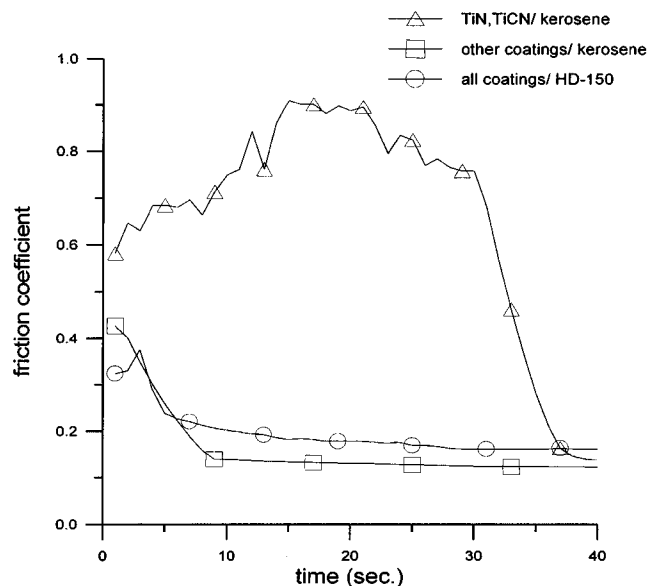
**Fig. 7** Typical traces of friction coefficients for the ball-on-disk, point-contact wear mode under lubricated conditions. (a) The TiN or TiCN coatings display an initial high friction coefficient, while the other coatings display low friction coefficients throughout the wear test under kerosene-lubricated condition. All coatings display low friction coefficients under HD-150 lubricated condition. (b) Initial traces of local friction coefficients of (a)

All the curves of friction coefficients, except for wear pairs of the TiN/steel ball and TiCN/steel ball, are low and smooth under the HD-150 or kerosene-lubricated conditions, as shown in Fig. 7(a). The wear pairs of the TiN/steel ball and TiCN/steel ball display an initial high friction coefficient (between 0.6 and 0.9) for about 31 s under kerosene lubrication, as shown in Fig. 7(b). This phenomenon indicates that, initially, a specific tribological behavior on the contact surfaces induced severe wear on disks coated with TiN and TiCN, as discussed in Section 4.3. Figure 8 summarizes two typical curves of the friction coefficients of coating/steel ball wear pairs, under dry condition. One is the  $Ti_{10\%}$ -C:H/steel ball wear pair, which reveals low friction coefficients (about 0.1) during the initial stage (about 87 s) and then suddenly increases up to 0.8, along with a fluctuation trace. The above demonstrates that the  $Ti_{10\%}$ -C:H coating, which has a higher carbon content, initially acts as a solid lubricant on the contact surfaces but wears out to the medilayer after the initial stage, under the high contact pressure and reciprocating motion between the contact surfaces. It thereby induces adhesive wear with high friction coefficients during the test. The other wear pairs all maintained a high and fluctuating curve of friction coefficients all through the wear tests. Adhesive wear or abrasive wear was the main wear mechanism.

The typical friction trace reveals an initial high value under kerosene-lubricated condition for either TiN or TiCN coating disks against the steel ball (ball-on-disk, point-contact wear mode), as shown in Fig. 7(b). In tests conducted in lubricated sliding contact conditions, the material transfer and adhesion wear predominantly occurred while friction coefficients were between 0.6 and 0.9; this also induced fatigue fracture on the coating. Therefore, the initially high friction coefficient was due to the transferred layer formed on the coating disk during initial wear tests. A tribochemical reaction and the reciprocating rubbing action under high contact pressure induced severe wearing on the coating disks. A short test analyzed the tribological behavior between the contact surfaces of these

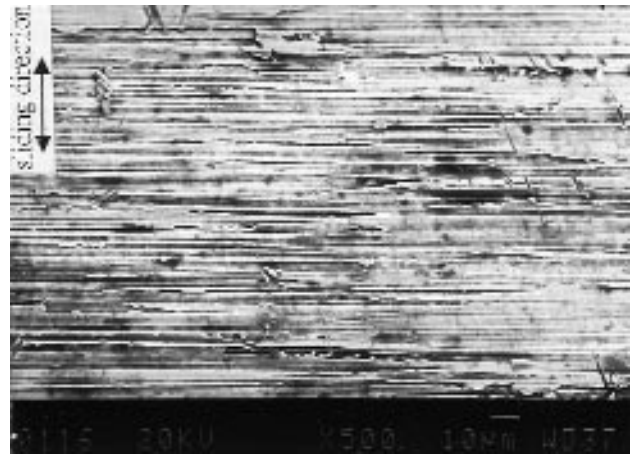
**Fig. 10** The wear scar of the 1045 steel cylinder sliding against the  $Ti_{10\%}$ -C:H coating. (a) Transferred layer is formed on the 1045 steel cylinder. (b) The same wear scar of (a) after the transferred layer is removed

the counterbody 1045 steel cylinder to the worn surface. A transfer layer was formed on the counterbody 1045 steel cylinder from the coating disk, as shown in Fig. 10(a). The original machining mark of the 1045 steel cylinder can be clearly observed below this transfer layer. For further analysis, the transfer layer on the 1045 steel cylinder was cleaned out after the wear test, as shown in Fig. 10(b). Figure 10(b) indicates that nearly zero wear occurred on the 1045 steel cylinder during the test. Obviously, the
