Environmental Degradation of Materials during Wet Storage of Spent Nuclear Fuels

Vivekanand Kain, K. Agarwal, P.K. De, and P. Seetharamaih

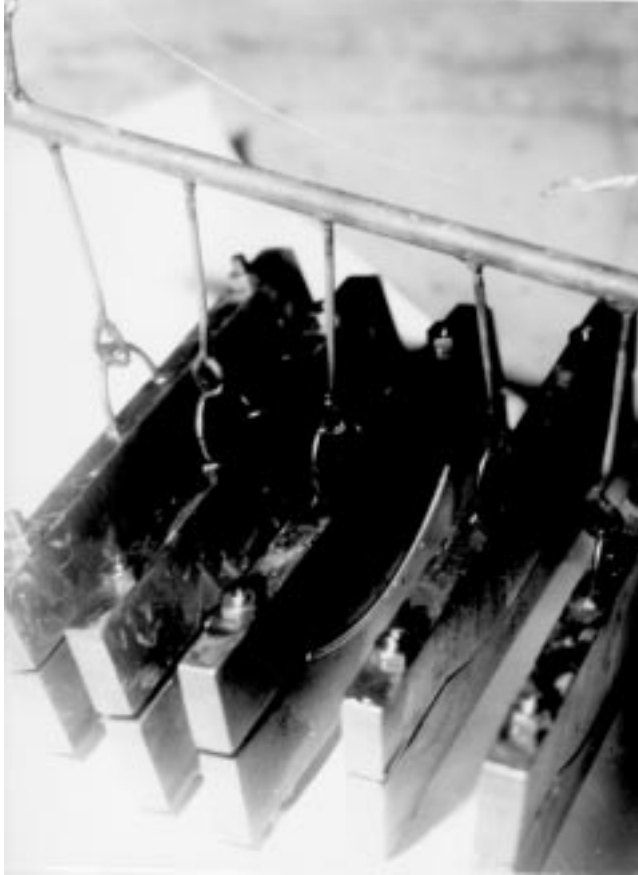
Fig. 2 CBB assemblies after exposure in the spent fuel storage pool

These samples were fixed in individual CBB assemblies and immersed close to the bottom of two SFSPs. The radiation level at the site of immersion of the samples is 1000 R/h (Roentgen per hour) maximum. At the Trombay SFSP, periodic inspection of these assemblies was carried out every 3 months, up to a total period of 1 year. At the Tarapur SFSP, inspection was carried out after a gap of 1 year. The parameters examined were surface appearance, pH in the crevices, and corrosion mapping. The CBB assemblies with fitted-in samples are shown in Fig. 2, at the time of removal from SFSP.

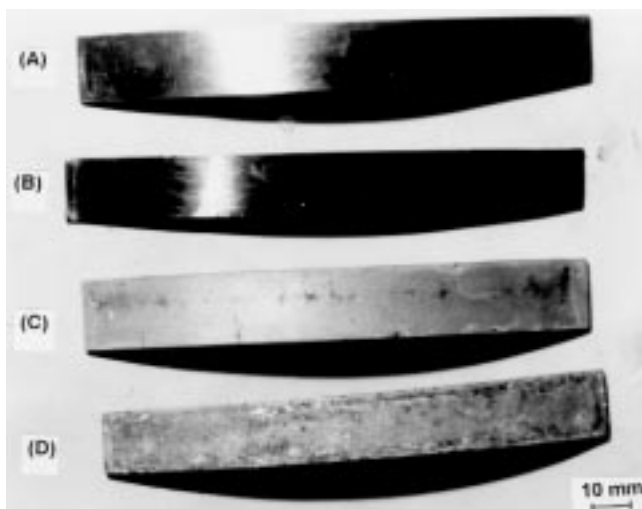
Fig. 4 Surface appearance of (a) type 304 stainless steel, (b) Zircaloy-2, (c) Al-1S (oxidized), and (d) Al-1S (polished) samples after exposure with CBB assemblies in spent fuel storage pool for 6 months

- The Al samples (both the as received and the autoclaved) in the CBB assemblies were found to be corroded after 6 months of exposure, in both the pools.

- After 6 months of immersion, the as-received sample showed more crevice corrosion compared to the autoclaved sample. The extent of corrosion in the two samples was comparable after 1 year of exposure.

- The Al samples (in both the surface conditions) showed pitting attack on the cross-sectional surface of the samples. The pits were decorated with whitish products on the surfaces and the pitting attack occurred in both the pools. However, the number of pits was less (<5) on the cross-sectional surfaces.

- Corrosion mapping carried out on corroded Al samples indicated that more than 60% of the crevice surfaces had undergone attack. After 1 year of exposure, the overall corrosion rate was measured to be 122 and 112 $\mu\text{m}/\text{yr}$ for the polished and autoclaved samples, respectively. The maximum depth of corrosion damage was measured in the metallographic examination to be 0.62 and 0.44 mm, respectively.

- There was no evidence of any localized attack on any of the SS or Zircaloy samples.
- There was no evidence of SCC on any sample.

The appearance of these corroded samples after 6 months exposure in SFSP is shown in Fig. 4.
