Mechanisms of Erosion-Corrosion on a Cobalt-Base Alloy and Stainless-Steel UNS S17400 in Aggressive Slurries

M. Reyes and A. Neville

Two materials, which are candidates in the construction of drill bits, have been studied in severe liquid-solid impingement conditions. Analysis of the weight loss was carried out on Stellite X40 (Co-base) and UNS S17400 (stainless steel) materials at 30, 60, and 90° angles of impingement under erosion-corrosion conditions at the free-corrosion potential and with applied cathodic protection.

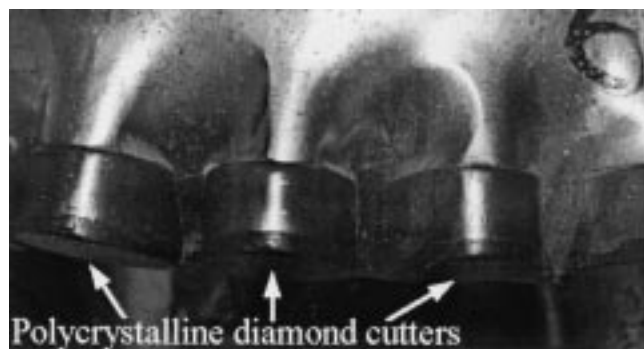
Fig. 1 Severe degradation of the material behind the diamond cutters

The drilling jets impinge on the material between and behind the polycrystalline diamond compact (PDC) inserts. The removal of material in the regions behind the PDC inserts causes loss of the materials that support the PDC cutting inserts, as shown in Fig. 1. The working life of a PDC drill bit in subsea can vary from 20 to 200 h depending on the working conditions. The body material currently used is primarily the cobalt-based superalloy Stellite X40. It is common for certain areas of the bit to erode at a high rate, and the diamond cutters are removed due to the loss of support.

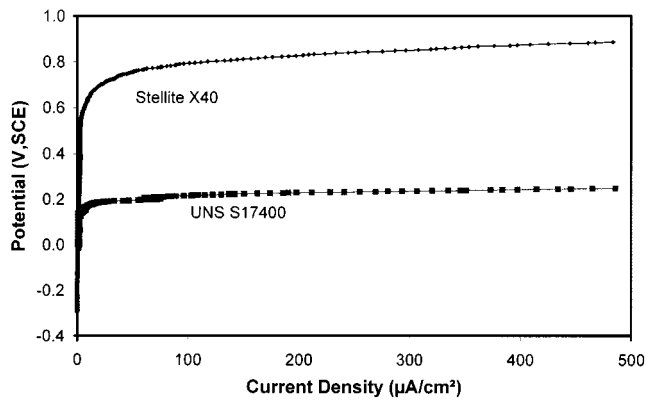
In the static saline conditions, both materials exhibit passivity, as is evident from the very low currents (typically $<5 \mu\text{A}/\text{cm}^2$), measured as a function of potential in the anodic-polarization curve presented in Fig. 5. The range of potential values over which the materials are passive (marked in Fig. 5 for Stellite X40) are contrasting—in excess of 700 mV for Stellite X40 compared with approximately 200 to 300 mV for UNS S17400. The lower breakdown potential, E_b , signifies a lower resistance of UNS S17400 to the onset of corrosion and the localized loss of passivity. In Table 3, the main mechanisms of corrosion are described, and it is apparent that both materials are affected by localized pitting corrosion. Pitting-initiation sites on Stellite X40 could normally be associated with the interface between the carbide phase and the matrix (Fig. 6), whereas on UNS S17400, no definite correlation with microstructural features could be made.

Fig. 5 Static anodic-polarization curves of Stellite X40 and UNS S17400 at 18 °C in seawater

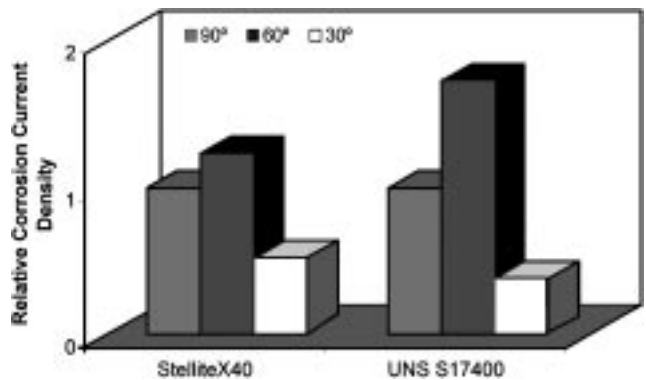
Fig. 9 Corrosion-current density as a function of angle for UNS S17400 and Stellite X-40 normalized to the value at 90°

From these data, it is possible to calculate the electrochemical corrosion mass loss per unit time using the Tafel extrapolation technique. This is shown clearly in Fig. 8 for UNS S17400 with values of 2.6, 11.6, and 6.7 $\mu\text{A}/\text{cm}^2$ for 30, 60, and 90° angles of impingement, respectively. Figure 9 shows the trends of the corrosion currents of both materials as a function of the impingement angle normalized to the value at 90°. For both materials, the largest value occurs at 60° and the lowest at a 30° angle of impingement.

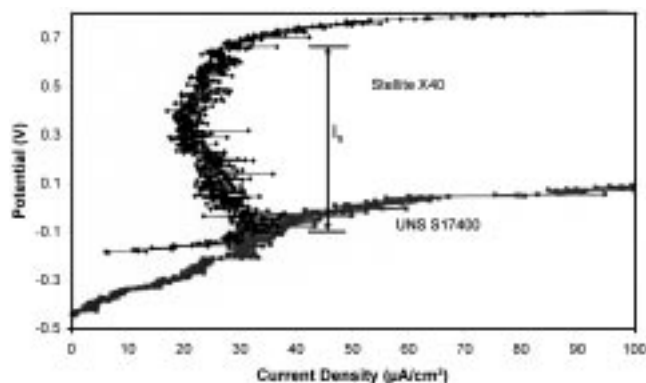
Figure 7 shows, for the two materials, the anodic-polarization curves recorded during liquid-solid impingement at a 90° angle of impingement. The materials clearly no longer exhibit passivity, and the form of the anodic-polarization plot on both materials is contrasting. The common features on both materials are the increased oscillation in the recorded current when compared with the static anodic-polarization response. In addition,

Fig. 7 Anodic polarization under 500 mg/L solids, liquid-solid erosion at 18 °C

feature is the stabilization of the current after attaining a value of around $30 \mu\text{A}/\text{cm}^2$ on Stellite X40, labeled I_s in Fig. 7. Immediately on increasing the potential from the free-corrosion potential on UNS S17400, the current increases (following Tafel^[13] kinetics), achieving a higher rate of increase once a potential of -0.1 V is reached. This is almost akin to the

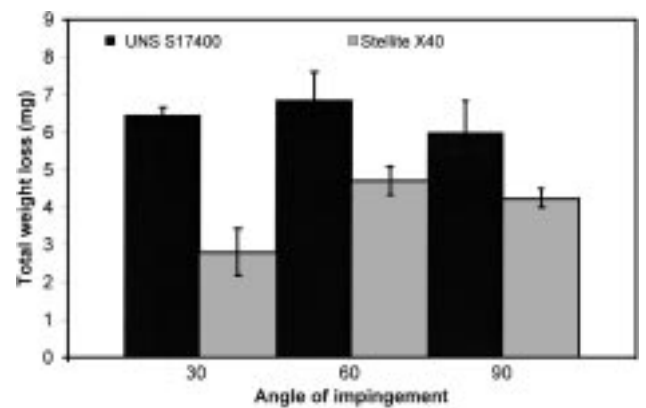
Fig. 10 Total weight loss as a function of angle for UNS S17400 and Stellite X-40

The important aspects of the material loss as a function of the impingement angle, given as TWL (Fig. 10), are described as follows.

- In common with the electrochemical corrosion results, the maximum TWL value on both materials occurs at a 60° angle of impingement.
- Contrasting trends at higher and lower angles are exhibited such that
 - on UNS S17400, TWL at 60° > TWL at 30° > TWL at 90°
 - on Stellite X40, TWL at 60° > TWL at 90° > TWL at 30°.
- UNS S17400 shows smaller changes in TWL as a function of the angle, although TWL values are larger.

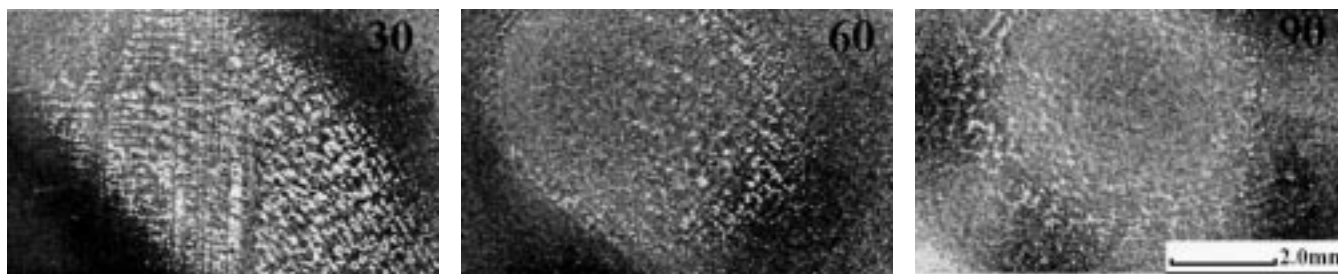
Pitting is also seen on Stellite X40 after anodic polarization under erosion-corrosion conditions outside the wear scar, being initiated in the carbide/matrix interface. Additionally, in the center of the impingement zone, the two-phase microstructure becomes much more evident due to the variation in hardness between the phases and the preferential erosion of the softer matrix. The network of carbides can be seen, protruding from the surface, at the three angles of impingement after erosion-corrosion for 4 h in Fig. 15.

Fig. 15 Wear scars of Stellite X40 under 500 mg/L solids slurry erosion changing angle of impingement
