Thermal Shock Testing of Thermal Barrier Coating/Bondcoat Systems

Keywords MCrAlY, thermal barrier coating, thermal shock testing

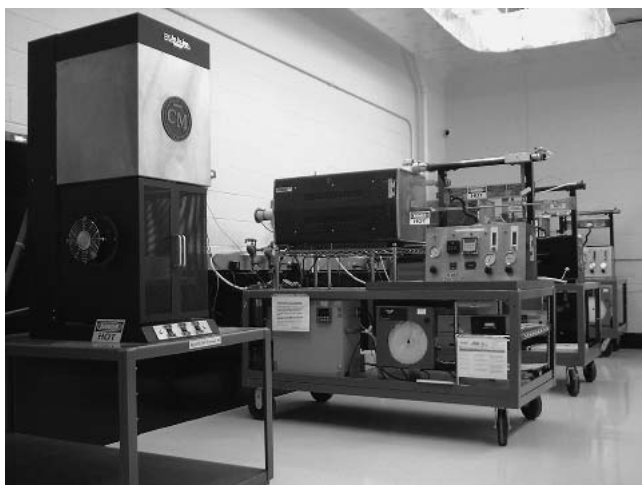
Fig. 5 Bottom-loading furnace and horizontal tube furnaces for cyclic FCT testing of TBC/bondcoat systems

Figure 5 shows a bottom-loading furnace and horizontal

tube furnaces used for testing. In the case of the horizontal tube furnace, the alumina tube is heated to the desired temperature, creating an isothermal heating zone of typically 15-20 cm in length. The samples are loaded onto a ceramic boat and introduced into the hot zone with a pneumatic manipulator (Fig. 6). The heating and cooling rates are several hundred degrees Celsius per minute (Fig. 7). The highest thermal gradients are achieved during cooling when forced air is used to cool the surface of the TBC. In the case of a bottom-loading furnace the hot zone is typically a cube with dimensions of $15 \times 15 \times 15$ cm. The samples are loaded on a ceramic fixture attached to a retractable bottom lid. Forced air cooling is accomplished through the use of a fan.

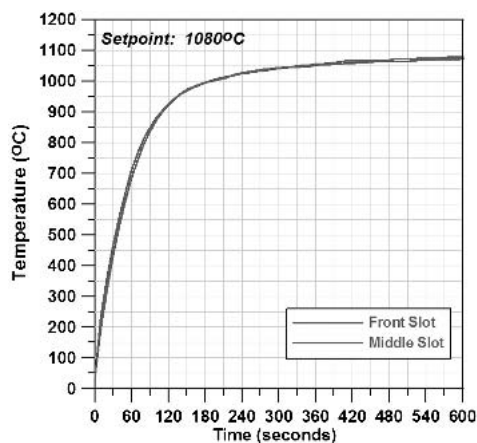
Fig. 7 Typical heat-up and cool-down rates in the FCT test measured with thermocouples attached to the sample surface. Furnace 5: temperature profile vs. boat position

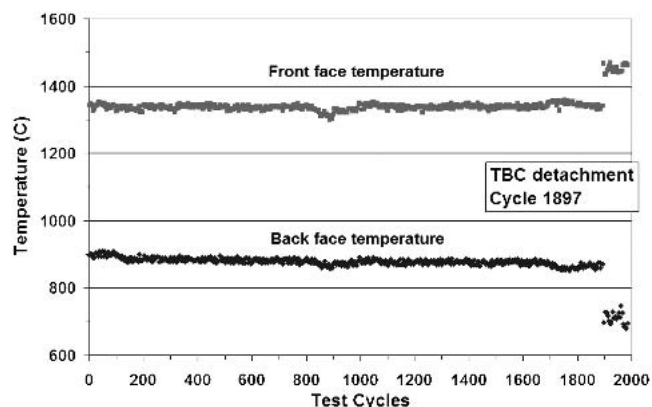
Fig. 9 Typical JETS temperature profile front- and back-face temperature over 2000 cycles with TBC detachment at 1897 cycles

The temperature gradient over the sample is dependent on the TBC thickness, composition, density, and microstructure. For example, a vertically macrocracked 40 mil 8YSZ coating typically gives a temperature difference between the front-face and back-face of approximately 400-500 °C. The temperature difference is also used to monitor the integrity of the TBC coating. A sudden significant increase in the temperature difference indicates a delamination within the TBC or at the bondcoat interface (Fig. 9).

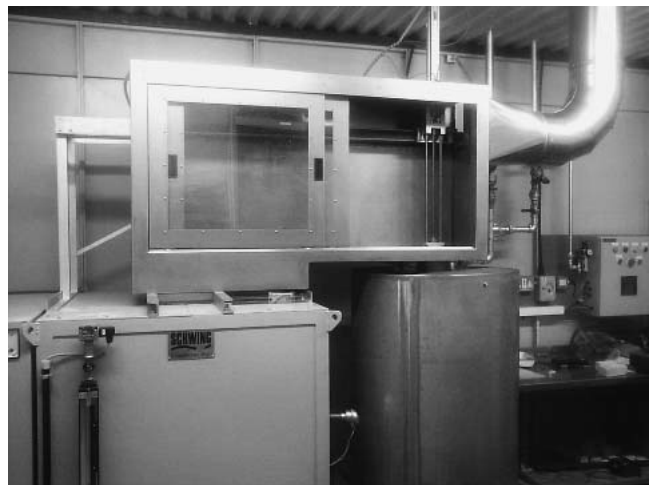
Fig. 12 Fluidized bed thermal shock rig in PST Weston-super-Mare, UK

cally operated at 1000 °C. Test samples are transported via a pneumatic system into a cooling zone in which compressed air is directed onto the TBC surface. A photograph of the rig is shown in Fig. 12.

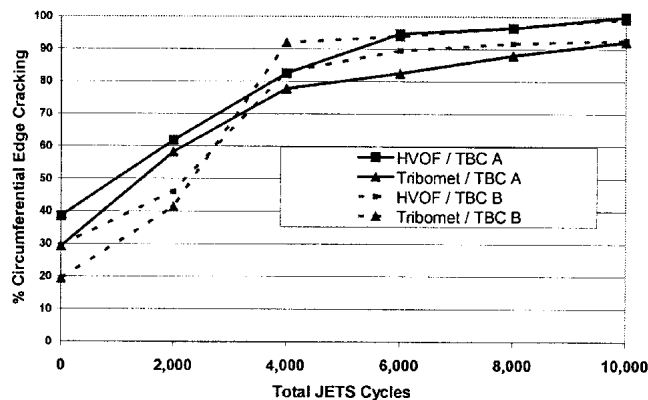
Fig. 16 Increase of cumulative edge cracking during JETS testing for TBC A and B on Tribomet and HVOF bondcoats

JETS testing of the samples from Example 1 was conducted for a total of 10 000 cycles. The results of the accumulated increase in the edge cracking are shown in Fig. 16 in 2000 cycle intervals.

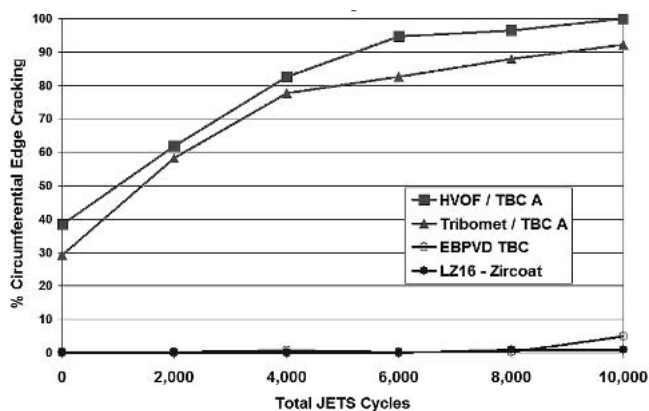
Fig. 20 JETS results for segmented TBC (1.1 mm thickness) and EBPVD TBC (0.5 mm thickness); low-density TBC is included for reference. The JETS heat flux corresponds to a front-face temperature of 1400 °C on the segmented TBC.

2.4.3 Example 3: Dense Vertically Macrocracked APS and EBPVD TBC. In the case of a highly strain-resistant TBC, such as a dense vertically macrocracked APS TBC, or an EBPVD TBC, the JETS test does not lead to failure within a reasonable measuring time. In Fig. 20, the JETS results for these two coatings are shown for over 10 000 JETS test cycles. The APS TBC with a dense vertically macrocracked micro-

structure of approximately two cracks per linear mm, and the EBPVD TBC with a columnar growth microstructure, only develop minor edge cracking after 8000 JETS cycles. In the FCT test, however, the life of these coatings is typically several hundred hours at 1135 °C and is predominantly dependent on the bondcoat degradation.
