# Microstructural Alterations Associated With Friction Drilling of Steel, Aluminum, and Titanium

Scott F. Miller, Peter J. Blau, and Albert J. Shih

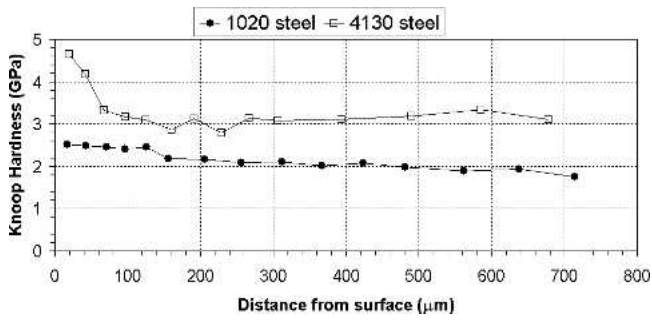
**Fig. 4** Microindentation hardness profiles of subsurface in friction drilled AISI 1020 and 4130 steel workpiece (0.245 N force used)

Knoop microindentation (the indentation load was 0.245 N) subsurface hardness profiles comparing the AISI 1020 with that of AISI 4130 steel are shown in Fig. 4. The zone of high hardness caused by the severe plastic deformation for AISI 1020 appears to extend 120  $\mu\text{m}$  below the surface, while AISI 4130 drops off more steeply at about 60  $\mu\text{m}$  below the surface. The AISI 4130, as expected, has higher hardness values. Hardening also occurred on the upset portion of the boss region, indicated as box C in Fig. 2(a). Figure 5 shows the microstructural texturing in this zone on AISI 1020 steel. The indentation hardness of this upset region was 3.01 GPa, but that of the drawn out tip at the bottom end of the hole was less, about 2.29 GPa. Both hardness values in the boss region are

higher than that of the sheet well away from the hole, about 1.46 GPa.

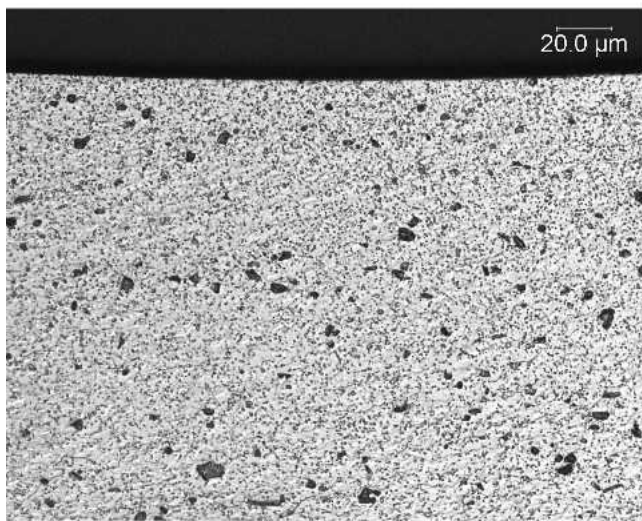
**Fig. 8** (a) Close-up view of box E in Fig. 2(c), microstructure of Al 5052 showing a fine crack parallel to the hole wall above a region where a section of wall material was torn free, and (b) cross-sectional view of line F-F in Fig. 2(c), microstructure showing very subtle evidence for shear from right to left, but showing no clear boundary between highly-deformed material and the underlying grain structure (Keller's etch)

Damage to the interior surface of the friction-drilled hole in Al 5052 sheet is evident in Fig. 7. Severe scoring and plastic deformation with surface delamination are present. Figure 8(a), marked as box E on the cross section in Fig. 2(c), exhibits thin platelets of aluminum that were removed, leaving some regions with microcracking below the deformed layers. The tendency of aluminum adhering to metalworking and machining tools is commonly known (Ref 20). The tremendous pressure and the high temperature generated by the process will “weld” the two active surfaces together. If the bonding energy of the “weld” is stronger than the cohesive energy of the workpiece materials, then workpiece adhesion may be formed on the tool (Ref 21). This is once more demonstrated in the case of friction drilling.

Figure 8(b) shows microstructure of the area in the bushing with the cross-section parallel to the plane of the sheet, marked as line F-F in Fig. 2(c). Compared with the white-etching layers seen in AISI 4130 steel in Fig. 6, Fig. 8(b) shows much less

obvious development of a discontinuous zone of near-surface deformation adjacent to the bore surface.
