# Crevice Corrosion of Titanium in High Temperature-Concentrated Chloride Environments

Crevice corrosion of titanium is activated in concentrated chloride media at 100 °C. This was possible only with the tightest gap (0.005 cm) between Ti-Ti surfaces. No crevice corrosion was observed with greater gap dimensions. The design of the crevice led to the occurrence of two concentric circular rings of corroded areas, with many pits on them. After potentiostating in the passive region for 5 h in 25% NaCl (pH = 4.7)—where hydrogen evolution is thermodynamically prohibited—hydrogen gas bubbles were observed to egress out of the crevice mouth during ongoing crevice corrosion. This indicates that hydrogen evolution occurs within the crevice. The results are compatible with the occurrence of gradually increasing ohmic potential shift and localized acidification in the crevice electrolyte as judged by the measured gradual increase of the crevice corrosion current. The high acidity of the bulk electrolyte does not seem to be sufficient or even a necessary condition for crevice corrosion to occur.

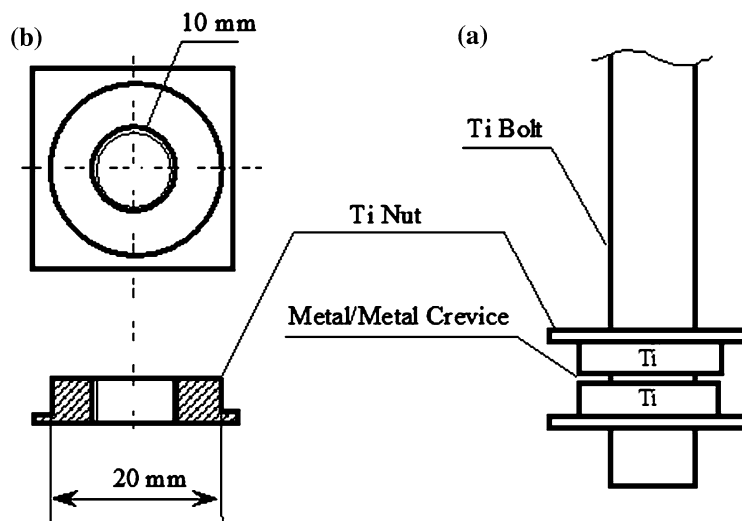
**Fig. 1** Schematic of the metal/metal crevice specimen. (a) Crevice setup and (b) top and side view of the titanium nut

A crevice was created between two nuts threaded onto a bolt, all made from commercially pure titanium. The crevice was made by finger-tightening the two nuts against each other on the bolt. A schematic diagram is shown in Fig. 1. This arrangement makes a metal/metal crevice between the adjacent surfaces of the two nuts. The crevice gap dimension was measured using an optical microscope. It was typically 0.005 cm. The bolt was designed in such a way as to eliminate crevice corrosion between the bolt and the nuts. It was machined down to a 3 mm thick slab in the region where the nuts are mounted. This made the gap between the bolt and most of the inner circumference of the nuts large enough so that crevice corrosion did not occur. It also exposed the crevice opening at the inner circumference of the nuts to the controlled potential and the bulk electrolyte. The nuts and bolt were examined after each experiment. In all the measurements

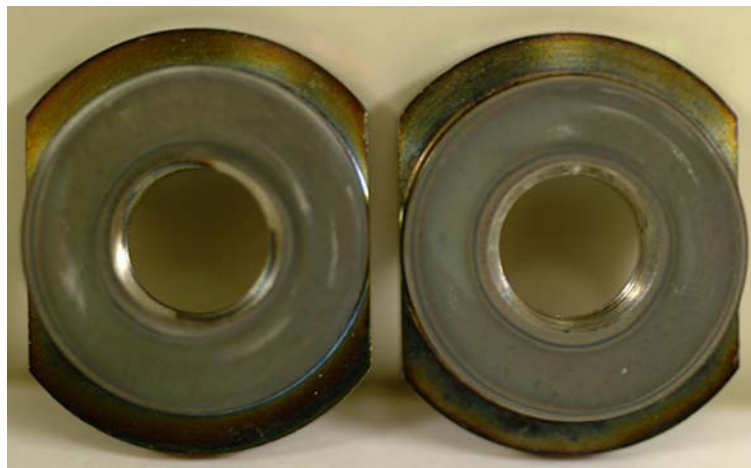
**Fig. 2** Photograph of the crevice surfaces after test #1, 1.5 % HCl at 80 °C

Conditions	Test #1	Test #2	Test #3
Electrolyte	1.5% HCl	1.5% HCl + 19%NaCl	25% NaCl
Temperature	80 °C	100 °C	100 °C
pH	0.6	0.6	4.7
$E_{H_2/H^+}$	-178 mV (SCE)	-174 mV (SCE)	-477 mV (SCE)
Duration	24 h	12 h	25 h
Current	~0.5 mA cathodic	~0.3 mA cathodic	Anodic current,
Result	No crevice corrosion, see Fig. 2	Crevice corrosion occurred, see Fig. 3	Crevice corrosion occurred, see Fig. 5

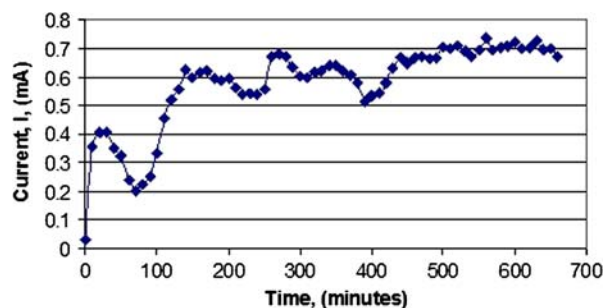
**Fig. 4** Current-time transient during on-going crevice corrosion of titanium immersed in 25 wt.% sodium chloride NaCl at 100 °C, test #3

the external surface of the crevice, the evolution of hydrogen at pH = 4.7 is thermodynamically unfavorable in view of the fact the equilibrium potential for h.e.r is -558 mV (SCE). Throughout the experiment, although we observed an anodic current started at the microampere range, it grew with time into the milliamper range, as shown in Fig. 4. This indicates the activity of crevice corrosion.

are hydrolyzed to produce an acidic local environment, with a pH well below 1 (Ref 3), which destabilizes the protective film (Ref 26). The localized breakdown of this film under the more active local potentials and constricted acidified solution deep inside the crevice leads to anodic dissolution of titanium, similar to the condition shown in Fig. 4. Figure 5 illustrates the crevice corrosion which resulted from this test.

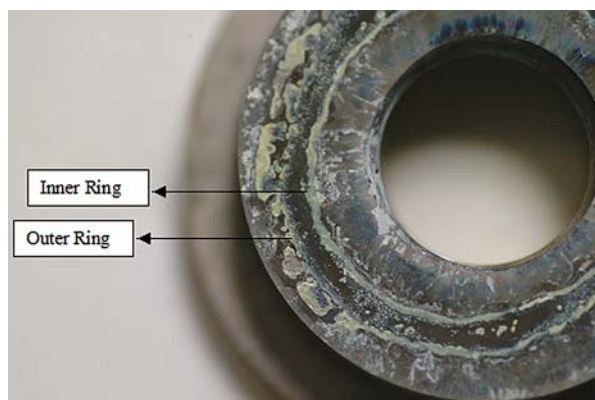
**Fig. 5** Photograph of one of the crevice sides after test #3. The two rings of the surface attack appear in the figure

An important finding in our study is that crevice corrosion attacked the surface in two circular rings with some pits into them, and no attack in the other areas. This can be readily explained in view of the fact that our experimental setup geometry provided a crevice with two circular mouths facing the electrolyte; one is the outside rim of the specimen and the other is much smaller next to the titanium bolt. It was always noticed that the two concentric rings were not in the middle of the crevice area, but rather shifted closer to the inner circumference of the nuts. A possible interpretation is the operation of the IR drop mechanism in this system which predicts similar behavior. More work is needed to clarify this behavior.

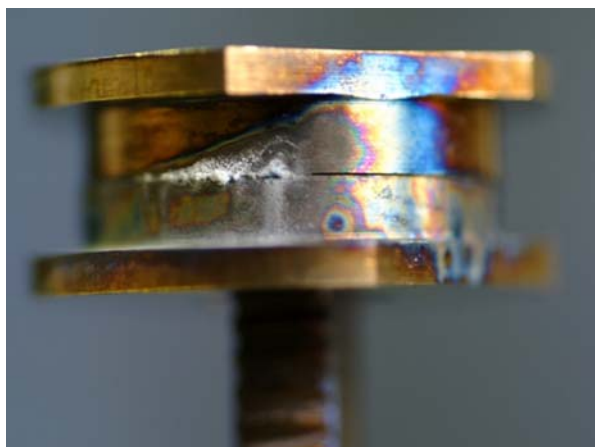
**Fig. 6** Photograph of the crevice cell after test #3, 25 % NaCl at  $100 \text{ }^\circ\text{C}$
