Influence of De-icers on the Corrosion and Fatigue Behavior of 4140 Steel

The purpose of this test was to evaluate the effects of calcium magnesium acetate (CMA) and sodium chloride (NaCl)—two common substances used to de-ice roadways—on the corrosion and fatigue behavior of annealed AISI 4140 steel. When CMA-corroded, NaCl-corroded, and as-machined samples were tested using $R = 0.1$, and $f = 20$ Hz, it was found that, within the scope of this study, samples corroded in both 3.5% CMA solution and 3.5% NaCl solution exhibited a lower fatigue strength than samples tested in the as-machined, uncorroded condition. For the short lives tested in this study, the difference in the effects of CMA and NaCl is minimal. However, at longer lives it is suspected, based on the trends, that the CMA solution would be less detrimental to the fatigue life.

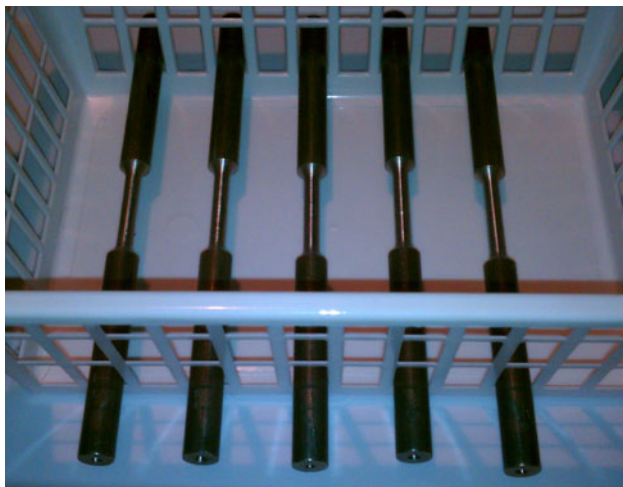
Fig. 1 Samples in holding rack prepared for immersion in the corrosion bath

For the corrosion process the machined portion of the samples were cleaned with alcohol to remove any oils or debris. Next they were divided into two groups of five and placed into two separate racks. Two polymer containment vessels were filled with 5 L of water, each. A 3.5% concentration was achieved by mixing 175 g of NaCl and CMA in to separate baths. The samples were placed horizontally in a holding rack (shown in Fig. 1). Once the NaCl and CMA had fully dissolved, the

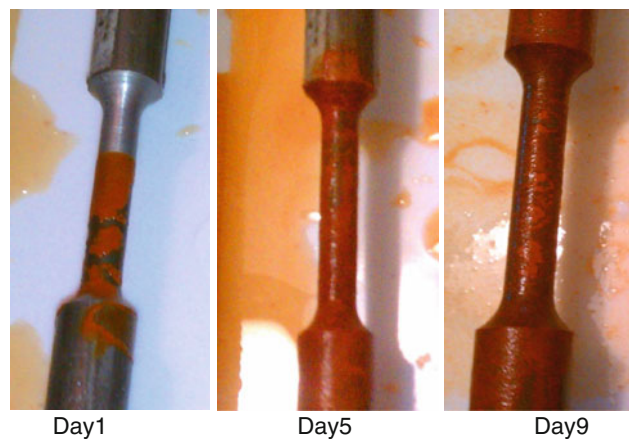
NaCl - Corroded

CMA - Corroded

Fig. 2 NaCl and CMA samples throughout the corrosion process

As shown in Fig. 2, the corrosion progressed rapidly over the course of 9 days. The corrosion caused by the NaCl penetrated deeply into the surface of the samples causing

pitting. The corrosion caused by the CMA appeared to be mostly confined to the surface, and there were also no signs of pitting or loss of area due to this oxidation. The CMA reacted with the steel in such a way that the oxide layer appeared to protect the steel from further oxidation, but more analysis needs to be performed to validate this claim.

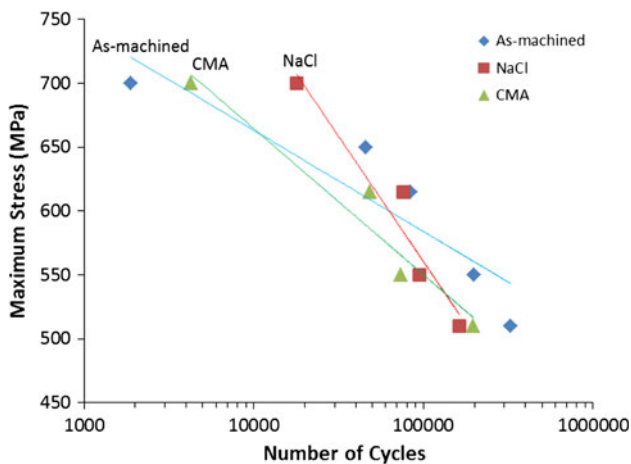
Fig. 4 Maximum stress versus number of cycles until failure

The test parameters and numbers of cycles until failure for each sample are shown in Table 2. This $S-N$ curve is presented in Fig. 4. The as-machined samples had longer lives at all stress levels except at the highest stress. At the highest stress it is not expected that superficial surface damage would control life. The highest stress level (~75% of reported yield strength) was high enough to actually provide some localized yielding, as was seen by a reduction in cross-sectional area. The variation in fatigue life for the three test conditions at the highest stress is more than likely a statistical phenomenon and not a direct function of the surface condition. The two corrosion baths had very little difference between the two for the stresses tested. The trend however, based on these results, is for NaCl to be more detrimental to the fatigue life. The lowest stress resulted

in runout tests of 10^6 cycles for all conditions (those data points are not shown in Fig. 4 for simplicity).

medium stress ranges (550 and 615 MPa) CMA exhibited the lowest fatigue strength. At lower stress (510 MPa) the NaCl sample exhibited the lowest strength; at a point below the yield strength (400 MPa) all three samples were runouts and were stopped after 10^6 cycles. This is based on the endurance limit defined in *Machine Component Design* (Ref 5). At 700 MPa the as-machined samples exhibited the lowest fatigue strength, although the differences between the three conditions, as was
