The Quasi-static Deformation, Failure, and Fracture Behavior of Titanium Alloy Gusset Plates Containing Bolt Holes

Therese Hurtuk, C.C. Menzemer, A. Patnaik, T.S. Srivatsan, K. Manigandan, and T. Quick

In this article, the influence of bolt holes, specifically their number and layout on strength, deformation, and final fracture behavior of titanium alloy gusset plates under the influence of an external load is presented and discussed. Several plates having differences in both the number and layout of the bolt holes were precision machined and then deformed under quasi-static loading. The specific influence of number of bolt holes and their layout on maximum load-carrying capability and even fracture load was determined. The conjoint influence of bolt number, bolt layout pattern, nature of loading, contribution from local stress concentration, and intrinsic microstructural effects in governing the macroscopic fracture mode and intrinsic microscopic mechanisms is presented and discussed.

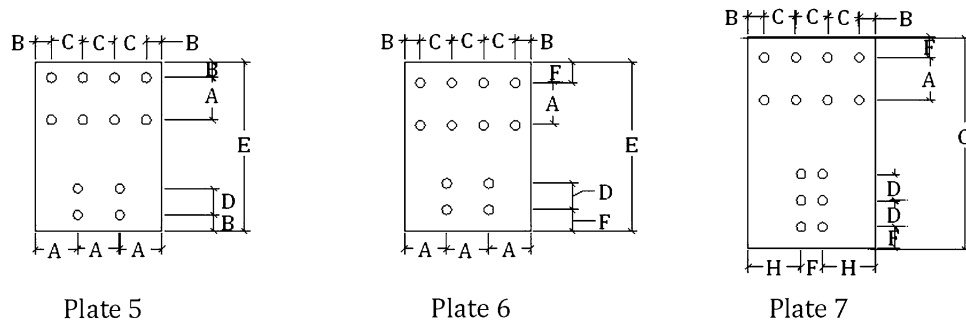
Fig. 4 Geometry and configuration of the test specimens prepared from Lot #2 of the Ti-6Al-4V alloy plate provided by TIMET (Wentzville, MO, USA). A: 101 mm, B: 38 mm, C: 76 mm, D: 64 mm, E: 406 mm, F: 51 mm, G: 508 mm, H: 127 mm, I: 28.6 mm, J: 457 mm, K: 32 mm, L: 32 mm, L: 25 mm, M: 89 mm, N: 60 mm

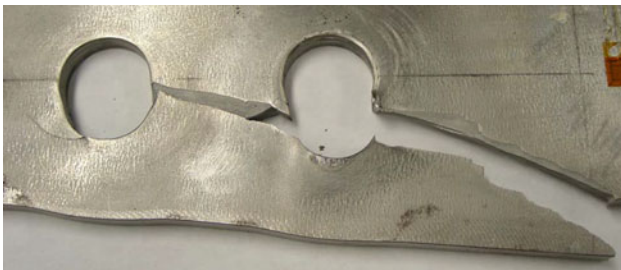
Fig. 9 Low-magnification micrograph showing overall morphology of failure of Plate #1

Plate #1 (Fig. 9) and Plate #2 (Fig 10) were observed to rupture essentially along the tension plane prior to rupture by fast fracture along the edges of the plate. Failure of both these plates occurred rapidly and without much warning. In considering the observed failure modes of steel gusset plates and aluminum alloy gusset plates in earlier studies (Ref 5-8), the observed failure of the Ti-6Al-4V alloy gusset plates under the influence of an external load is as expected. Under conditions of load-controlled testing, the observed failure load coincided well with the maximum load applied to the gusset plate.

Plate #1 experienced normal tensile rupture between the bolt holes followed by diagonal shear rupture towards the edges. While the observed failure of Plate #2 was identical, the path followed was noticeably different. Tension rupture occurred between the holes located at the bottom. Subsequent rupture towards the left side of loading was curved in a vertical direction, i.e., along the load axis, and rapidly extended to the edge of the plate. These two plates revealed visible signs of

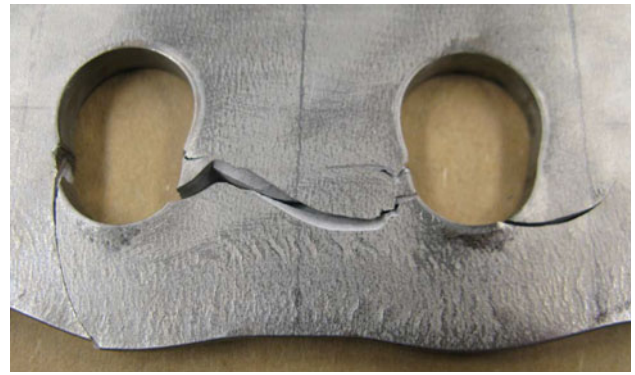
Fig. 10 Low-magnification micrograph showing overall morphology of failure of Plate #2

yielding prior to failure with the greatest yielding evident for Plate #2 indicative of the occurrence of the “orange-peel” effect. Also, for Plate #2 bulging was evident along the bottom of the plate. This evidence of permanent deformation is ascribed to be due to local compressive yielding, or bearing stresses, caused by the bolts against the holes. The maximum strength of Plate #1 was 390 kN (87 kips) and occurred at the time of failure. The maximum strength of Plate #2 was 401 kN (89.54 kips) and occurred immediately prior to failure [at 374 kN (83.5 kips)].
