# Low-cycle fatigue-crack initiation study in René 95

M. N. MENON, W. H. REIMANN

*Air Force Materials Laboratory, Wright-Patterson Air Force Base, Dayton, Ohio, USA*

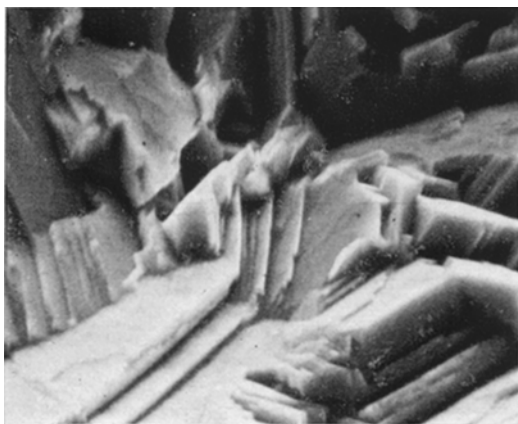
Figure 7 SEM of stage I fracture surface,  $\times 2100$ .

fracture. Fig. 7 shows a typical stage I area, which was always followed by a stage II area containing striations (Fig. 8). Both these areas can be seen in Fig. 9, which is a SEM micrograph of the regions near cracks 1 and 2, as viewed from the edge of the fracture surface at an angle. A comparison of Figs. 9 and 3 indicates that the cracks propagated in stage I mode until about 46 000 cycles, at which the fatigued area reveals indications of transition to stage II mode and further propagation in that mode until failure.

After extensive deformation, it is possible, however, that well defined slip bands could eventually form and become more and more intense with continued cycling as a result of dislocation accumulation. Cracking would then eventually occur on these bands leading to the extensive stage I facets observed in René 95. Absence of any dimples in the stage I area also indicates that the cracking followed such a planar mode through the recrystallized (necklace) grains. These planar bands of deformation can intersect within a grain itself or such bands from adjacent grains can intersect at the grain boundary leading to a situation in which the crack changes direction as it propagates. The facets shown in Fig. 7 are believed to have originated in the above manner.

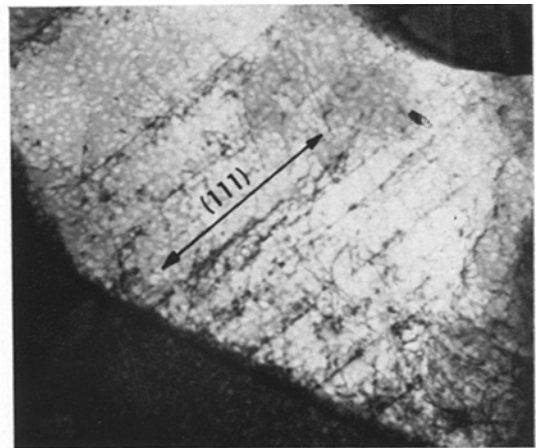
*Figure 15* Slip band formation in a necklace grain,  $\times 15\,500$ .

representative of a large number of foils examined. The deformation in the fine recrystallized grains was also very homogeneous in that the inter slip band spacing was extremely small (Fig. 15).
