High temperature stress relief cavitation of an Al-bearing α -brass

L. KJELLSSON, L. E. SVENSSON, R. SUNDBERG*, G. L. DUNLOP
Department of Physics, Chalmers University of Technology, Fack, 402 20 Göteborg 5, Sweden

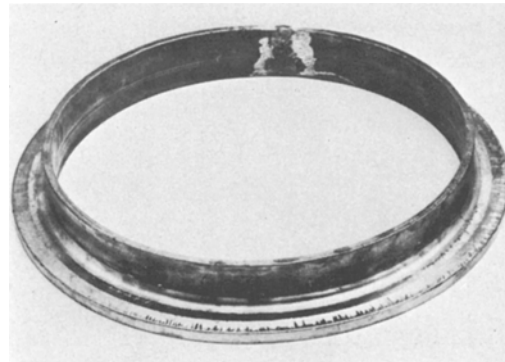
Figure 1 A pipe flange of aluminium brass made by welding together the two ends of an extruded "L" profile.

The present investigation was undertaken as a result of a problem which occasionally arises during the fabrication of pipe flanges (see Fig. 1)

from an Al-bearing alpha brass. The flanges are fabricated from "L-profiles" (extruded at $\sim 800^{\circ}\text{C}$) by bending the profiles at room temperature and welding the ends together. The flanges are then subjected to a stress relief annealing treatment at 550°C for 3 min. Subsequently the diameters and shape of the flanges are adjusted slightly to their correct values in a "calibration" operation at room temperature. During this latter operation, intergranular cracking and sometimes fracture can occur away from the weldment in certain casts of material of the same nominal composition despite the fact that the strain during calibration is considerably less than that which occurs during the initial bending of the profile to form the flange. Preliminary investigations have shown that the intergranular embrittlement is associated with the formation of intergranular cavities during the stress relief annealing treatment.

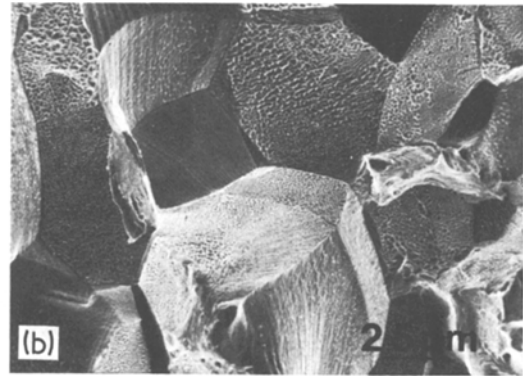
Figure 4 Fracture surfaces of tensile specimens taken from stress relieved flanges and strained to fracture at room temperature. (a) Cast No. 1, transgranular ductile fracture. (b) Cast No. 2, intergranular fracture.

The room temperature fracture surfaces of tensile specimens taken from flanges of both casts are shown in Fig. 4. Cast No. 1 exhibited typical transgranular dimpled fracture surfaces while the fractures in cast No. 2 were mainly intergranular and macroscopically brittle. Close examination of the fractures from cast No. 2 revealed that the intergranular fracture surfaces were essentially of three types (Fig. 5):

The relatively smooth and featureless intergranular surfaces visible in the room temperature fracture surfaces (Figs. 4b and 5) probably arise through elevated temperature interlinkage of cavities to form cracks covering whole grain boundary facets. It has been shown previously that such featureless surfaces can arise by smoothing of the previously cavitated surface by surface self-diffusion [16].
