# Thermal ageing effects in AISI type 316 stainless steel

The effects of long-term thermal ageing on the microstructure of AISI type 316 stainless steel are described. The microstructure of the aged steel is related to the reported embrittlement of the steel. The precipitation found is complex and the embrittlement appears to result, in part, from specimen preparation techniques interacting with the microstructure. The dominant creep deformation mechanism under service conditions appears to be diffusion creep.

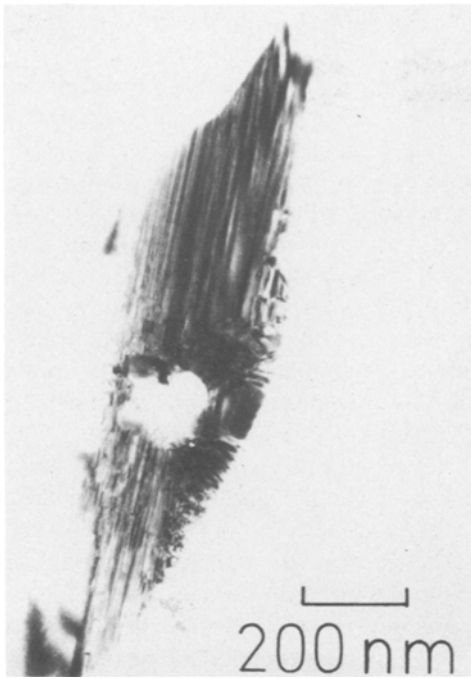
Figure 7 Laves phase precipitate with  $M_{23}C_6$  nucleus.

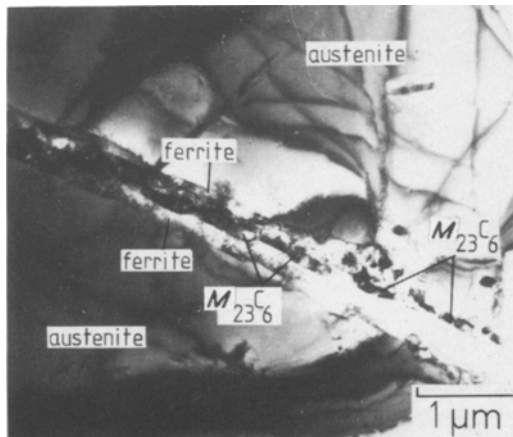
Figure 8 Ferrite in Specimen A.

Ferrite and  $M_6C$  occurred only in association with  $M_{23}C_6$  and Laves. Ferrite was present only in Specimen A, occurring either as continuous sheets on each side of the  $M_{23}C_6$  grain boundary precipitation, forming a sandwich, or as single particles growing out of the  $M_{23}C_6$  grain boundary precipitation into the austenite matrix (Fig. 8).

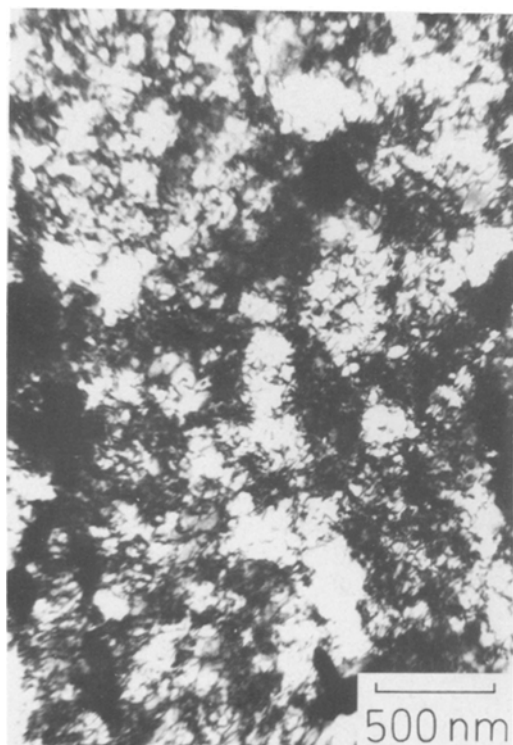
Figure 19 Thin foil from accelerated creep test specimen, showing very high dislocation density.
