The use of controlled copper dissolution as an anti-fouling system

G. W. J. SWAIN, R. A. FARRAR, S. P. HUTTON*

Department of Mechanical Engineering, University of Southampton, Southampton, UK.

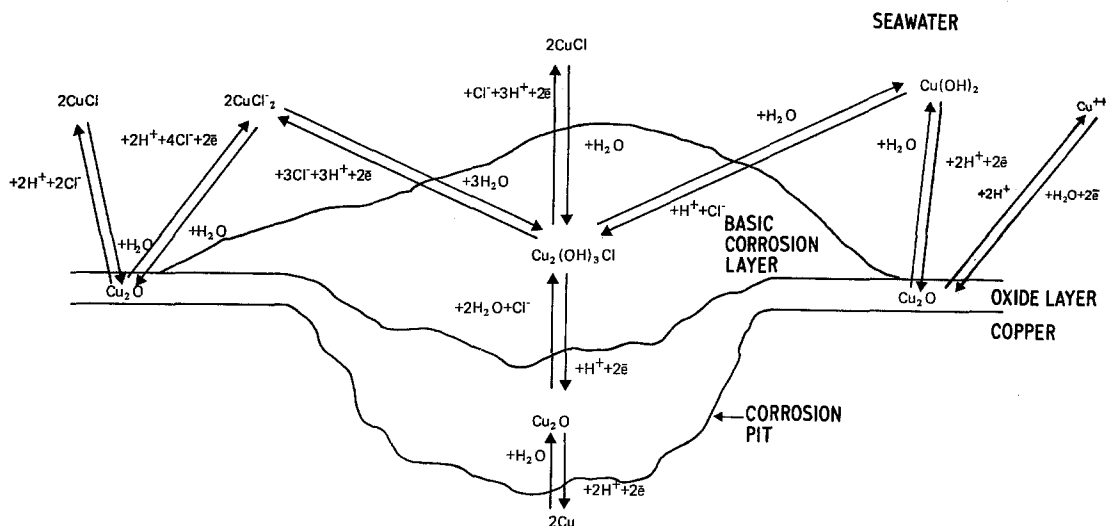
Figure 1 Chemical model for freely corroding copper in seawater.

Fig. 1 illustrates the various reactions that might occur in seawater. It shows that copper dissolution is not always a uniform process and that localized anodic and cathodic areas may be set

up. In the cathodic areas copper dissolution rates may be depressed below the level necessary to prevent fouling whilst at anodic areas pitting and wasting of the metal may occur. Anodic areas also encourage the formation of insoluble corrosion products and these may allow settlement by marine organisms.

A chemical model for freely corroding copper was presented earlier in this paper and illustrated in Fig. 1; the present results appear to confirm this model. This indicates that freely corroding copper loses its anti-fouling action when insoluble

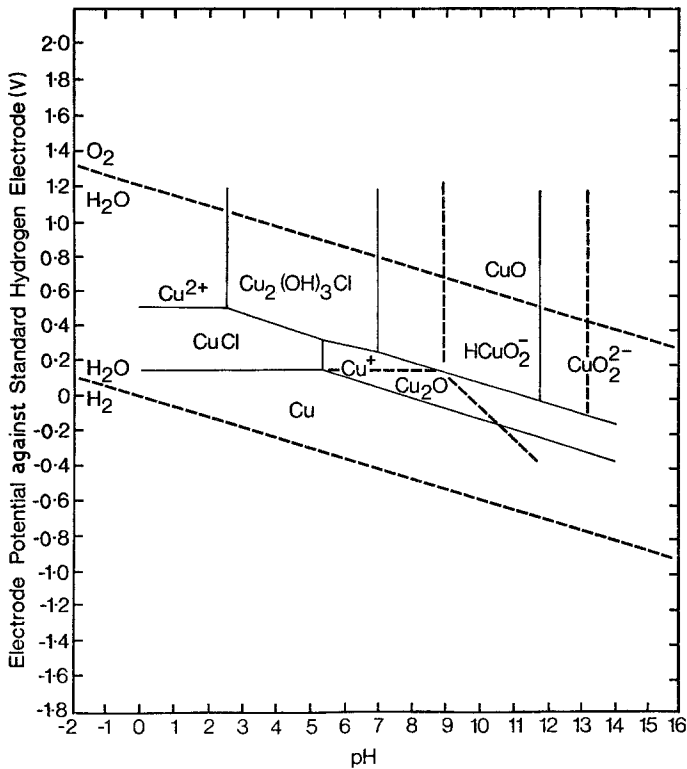
A more detailed picture of the chemical reactions involved with the seawater corrosion of copper can be obtained from the electrode potential–pH diagram devised by Bianchi and Longhi [15]. These diagrams indicate the reactions most likely to occur at known pH and potential values, and although they are subject to modification by inorganic constituents and other ambient parameters, they are valuable in predicting the direction which a reaction may take. Fig. 2 illustrates the possible corrosion reactions of copper at 25°C . The most favourable reaction for marine anti-fouling is:

Figure 2 Equilibrium diagram for copper in seawater at 25°C. Solid phase taken into consideration. Cu, Cu₂O, CuCl, CuO, Cu₂(OH)₃Cl (after [15]).

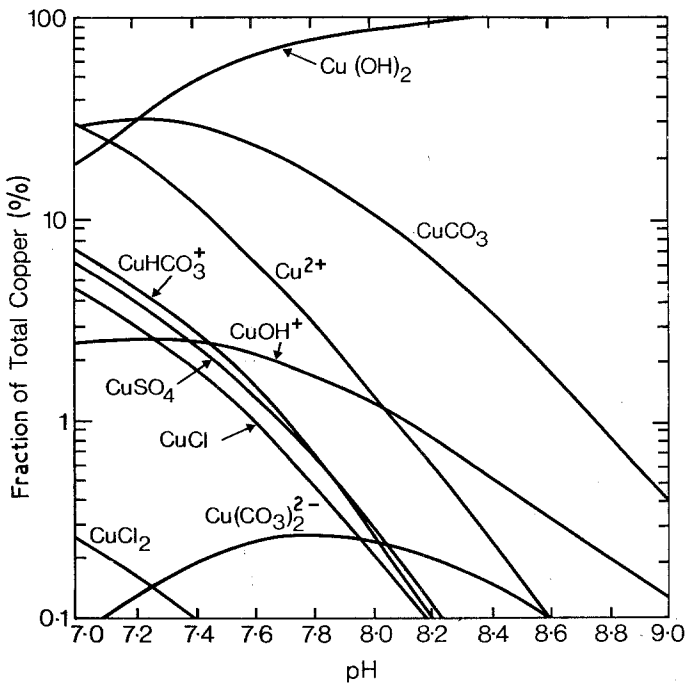
Another important factor, however, is the fate of the copper speciation once it enters solution. The work of Zirino and Yamamoto [16] has indicated that the thermodynamic stability of given species depends upon the local pH; Fig. 3 illustrates this variation. It is particularly significant that the cupric ion concentration varies rapidly in the pH range 7 to 8.6 and would therefore be strongly dependent on local pH changes

Figure 3 The effect of pH on the speciation Cu²⁺ in seawater at 25°C (after [16]).

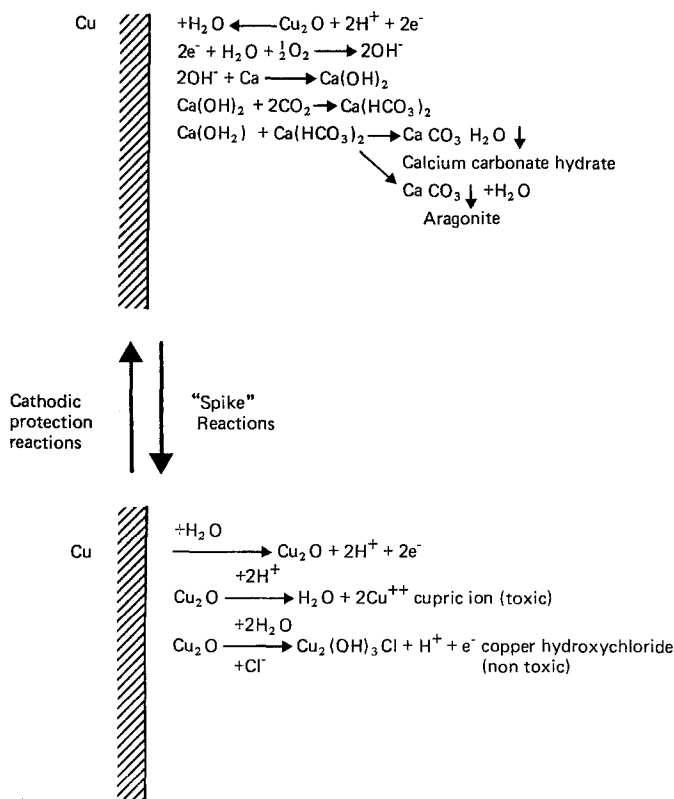
Figure 4 Surface reactions for the electrochemically controlled copper specimens (\downarrow indicates precipitation of insoluble products).

The possible changes that may occur at the surface of the copper are illustrated in Fig. 4. The important factor to notice is that, in both the

cathodic and anodic modes, the surface may become non-toxic. In the cathodic regime there will be no copper released and a slow build up of hydrated calcium carbonate, whereas in the anodic regime, the cuprous oxide layer will eventually be converted into non-toxic copper hydroxychloride.

In the case of the fully cathodically protected samples, these chalk layers grew to approximately 140 to 170 μm after 83 days exposure and displayed significant fouling settlement. In Fig. 4, the possible electrochemical reactions were illustrated and it was noted that cathodic chalking will occur and that it will become increasingly difficult to reverse the reaction as the chalk layer thickens due to the insolubility of the calcium salts.

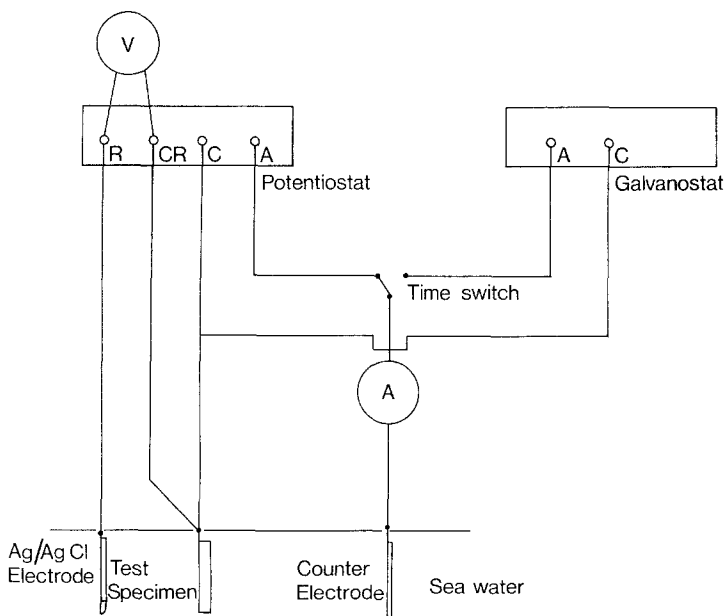
The metal coupons (100 mm by 100 mm by 1 mm), together with platinized titanium counter electrodes and silver-silver chloride reference electrodes were coupled so that the current was supplied from either a potentiostat or a galvanostat (see Fig. 5). When the potentiostat was in use, the copper was cathodically protected with respect to the reference electrode, but in the galvanostat mode the polarity was reversed and the coupon forced to corrode at a predetermined rate. During this so called "spiked" condition, toxic copper ions were released into the seawater. Details of the precise voltages and currents are indicated in Table

Figure 5 Electrochemical control arrangement.

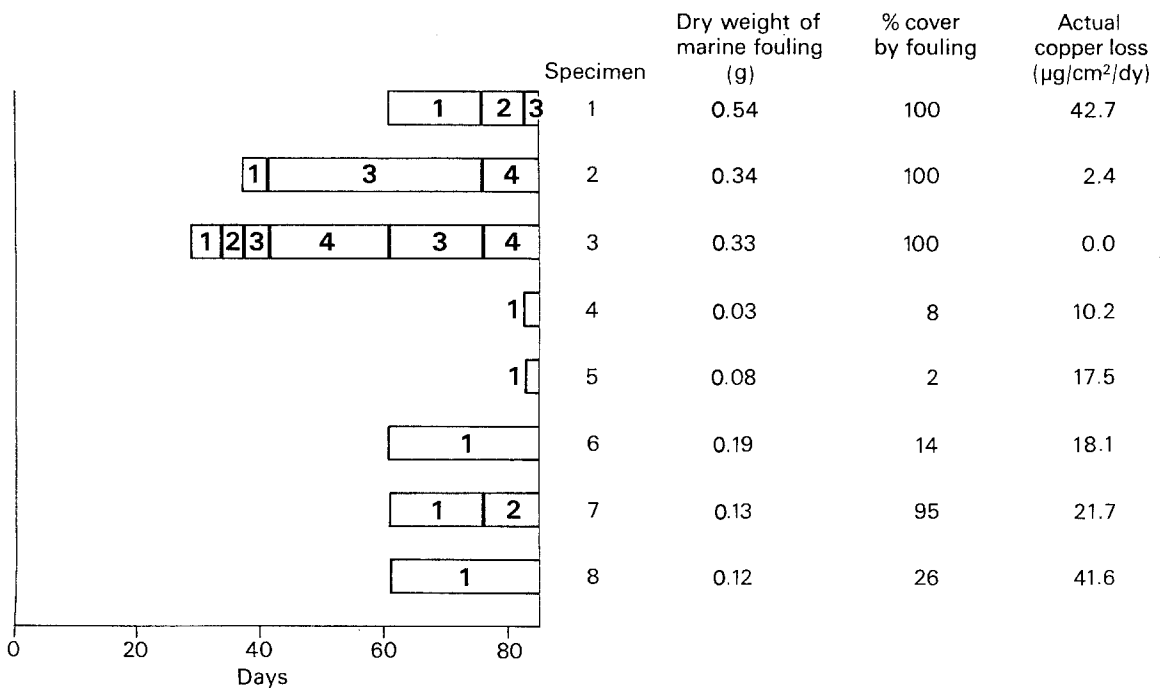
In the case of the freely corroding samples, the onset of fouling occurred somewhat earlier, around 60 days exposure, compared to some of the electrochemically controlled samples in which approximately 100 days were required. This is quite surprising as the total copper release rate for the freely corroding samples was substantially

greater than for any of the spiked samples. Interesting differences were also noted between the spiked samples, those which were subjected to the higher "spike" current densities (Specimens 7 and 8), fouled more rapidly compared to those with lower "spike" densities (Specimens 4 and 5). Rather smaller differences were noted between the samples subjected to different "spike" frequencies. This can be partially explained by the fact that the silver-silver chloride electrodes kept failing during the test which allowed the uncontrolled corrosion of samples until the electrode was replaced. The reference electrode failures were due to their construction being insufficiently rugged to cope with the test tank conditions.

Figure 6 The progression of marine fouling on freely corroding (1), cathodically protected (2, 3) and spiked copper plates (4-8) during the exposure period. The dry weight gain and percentage cover by marine organisms at the termination of the experiment are noted. See Table I for fouling types.

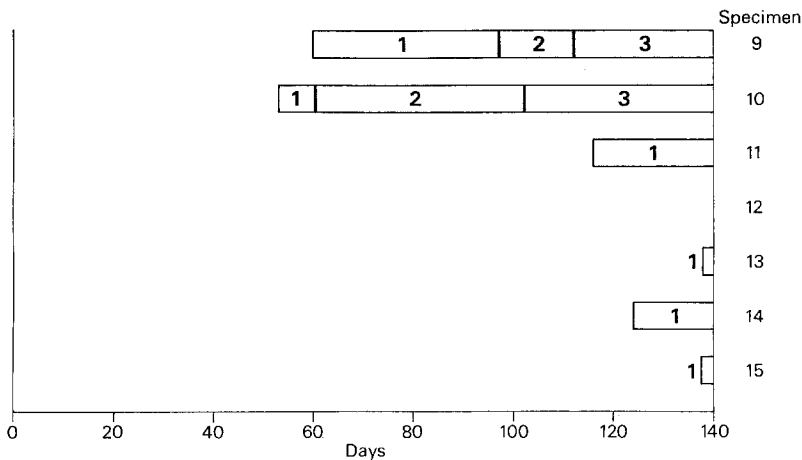
Figure 7 The progression of marine fouling on freely corroding (9), cathodically protected (10) and spiked copper plates (11 – 15) during the period. See Table I for fouling types.

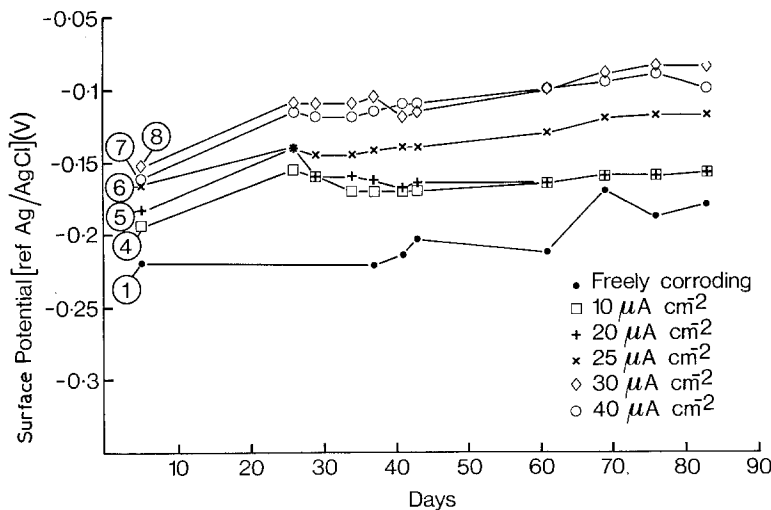
The surface potentials of the spiked specimens became more positive during the anodic phase indicating their tendency to corrode (see Fig. 8).

Figure 8 Variation in maximum surface potential due to spike current during exposure period in test tank (specimen numbers defined in Table IIA and B).

freely corroding sample, but are significantly less than those developed by the high spike current density samples (Fig. 8, Specimens 7 and 8).

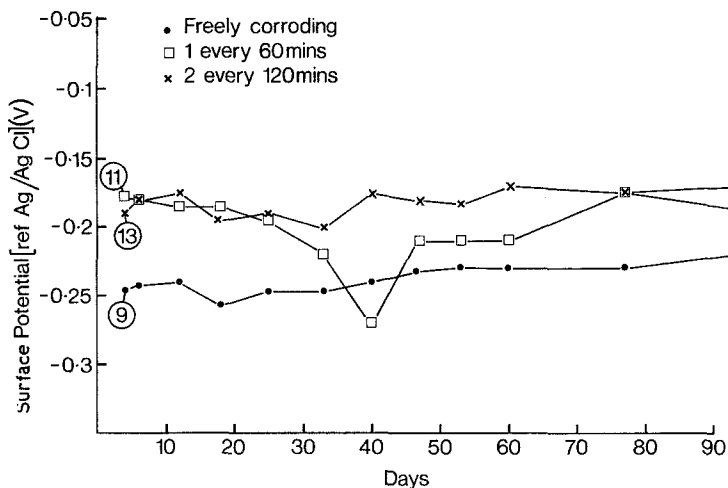
Figure 9 Variation in maximum surface potential due to spike current exposure period in test tank (specimen numbers defined in Table IIA and B).

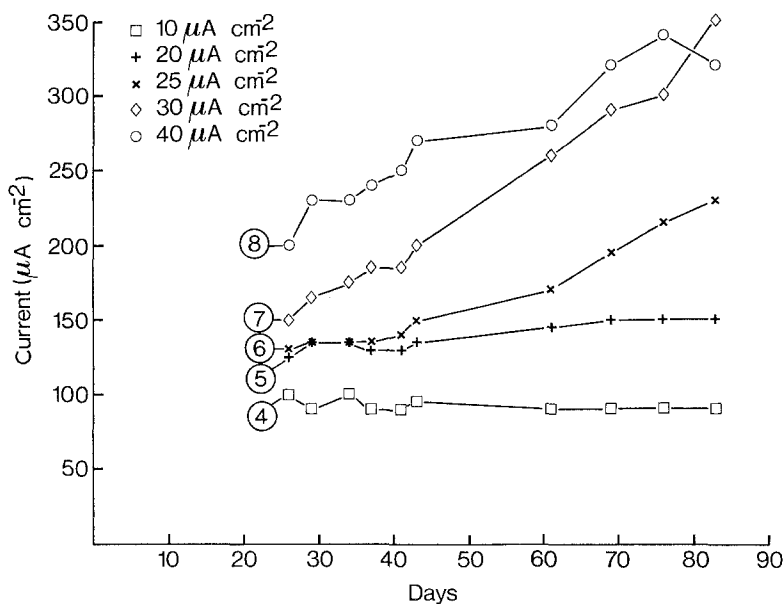
A similar trend (Figs 10 and 11) was also noticed with the variations in the maximum cathodic protection current (this being measured immediately after the return from the anodic mode). In the case of the lower current densities, this value remained essentially constant in the range 90 to 110 $\mu\text{A cm}^{-2}$; but as the current density was increased the increased the initial current demand was higher at 200 $\mu\text{A cm}^{-2}$ (Specimen 8) and continued to increase with exposure time, values of about 320 $\mu\text{A cm}^{-2}$ being observed for Specimen 8 after 80 days.

Figure 10 Variation in maximum cathodic current during exposure in test tank (specimen numbers defined in Tables IIA and B).

The slow change in the maximum cathodic protection current (Fig. 10) is a clear indication of the increasing difficulty being encountered in returning the sample from its anodic mode. This maximum value must represent the energy required to return the sample from a particular regime in the effective pH-potential diagram, and we may conclude that when this value is low, the surface is in a suitable state for maintaining the anti-fouling condition.

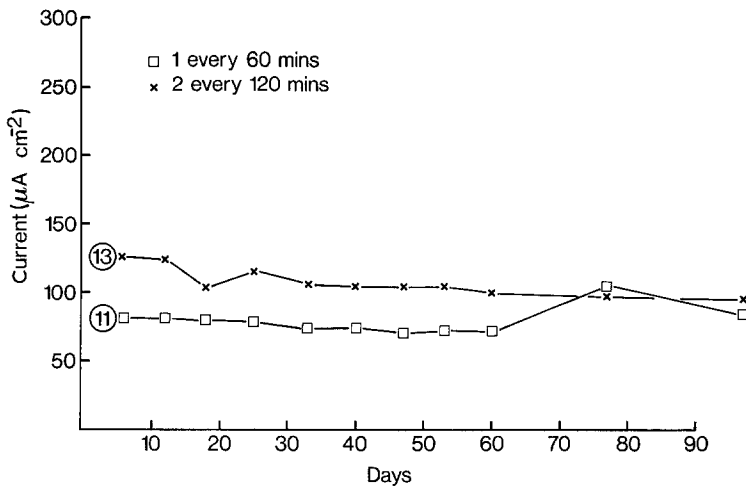
Figure 11 Variation in maximum cathodic protection current during exposure period in test tank (specimen numbers defined in Tables IIA and B).

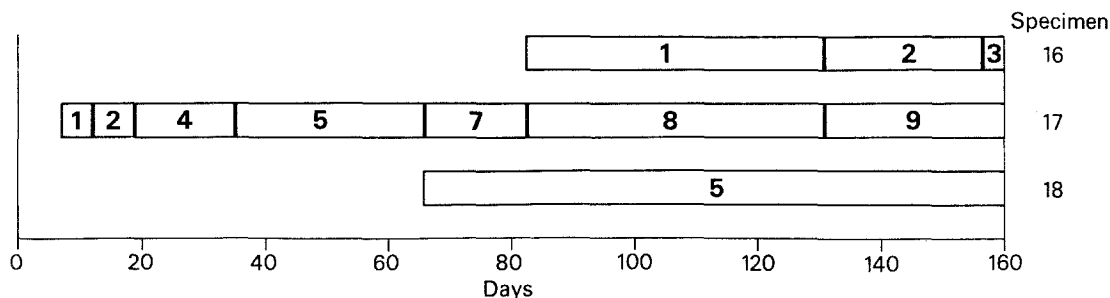
Figure 12 The progression of marine fouling at the Fawley site on freely corroding (16), P.V.C. control (17) and spiked copper plates (18) during the exposure period. See Table I for fouling types.

The progression of the fouling is indicated in Fig. 12, and the condition of the samples at the termination of the test is illustrated in Fig. 13. As with the experiments at Eastney, the control sample (in this case PVC) fouled very early in the exposure sequence and rapidly developed tertiary fouling. The fouling pressure at Fawley was obviously far higher than anything noted with the previous sets of experiments.

of exposure). It was therefore decided to increase the spiked current density to give copper outputs of $18.9 \mu\text{g cm}^{-2} \text{day}^{-1}$. The results in Fig. 12 seem to suggest that this increase in copper release did influence the fouling progression, and a close examination of the surface indicated that the barnacles were in a severely stressed condition and that some of the lower orders of fouling were beginning to die back.

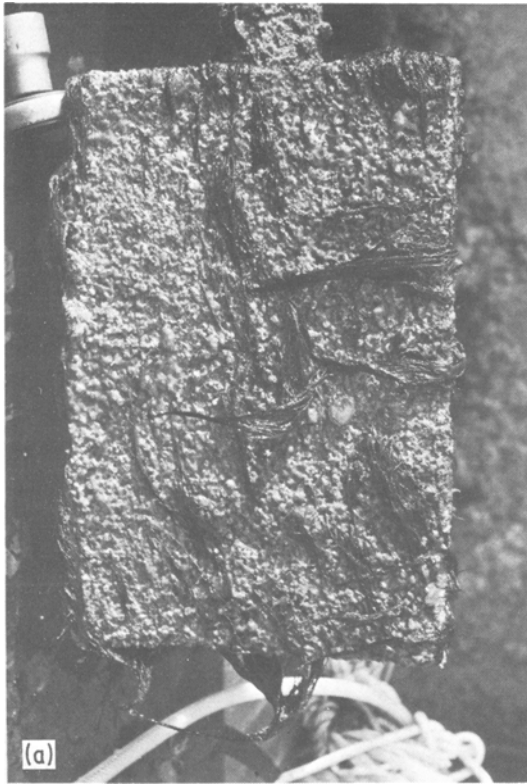
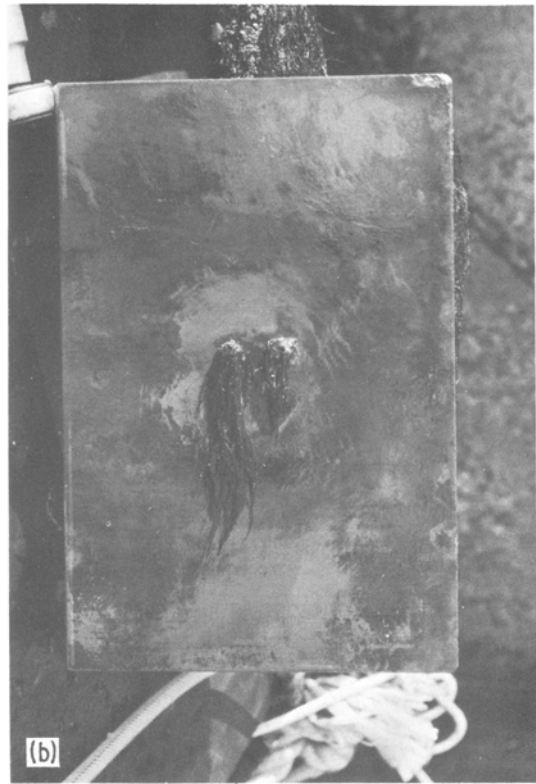
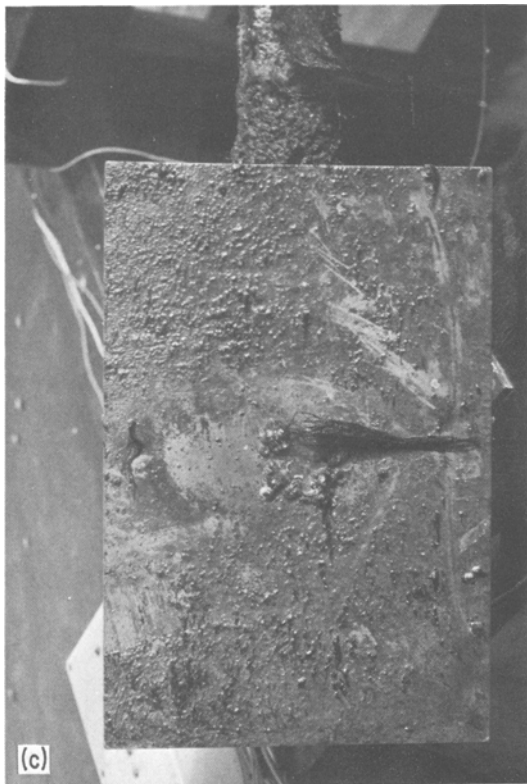
Figure 13 Surface condition of (a) P.V.C. control sample, (b) freely corroding copper plate and (c) spiked copper plate after 110 days exposure at the Fawley site.

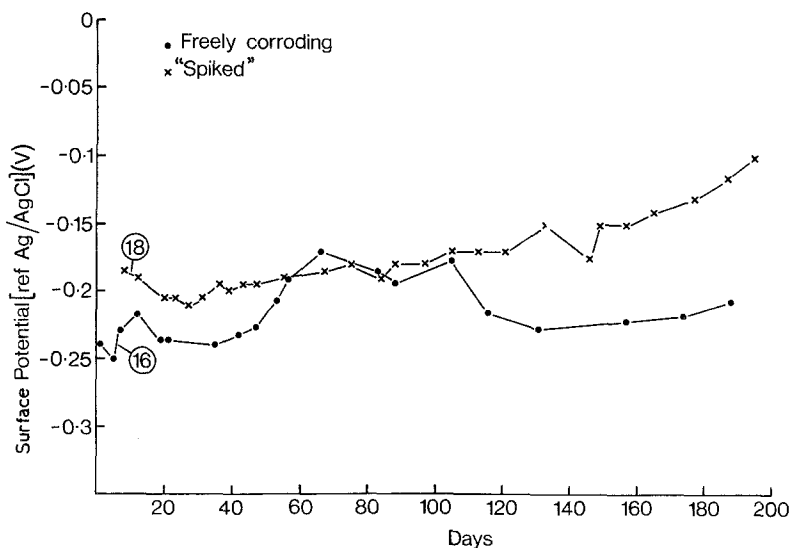
Figure 14 Variation in maximum surface potential due to spike current during time at the Fawley site (specimen numbers defined in Table III).

The surface potential of the freely corroding copper specimen appeared to follow similar trends to those obtained at the Eastney site, starting at about -0.24 V and rising to -0.18 V as illustrated in Fig. 14 (Specimen 16). In the case of the spiked sample, the earlier trends at Eastney were repeated, with the potential values during spiking rising to -0.15 V after 140 days and to -0.1 V after 200 days exposure (Fig. 14, Specimen 18). These values are consistent with the behaviour of the

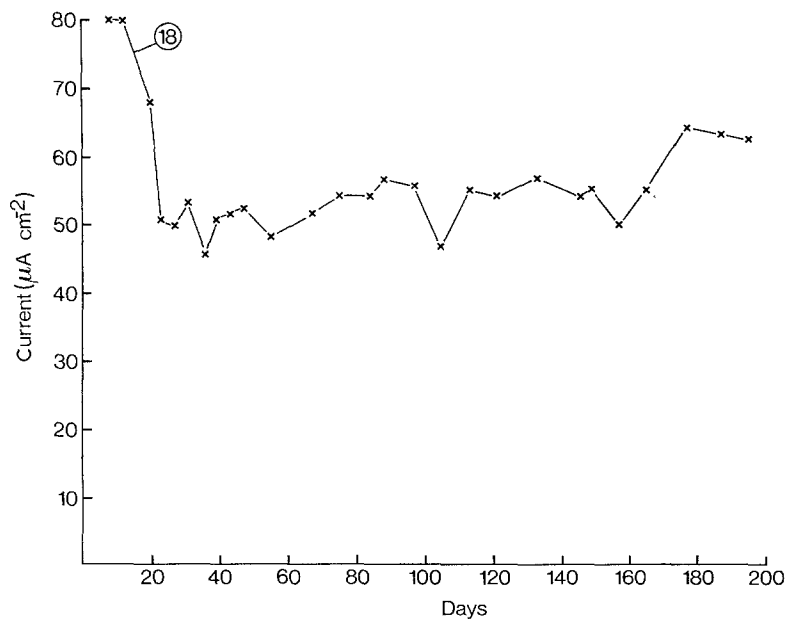
The values obtained for the maximum cathodic protection current are illustrated in Fig. 15, and are consistent with the lower spike current density samples of the previous tests (Specimens 4, 11 and 13) which also displayed the relatively uniform pattern once the corrosion regime had been established (within 25 days). The minimum cathodic protection current was again established within 1 minute after reversal from the anodic mode and values of 8 to $12 \mu\text{A cm}^{-2}$ were measured throughout the 200 day exposure period.

Figure 15 Variation in maximum cathodic protection current during exposure period at the Fawley site (specimen number defined in Table III).
