# Fatigue-crack initiation in IMI 829 caused by high-temperature fretting

Fretting fatigue tests have been carried out on a recently developed near- $\alpha$  creep-resistant alloy, IMI 829. The fretting fatigue characteristics have been determined at temperatures of 400 and 600°C under conditions of high and low fatigue stresses. In each case fatigue-crack initiation has been examined and related to the fretting damage on the surface of the specimen, and the microstructure of the alloy.

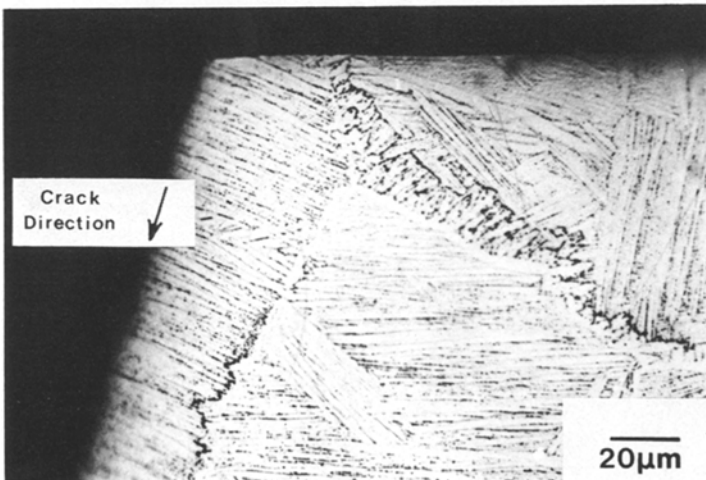
*Figure 7* Fretting fatigue crack initiating and propagating across the boundaries of the  $\alpha$ -platelets. Tested at 400° C, low fatigue stress.

The fretting fatigue cracks invariably started at the edge of the fretting scar, and were observed to propagate into the specimen at a very steep angle, i.e. near to 90° to the surface rather than the more usual 45° (Fig. 5). Careful sectioning through the scar region showed that the initial stages of the fretting fatigue crack either propagated in a direction parallel to the boundaries of the  $\alpha$ -platelets (Fig. 6) or alternatively propagated across the  $\alpha$ -platelets (Fig. 7). The actual mode of crack propagation appears to depend on the angle that the  $\alpha$ -platelets make with the specimen surface, e.g. if the platelets are orientated so that the fatigue crack cannot initiate and grow across the plates (i.e. platelets perpendicular to surface), then the crack will grow parallel to the  $\alpha$  boundaries.

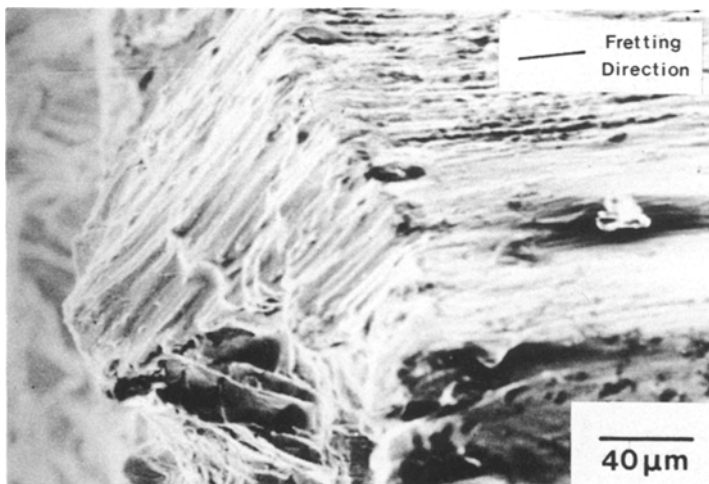
Figure 18 Fatigue crack initiation and growth at 45° to the surface of the specimen. Test temperature 600° C; high fatigue stress.

At these high temperatures and stresses considerable amounts of plastic deformation are taking place in the specimen substrate below the fretting bridge foot. This plastic deformation causes large shear stresses to develop in the metal

substrate below the fretting scar, resulting in the fatigue crack growing at approximately 45° to the surface (Fig. 18). At these high temperatures and stresses the growth direction appears to be quite independent of the position and orientation of the  $\alpha$ -platelets.
