# Tensile failure mechanisms in synthetic fibre-reinforced mortar

The ultimate tensile behaviour of fibre-reinforced cementitious composites is closely related to its failure mechanisms which in turn are dependent on reinforcement parameters such as fibre characteristics and the fibre/matrix interface properties. Based on the direct tensile tests of mortar specimens reinforced with various synthetic fibres, this paper attempts to explain such relationships and to indicate directions towards more effective fibre reinforcement.

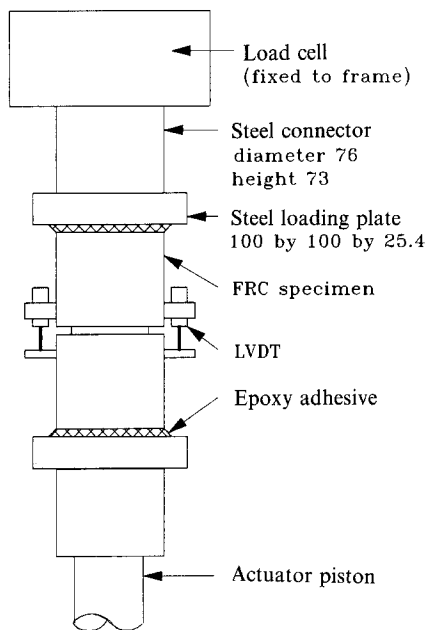
Figure 2 Schematic illustration of the loading fixture for the direct tensile test. Dimensions in mm.

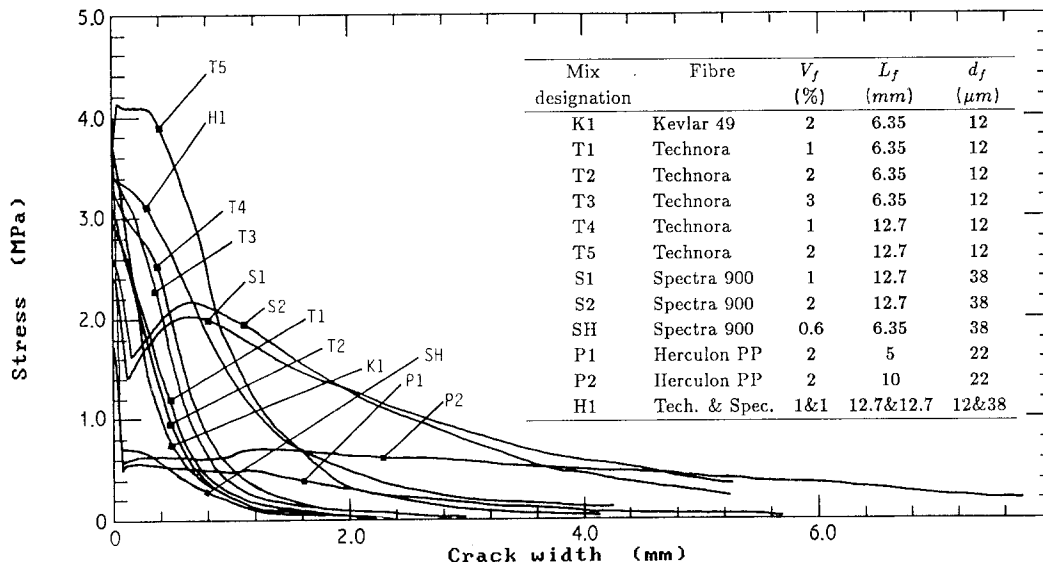
Figure 3 Stress-crack separation curves for FRC.

Matrix spalling due to fibre pull-out at angles was observed in the direct tensile test of mixes S1 and S2. Large numbers of mortar segments were separated from the specimen during testing and some such remaining pieces can be seen in the scanning electron micrograph of Fig. 6. The dimension of the spalled pieces shown in the photograph is typically 1 to 2 mm, which is close to the size of the sand component of the matrix. This phenomenon of matrix spalling has been observed in tests of single-fibre pull-out at different angles [6]. In that study it was found that the tension in the fibre was suddenly released when the matrix wedge spalled off. Correspondingly, in the direct tensile tests, the stress shortly after matrix cracking also exhibited a sudden drop and a subsequent rise as shown in Fig. 3.

These observations of failure mechanisms are consistent with the direct test results for aramid FRC. Because the crack always tries to propagate through fibre bundles which possess a slight inclination to the crack plane rather than taking a planar path at a random location, it follows that the number of fibre bundles encountered by the crack will not be proportional to the number of fibres across a given plane. Consequently, the  $\sigma$ - $\delta$  curves for aramid FRC (Fig. 3) may show very weak dependence on the fibre volume fraction.

The failure mechanisms for this hybrid FRC are the combination of those of aramid FRC and those of Spectra FRC. The  $\sigma$ - $\delta$  curve of mix H1 (Fig. 3) is very close to the average, rather than the sum, of those of

The Herculon PP fibres were designed for use in non-woven materials and not specifically for use in FRC. They were included in this study to evaluate the hypothesis that undrawn fibres might contribute to concrete reinforcement. However, because of their low yielding stress, the fibres could not provide significant resistance to crack opening, and the FRC post-cracking behaviour as indicated by the  $\sigma$ - $\delta$  curves for mixes P1 and P2 (Fig. 3) is unsatisfactory. Although

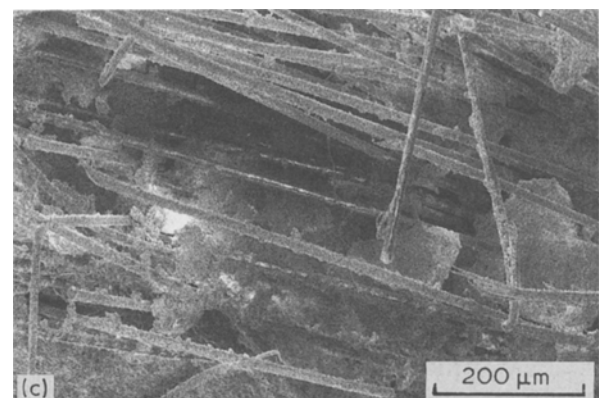
Figure 11 Scanning electron micrographs of fracture surfaces of aramid FRC tested in direct tension. (a) mix T1, Technora 6.35 mm 1%; (b) mix T2, Technora 6.35 mm 2%; (c) mix T5, Technora 12.7 mm 2%.

Bundles of fibres were the dominant form of fibre distribution in all the aramid FRC tested (mixes K1, T1 to T5), as shown by some typical scanning electron micrographs in Fig. 11. The vast majority of the reinforcing fibres appeared in bundles or clumps in the matrix although some isolated fibres can also be seen (Fig. 12).

When the crack confronts fibre bundles lying nearly perpendicular to the loading direction, the crack may turn and propagate through the bundle in the bundle longitudinal direction. As the crack opens further, the bundles are split (Fig. 11) or peeled off from the matrix (Fig. 15). In some cases, bundle splitting may also be associated with fibre splitting (fibrillation), as shown in Fig. 16.

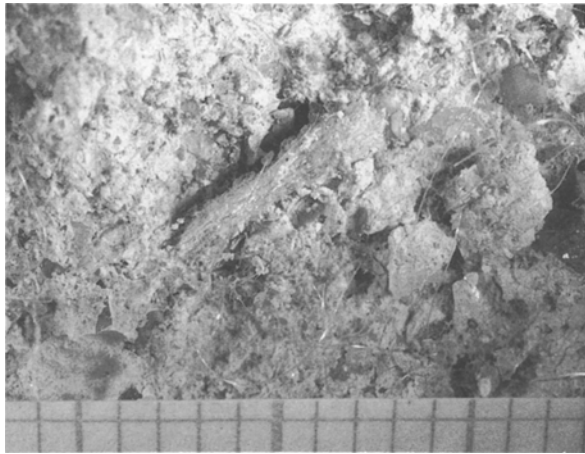
Figure 18 Photographs of fracture surface of mix H1 tested in direct tension. Spacing of grids in photographs is 1 mm/grid.

The fracture surface of mix H1, a hybrid FRC containing 1% 12.7 mm Technora and 1% 12.7 mm Spectra 900 fibres, tested in tension is shown in Fig. 18. It was observed in the specimens that the majority of Technora fibres were in fibre bundles and that the Spectra 900 fibres were partially in separated form and partially in bundles. The fracture surface profile of mix H1, shown in Fig. 19, is very similar to those of aramid FRC. On the fracture surface, Spectra 900 fibres pulled out from the matrix can also be seen.
