Abrasion-induced microstructural changes and material removal mechanisms in squeeze-cast aluminium alloy-silicon carbide composites

An attempt has been made to understand wear-induced subsurface microstructural changes and material removal mechanisms in squeeze-cast BS LM11 alloy dispersed with 10 vol % SiC. Particles as well as fibres of SiC were separately dispersed in the alloy matrix to determine the influence of shape of the dispersoid on the abrasion behaviour of the latter. Abrasion tests were conducted on a standard rubber wheel abrasion test apparatus. Silica sand was used as the abrasive medium. Abrasive wear rates of the specimens were found to decrease gradually with the number of test intervals until a steady state value was attained. This was attributed to the protrusion of the reinforcement phase and abrasion-induced work hardening of the matrix in regions close to the abraded surface. The dispersoid/matrix interface as well as the shape of the dispersoid was found to influence the abrasion rate of the composites. A poor dispersoid/matrix interface led to higher rate of abrasion due to pull-out of the dispersoid. On the other hand, good bonding between the dispersoi

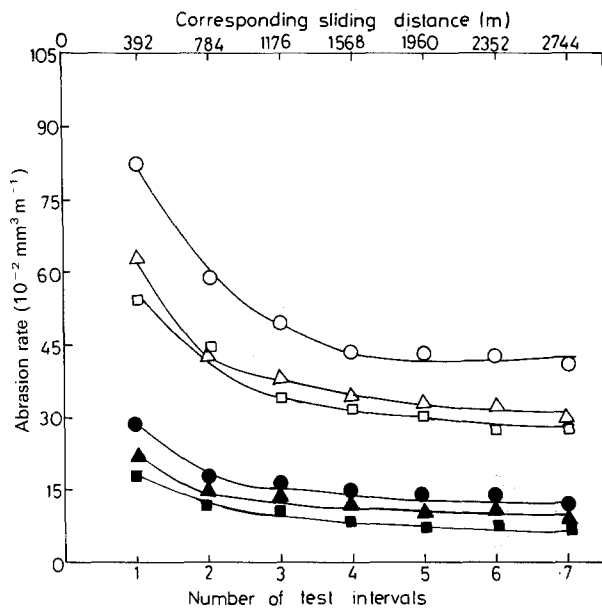
Fig. 2 shows the abrasive wear rates versus the number of test intervals at the applied loads of 22 and 49 N for the base alloy and the composites. It can be seen in the figure that increasing the applied load from 22 to 49 N led to an increase in the wear rate of the specimens by nearly three times. Further, the abrasive wear rate decreased initially with the number of test intervals and thereafter attained a steady state value. The extent of decrease was of the order of 40–60% (Fig. 2). The alloy dispersed with SiC particles showed the minimum wear rate while the base alloy suffered

Figure 2 Abrasive wear rate of the base alloy and its composites containing SiC particles/fibres as a function of the number of test intervals. Applied load: (○, △, □) 49 N; (●, ▲, ■) 22 N, (○, ●) LM11, (△, ▲) LM11-SiC fibre, (□, ■) LM11-SiC particle.

from the maximum rate of wear. The wear rate of the composite containing SiC fibres was in between the two (Fig. 2). This trend was observed at both of the applied loads.

wear rates of composites ($25\text{--}35 \times 10^{-2} \text{ mm}^3 \text{ m}^{-1}$) were found to be much higher than that of low-carbon steels ($5.85 \times 10^{-2} \text{ mm}^3 \text{ m}^{-1}$) tested under identical conditions. This could be attributed to the low volume fraction of the hard phase ($0.10 V_f$). The interparticle/fibre spacing in the present case was too large to provide complete protection for the softer aluminium alloy matrix from the action of abrasive particles. However, partial protection provided by the hard SiC dispersoid in this case is evident from the relatively low abrasion rate of the composites, compared to the base alloy (Fig. 2).

The abrasive wear rates were found to decrease progressively with increasing number of test intervals before a steady state value was recorded (Fig. 2). Because the starting surface was metallographically polished, the softer matrix is expected to be preferentially abraded in the beginning of the test. Further, with increase in the number of test intervals, more and more hard second-phase particles/fibres would protrude from the surface and thus offer protection to the latter. This may be one of the reasons for the observed decrease in abrasive wear rates with the number of test intervals (Fig. 2). Secondly, the matrix also became work hardened during the course of abrasion, as evinced by the identical wear behaviour of the base alloy (Fig. 2). Abrasion-induced subsurface matrix work hardening was also indicated by the difference in hardness between the bulk and that close to the abraded surface (Fig. 7). Microstructural investigations carried out on the transverse sections of the specimens also confirmed the work hardening of the matrix (Fig. 6). It is well known that the microstructure of a cast Al-4.5% Cu alloys consists of a CuAl_2 precipitate network in α -aluminium as can be seen in Fig. 6a (central and bottom regions). The network of CuAl_2 was completely broken down into small spherical particles in the subsurface regions (Fig. 6b, c), indicating heavy deformation of the latter [14]. Further, the extent of breaking of the network gradually decreased as the distance from the abraded surface increased (Fig. 6a). It is also interesting to note that the upper half of the hardness indentation mark closer to the abraded surface was less than the lower half, which is away from the abraded surface (Fig. 8), suggesting that the regions closer to the abraded surface were work hardened. Thus, the observations made in Figs 6 and 8 clearly indicate the work hardening of the subsurface regions during abrasion, as reflected in Fig. 7. Work hardening of steels during abrasion has also been reported earlier [15, 16]. In the present investigation, protrusion of hard particles/fibres and work hardening of the matrix during abrasion appeared to be responsible for the reduced abrasion rate with the number of test intervals (Fig. 2).

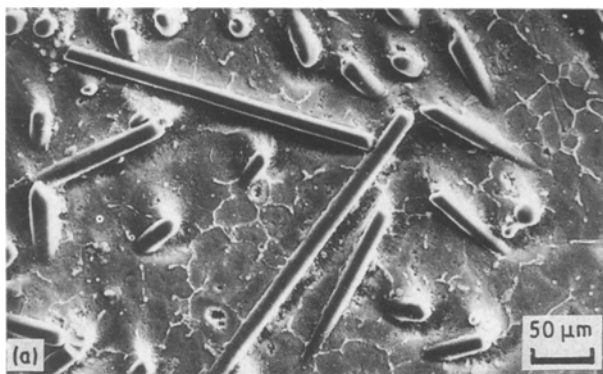
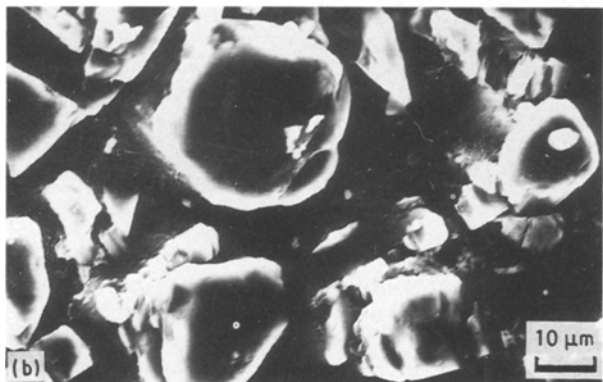
Scanning electron micrographs of the metallographically polished specimens of the alloy dispersed with SiC fibres and SiC particles revealing the distribution

Figure 3 Scanning electron micrographs of metallographically polished surfaces of (a) LM11-SiC fibre, and (b) LM11-SiC particle composites.

of the dispersoid phase in the matrix are shown in Fig. 3a and b, respectively.

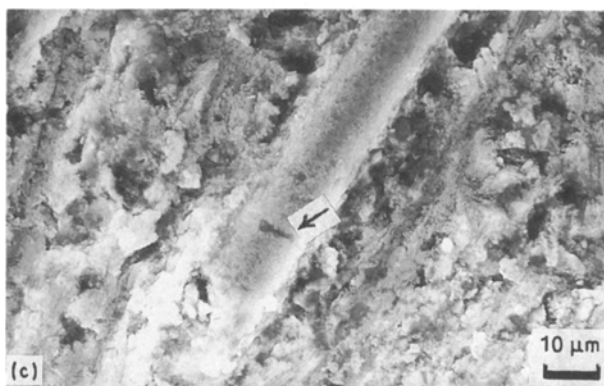
Abraded surfaces of the SiC fibre composite showed a large number of fibre pull-outs at the higher load (Fig. 4a). However, at lower load, events of fibre pull-out in this composite were relatively less and some fibre protrusion was observed on the abraded surface (Figs 4b and c). Partial bonding of the dispersoid with the matrix may be noted in Fig. 4b while Fig. 4c (marked by arrow) reveals microcracks on a typical SiC fibre. On the other hand, the abraded surface of the alloy dispersed with SiC particles did not show particle pull-out to a significant extent, even at the higher load (Fig. 5a). There was, however, fracture and partial removal of SiC particles (Figs 5b and c, arrowed) during abrasion. A good particle/matrix interface in the abraded surface of this composite may be

Figure 4 Abraded surfaces of the LM11-SiC fibre composite showing (a) pull-out of SiC fibres at 49 N, and (b, c) the protrusion of SiC fibres at 22 N. The weak fibre/matrix interface (b) and microcrack in a fibre generated during abrasion (c, arrowed) may be noted.

both loads. Removal of the SiC particle during abrasion appeared to be due to pitting (Fig. 5b and c, arrowed) probably caused by progressive fracture events. By contrast, the abraded surfaces of the alloys containing SiC fibres showed a considerable number of fibre pull-outs at higher load (Fig. 4a) leading to a higher rate of abrasion (Fig. 2). No significant fibre protrusions were observed in this case. However, at lower load, events of fibre pull-out were fewer in number and some fibre protrusion was observed (Fig. 4b, c). Microcracks on the SiC fibre in the abraded surface (Fig. 4c, arrowed) are formed by fine, sharp and angular abrasive particles and indicate the initial stage of fracture of the hard dispersoid phase [17]. Another important parameter in controlling the wear rate of the composites could be the shape of the dispersoid. It may be noted that the fibres had sharp tips. Such regions act as stress raiser points, thereby offering easy nucleation of cracks. The cracks would easily propagate via the poor fibre/matrix interface, ultimately leading to higher abrasion rates of the fibre composite. On the other hand, SiC particles having relatively smoother edges and sound interface with the matrix probably did not allow the microcracks to nucleate at, and propagate via, the particle/matrix interface as easily as in the case of the LM11-SiC fibre composite. The higher length-to-diameter (L/D) ratio of the SiC fibres also indicates increased probability of their fracture and partial removal than that of the smoother-edged particles. This explains the lowest wear rate of the composite containing SiC particles (Fig. 2).

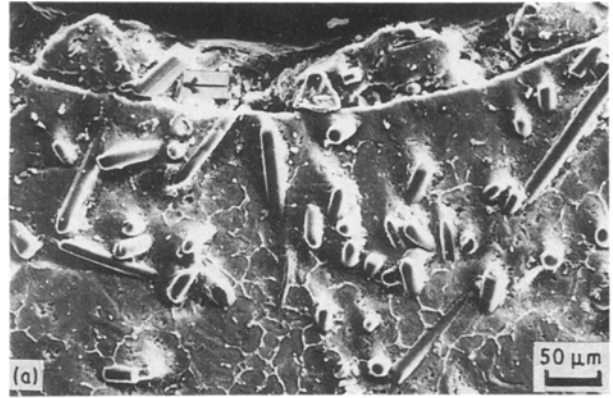
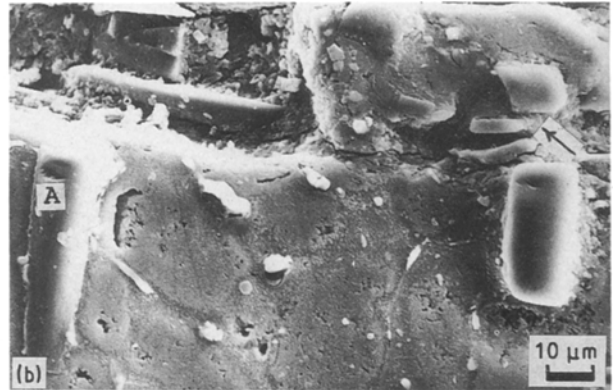
Figure 5 Abraded surfaces of the LM11-SiC particle composite showing (a) complete retention of the dispersoid particles during abrasion, and (b, c) pitting of a SiC particle (arrowed). A good particle/matrix interface may also be noted in (c). Applied load 49 N.

noted in Fig. 5c. Protrusion of the dispersoid on the abraded surface may also be noted in Fig. 5.

There appears to be a direct correlation between the observed abrasion rates and the particles (or the fibre)/matrix interface on the abraded surface. For example, the particle/matrix interface in the LM11-SiC particle composite appeared to be strong (Fig. 5c) and there were hardly any particle pull-outs (Fig. 5a). The abrasive wear rate of this composite was the lowest of all the three materials (Fig. 2) tested at

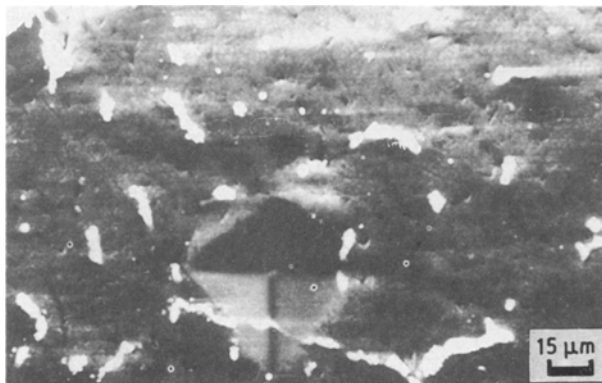
Figure 8 A typical microhardness indentation mark in the subsurface region. Note: the upper half of the mark closer to the abraded surface (top) is less than the lower half.

A higher hardness of the matrix close to the abraded surface, then in the bulk, may be noted in the figure. A typical microhardness indentation mark made in the regions close to the abraded surface is shown in Fig. 8.
