# Wear of coatings in wool-severing applications

Various surface treatments; including thermally sprayed ceramic coatings, titanium nitride (TiN) deposited by physical vapour deposition and nitrogen implantation processes, have been applied to combs and cutters that are used for wool severance. A series of laboratory and field tests have been carried out to evaluate the relative merits of the different treatments.

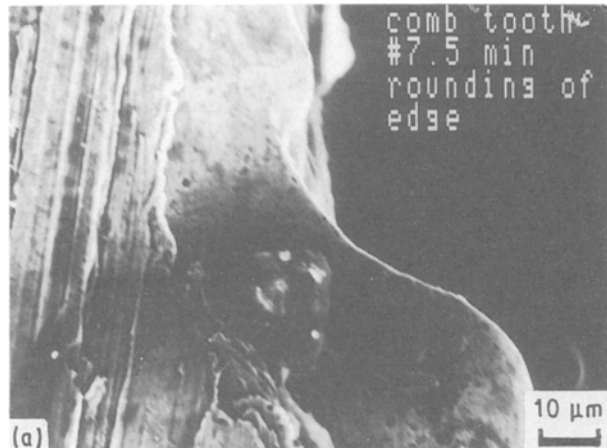
Figure 3 (a) Damage to uncoated comb after 7.5 min testing. (b) Damage to cutter after 6 min testing.

unused comb and cutter were also examined. They were then run in the shearing test rig, with grit, for 1, 6 and 7.5 min. The combs were inspected for damage after each period. After 7.5 min the comb edges began to round off, with severe damage similar to that seen

on the used comb (Fig. 3a). The cutter edges exhibited brittle fracture and spalling (characteristic of delamination) at the tips (Fig. 3b) due to fretting.

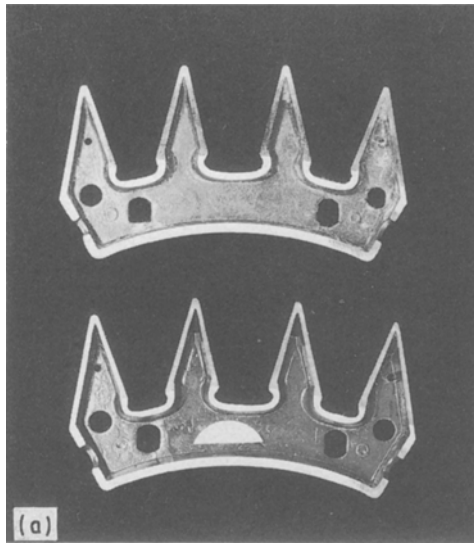
Figure 5 (a) Wear pattern on uncoated cutters with TiN-coated combs. The cutters were used in either a field trial (upper cutter) or a laboratory test (lower cutter) and exhibit similar wear morphologies. (b) Comparison of wear profile along ( $\diamond$ ,  $\square$ ) inner and ( $+$ ,  $*$ ) outer edges of a middle tooth of each cutter.

A wear pattern could be observed (Fig. 5a) on the sliding surface of the cutter after 10 min running time in the shearing test rig. Surface roughness data from components measured before and after shearing wear tests are shown in Table II. In all cases the cutter was not coated. Fig. 5a shows the surface morphology

features of the coated and uncoated cutters. The lower cutter was used in a 10 min laboratory test, whereas the upper cutter was used in a field trial on 33 sheep. The same features were observed on both of these cutters and indicates that the accelerated laboratory tests replicates the field conditions that these components experience.

Wear patterns on these cutters showed similar features to those tested in the laboratory (Fig. 5a). The cutters were removed from service due to the formation of a step at the rear of the cutting surface. This change in the cutter profile caused wear so that the tip was not cutting. This particular wear pattern results from interaction of the cutter with the groove which is machined in the comb, Fig. 8. SEM examination showed that surface cracks were less than 1% of the total area. These features of the wear process will be discussed later with respect to the wear mechanism.
