Some aspects of crack initiation in mild steel under corrosion fatigue condition

The initiation of corrosion fatigue cracks has been studied for mild steel tested in 0.6 M sodium chloride solution. The results indicate that cyclic stress enhances the formation and coalescence of micropits at, and around, the inclusions, leading to the nucleation of cracks. Dissolution of the inclusions promotes local transport of hydrogen into the metal. Hydrogen plays a significant role in the initiation of voids and microcracks. Crack initiation also occurs with the formation of voids in and around slip bands, at grain boundaries and in the pearlitic regions.

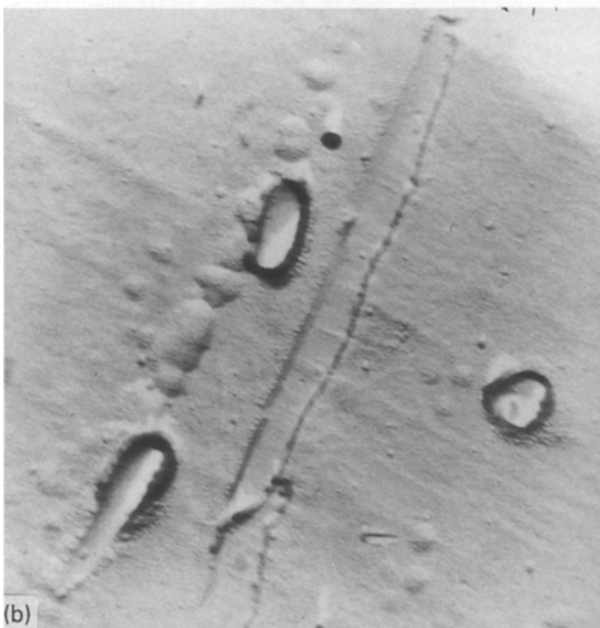
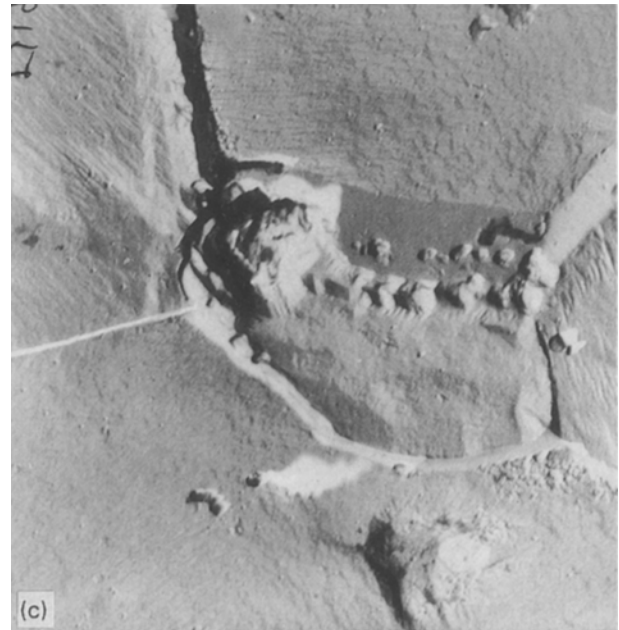
Figure 1 Transmission electron micrograph of an annealed specimen (920 °C for 3 h in argon) after fatigue tests at 95 MPa, $R = -1$. (a) Dissolution of the ferrite–cementite interface resulting in the formation of microvoids. 6.26×10^5 reversals; $\times 11\,300$. (b) Fracture of inclusion and formation of intrusion-type defects at hydrogen blisters. 1.05×10^6 reversals; $\times 11\,300$. (c) Formation of subgrains and microcracks at subgrain boundaries after 1.05×10^6 reversals; $\times 8200$.

Further increase in the number of reversals showed formation of slip bands between the pearlitic regions, micropits within the slip bands and microcracks around pearlitic colonies. Localized attack at the ferrite–cementite interfaces resulting in the formation of microvoids and terminations and bends in the cementite lamellae in the pearlitic regions were found to occur (Fig. 1a). Extrusion–intrusion effects associated with grain boundaries, formation of hydrogen blisters in the vicinity of many inclusions irrespective of the shape, size or chemical composition of the inclusions, and nucleation of intrusions in the region of high blister density were observed in the as-received as well as in the annealed specimens (Fig. 1b). The formation of subgrains and microcracks at subgrain boundaries, deformed regions with microcracks and

etch pits associated with distorted regions are illustrated in Figs 1c, 2a and b, respectively. Grain-boundary deformation causing nucleation of microcracks was also found to occur with increasing number of reversals.

(Figs 1b and 4) and microvoids with associated plastically deformed regions, indicates that effective redistribution of hydrogen during compressive loading is unlikely.

The lamellar structure in the pearlitic regions degenerates into ribbons of cementite, perforated lamellae, or even to isolated fragments (Fig. 1a) with the application of cyclic stress. Localized dissolution at the ferrite-cementite and pearlite colony-matrix interfaces appears to be enhanced with the formation of microvoids. Voids also form between the fractured ends of cementite lamellae under the influence of stress. Linking up of these voids appears to be the precursor of incipient crack formation in and around the pearlitic regions.

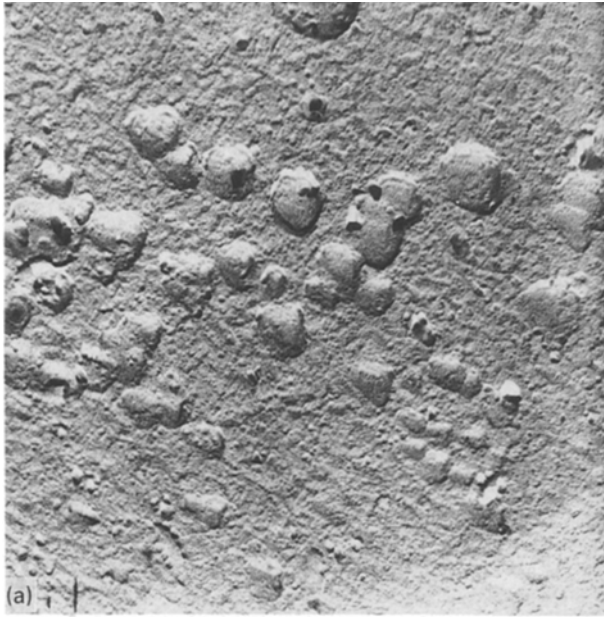
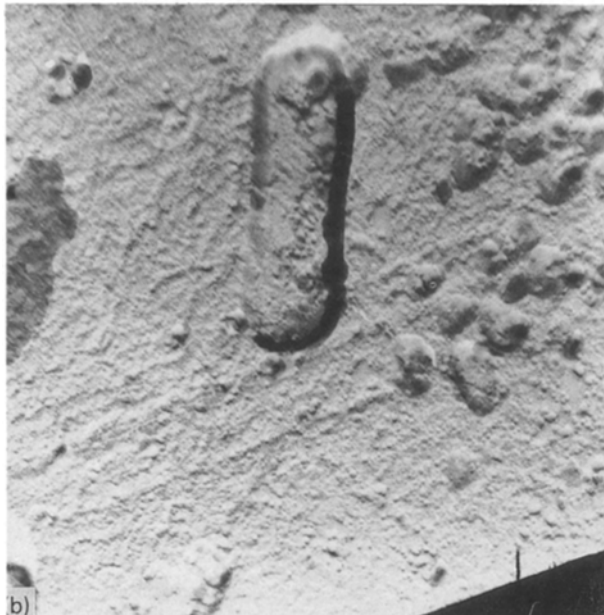
Figure 4 Transmission electron micrograph of an as-received specimen after 2000 reversals at 193 MPa, $R = -1$. (a) Formation of hydrogen blisters and submicroscopic cracks near inclusions; $\times 20\,500$. (b) Intersection of slip bands and hydrogen blisters; $\times 20\,500$.

At 193 MPa, $R = -1$, microcracks associated with hydrogen blisters near inclusions (Fig. 4a), voids caused by intersecting slip bands and hydrogen blisters (Fig. 4b), and dissolution at the ferrite–cementite interface resulting in the formation of microvoids in the ferrite, were observed after 2000 reversals. With an increasing number of reversals, dissolution of the inclusions and microvoid formation in the slip bands also appeared to occur. In the low-density regions, deformation and microcrack formation at the grain boundaries, and slip bands with micropits were observed. As the number of reversals was further increased, linking up of microcracks at the grain boundaries and around the inclusions were found to occur.

Therefore, it appears that localized corrosion occurring at or near the inclusions nucleates pits which contain an acidic environment within them. As a consequence, dissolutions of the inclusions and metal occur with H_2S evolution. The presence of hydrogen blisters in the vicinity of the inclusions (Fig. 4a) suggests that hydrogen discharge takes place on the steel

Slip bands are found to occur in the matrix with increasing number of reversals. These bands also intersect inclusions (Fig. 5) and hydrogen blisters (Fig. 4b) causing voids from which cracks initiate. Additionally, microvoids were found in slip bands and in the matrix. It was observed that the individual microvoids do not grow, but that propagation occurs by linking. The linking of these microvoids results in the formation of microcracks in the slip bands and sub-grain boundaries.
