Deformation and fracture of Al-8Fe rapidly solidified alloys

The effects of the rapid solidification on the deformation and fracture of Al-8Fe alloys, from TEM fracture specimens, have been studied. The most general conclusion which can be drawn in this study is clearly in agreement with a plastic deformation mechanism. Crack propagation occurs by localized plastic rupture mechanisms which result from enhanced slip along $\{111\}_\gamma$ planes. Crack propagation occurs within the deformed zone either by the nucleation, growth and coalescence of holes ahead of the crack-tip, or through the emission of dislocation from the crack-tip. The resulting fracture is along the active $\{111\}_\gamma$ slip planes. The principal effect of secondary phases ($\text{Al}_{13}\text{Fe}_4$) on the fracture propagation in Al-8Fe alloys was that the secondary phases increased the stress level at which plastic deformation occurs at the crack-tip and increased the stress level at which the crack propagates. This work clearly shows that in order to obtain coarse intermetallic precipitates in the specimens after ageing heat treatments the crack propagation and deformation processes occur at lower stress

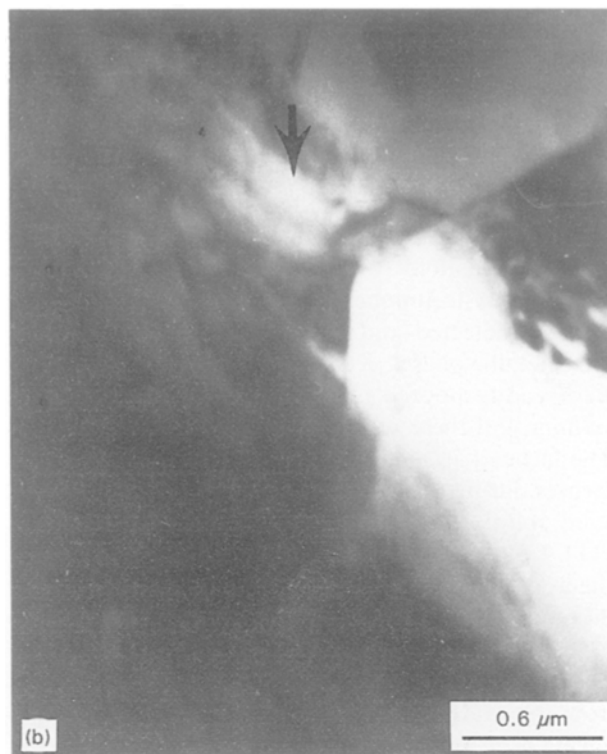
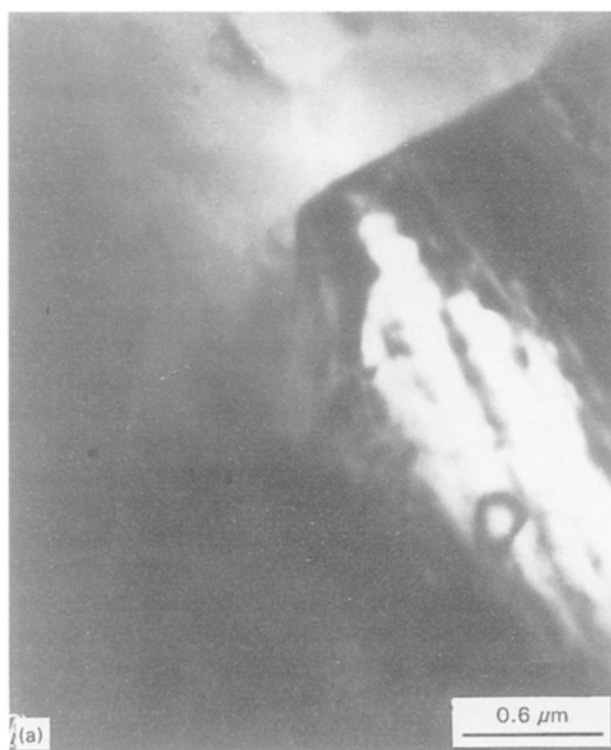
Figure 7 Continued.

Figure 7 Deformation crossing grain boundary in a rapidly solidified Al-8Fe alloy after isochronal ageing at 500 °C for 2 h, strained under TEM. (a) Crack blocked before the grain boundary; (b) thinning and microvoid formation in the second boundary; (c) opening of the microvoid and joining to the main crack.

Grain boundary deformation and a crack crossing a grain boundary was observed between a propagating crack and a microstructure in rapidly solidified Al-8Fe alloys (Fig. 7). The deformation band passed through the grain selecting the $\{111\}\langle 110 \rangle_\gamma$ slip

plane system having a maximum resolved shear stress and interacting with the grain boundary. Propagation of the crack was generally blocked before the grain boundary (Fig. 7a). The deformation band passed through the grain boundary (Fig. 7b). A microvoid formed on the other slip plane of the second grain (marked by the arrow in Fig. 7b). The opening of the microvoid (Fig. 7b) and joining to the main crack (Fig. 7c) are typical in formation of transgranular ductile fracture surfaces.

The common interaction between a propagating crack and a grain boundary in both as-received and after ageing rapidly solidified alloys was observed (Fig. 7). The deformation band passed through the grain boundary selecting the $\{111\}\langle 110\rangle_\gamma$ slip planes having a maximum resolved shear stress in the adjacent grain and interacting with the grain boundary close to the intersection of the pile-up with the grain boundary. Propagation of the crack was generally blocked before the grain boundary. A microvoid formed on the second grain (marked by an arrow in Fig. 7b). The opening of microvoids (Fig. 7c) joined to the main crack are typical of the transgranular ductile fracture surfaces.
