Tensile behavior of SiC/C and Rene'41 following isothermal exposure and thermal fatigue

The performance of a coated silicon carbide/carbon composite under isothermal and thermal fatigue conditions was investigated. The material studied is known as Ceracarb™ which consists of eight-harness satin weave Nicalon® silicon carbide cloth reinforcement, a carbonaceous matrix, and a silicon carbide composite coating. This advanced composite is being considered for replacing the nickel based superalloy Rene'41, as the exhaust nozzle components on military afterburning turbine engines. Thermal fatigue experiments, performed in the laboratory using a thermal cycling test system, were intended to roughly simulate the thermal excursions of an afterburning exhaust nozzle. Several thermal profiles were used to characterize the role of temperature, number of cycles, temperature range, and time at temperature, on the room temperature residual tensile strength of the material. The same thermal profiles were also conducted on test specimens of Rene'41 in order to compare its durability in the laboratory simulation test set-up to the composite. Both materials showed no loss in strength from the as-rec

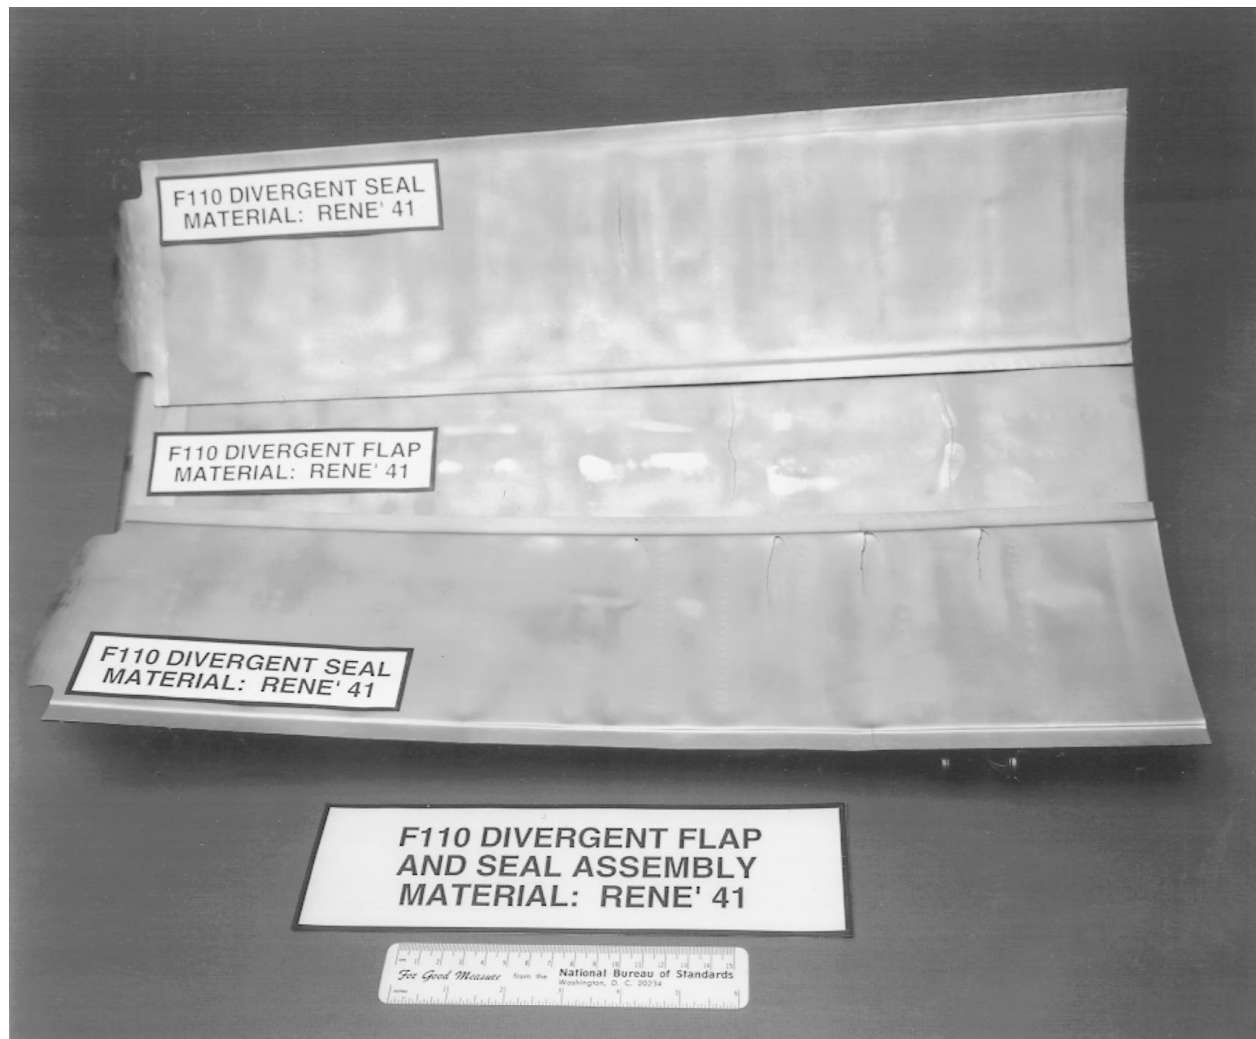
Figure 1 A photograph of a GE-F110-100 exhaust nozzle divergent flap and two divergent seals that have been removed from service due to severe cracking. The Rene'41 components suffer from extensive creep deformation and cracking due to the environment.

An example of the cracking experienced by the exhaust nozzle components during service on a military afterburning engine is given in Fig. 1. Pictured in the figure are two divergent seals on either side of a divergent flap. These parts are from an F110 engine that was mounted on a F16 Fighter. Extensive cracking in these components, such as shown in the figure, cause

Cracking in the metal seals and flaps are a result of the severe thermal environment. During operation, stresses develop as a result of pressure differentials, thermal gradients, and physical constraints on the components. These stresses in combination with a steep loss in tensile strength and lowered creep resistance at temperatures above 700° [9, 10, 14–16], allows for the damage to occur.

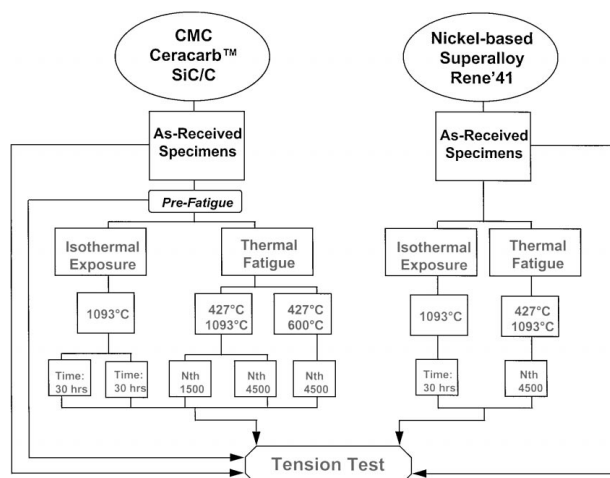
Figure 7 Pictorial overview of the testing scheme for both the Ceracarb™ material and the Rene'41.

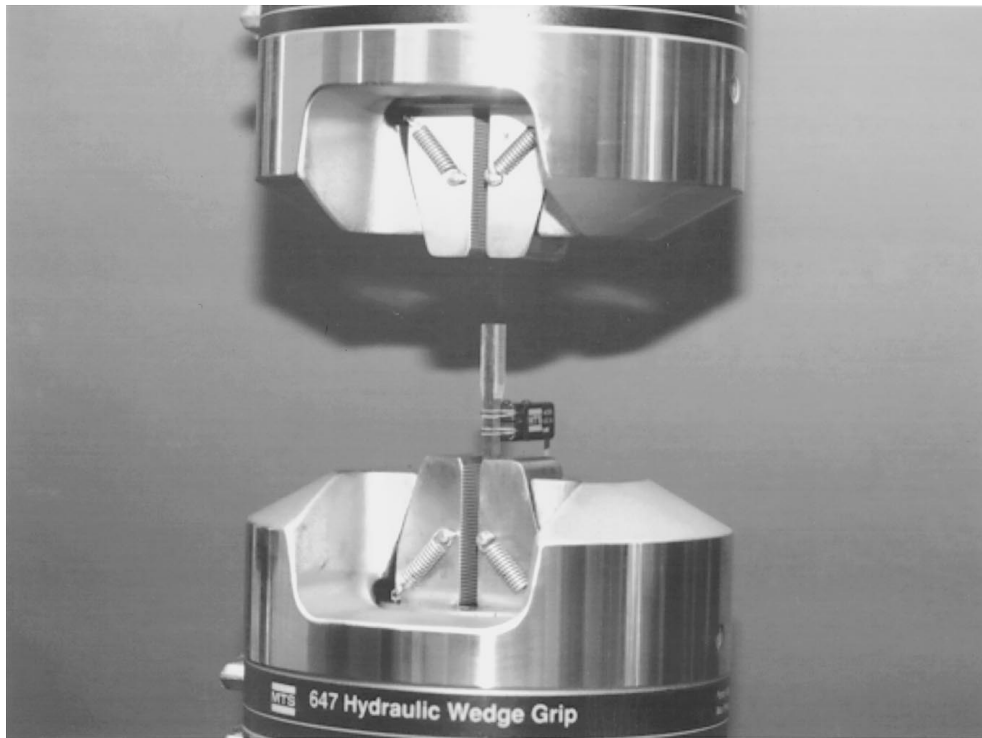
Figure 10 Photograph of the testing apparatus used for all tensile testing. Also shown is a tabbed Ceracarb™ test specimen mounted with a clip-gage extensometer.

test machine mounted with wedge grips and serrated grip inserts. A photograph of the testing apparatus described above is shown in Fig. 10. Tension tests were performed on both materials in the as-received, pre-conditioned, and thermally treated conditions with this set-up. All tests were run at room temperature and with a constant testing rate of 0.05 mm/s. A clip-gage extensometer was used for strain measurement.

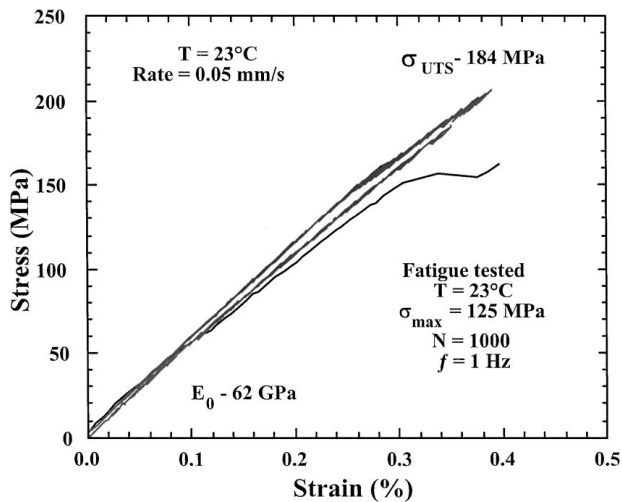
Figure 12 Stress vs. strain traces for Ceracarb™ material which had been previously pre-fatigued under tension-tension cyclic loading to maximum stress of 125 MPa for 1000 cycles.

The stress-strain curves for the Ceracarb™ test specimens that first underwent pre-conditioning fatigue and were subsequently tension tested are plotted in Fig. 12. These tests were performed to determine if the mechanical fatigue had an influence on the strength of the material. The average strength and modulus for the three specimens tested were approximately 184 MPa and 63 GPa, respectively. A comparison of the as-received strength and that following pre-conditioning fatigue shows that the mechanical fatigue cycles had no effect on the strength of the composite. There is an effect from the pre-conditioning fatigue on the modulus and the overall shape of the stress-strain response. The average modulus for the pre-fatigued material was

approximately 9 GPa lower than for the as-received material. This result was consistent with the difference in modulus measured during the pre-conditioning fatigue tests between cycle one and cycle 1000 shown in Fig. 8. The stress-strain curves for the pre-conditioned specimens show linear behavior from the onset of loading to a point above the pre-conditioning stress level of 125 MPa, whereas the as-received material showed non-linear behavior. The change in the stress-strain response is explained by the increase in the amount of matrix cracking induced by the fatigue testing.

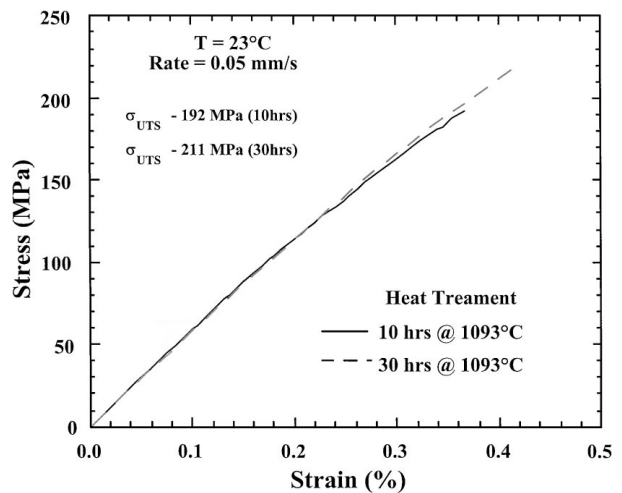
Figure 13 Representative stress vs. strain traces for Ceracarb™ material which had been pre-fatigued and heat treated for 10 to 30 hours at 1093°C.

The test specimens which were heat treated for either ten or thirty hours showed no loss in strength compared to the as-received material. Average strength and modulus measured for the specimens exposed for ten hours were 192 MPa and 59 GPa, respectively. The average strength of the material exposed for thirty hours was 211 MPa and the average modulus was 57 GPa. From these data, it appears that neither of the isothermal exposure conditions were detrimental to the retained strength. The drop in modulus observed for both heat treat conditions compared to as-received material was similar to that seen in the non-exposed pre-conditioned material. The stress-strain behavior of material heat treated for either 10 hours or 30 hours is nearly identical, although the strength of the material heat treated for 30 hours is slightly higher. A representative stress-strain curve from both the exposures can be found in Fig. 13. The stress-strain behavior is the same as described for the pre-conditioned material, the response is linear from the onset of loading, up to the pre-conditioning fatigue stress level of 125 MPa.

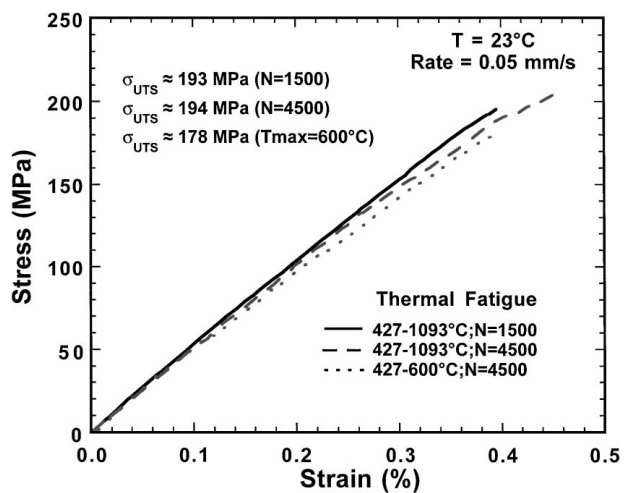
Figure 14 Representative stress vs. strain traces for Ceracarb™ material which had been pre-fatigued and subsequently thermally fatigued between 427°C and 1093°C for 1500 cycles and 4500 cycles and also from 427°C to 600°C for 4500 cycles.

curves generated from specimens tested under the various thermal fatigue conditions are shown in Fig. 14. The stress-strain response was found to be similar to that observed for the pre-conditioned and the heat treated test specimens.

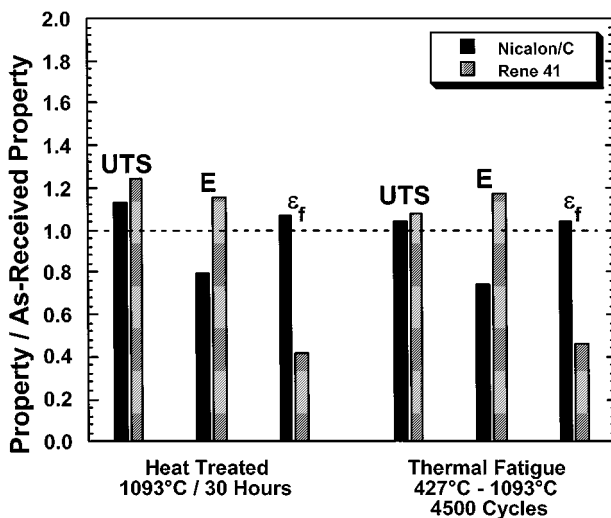
Figure 20 The residual strength data after heat treatment and thermal fatigue for each material were normalized by the respective as-received values and plotted for comparison.

The durability of the Ceracarb™ material was compared to the current exhaust nozzle component material, Rene'41. The residual strength data after heat treatment and thermal fatigue for each material were normalized by the respective as-received values and plotted in Fig. 20. The Ceracarb™ material suffered no loss in strength from the as-received condition, but did see a decrease in modulus. The decrease in modulus was discussed earlier and was attributed to the increased density of matrix cracks imparted by the mechanical pre-conditioning fatigue and not due to the heat treatment or the thermal cycles. Strain to failure for the CMC was slightly larger than unity, indicating that the material experienced a slight increase in toughness as a result of the thermal conditioning. No significant change in tensile properties from the isothermal exposure or from the thermal fatigue suggests that the Ceracarb™ material does not degrade under the time at temperature conditions nor the thermal fatigue conditions tested in this study.

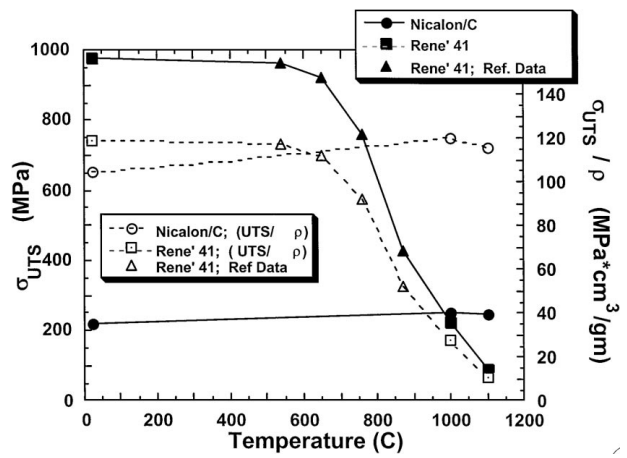
Figure 21 Plot of the ultimate tensile strength (UTS) and specific strength as a function of temperature for both Ceracarb™ and Rene'41. Rene'41 data between 600 and 900°C are found in reference [15].

The results of the tension tests are shown in Fig. 21. This figure shows the strengths and the specific strengths of both materials in terms of test temperature. It should be noted that the trace for the Rene'41 material also contains data from reference [15] for strength at temperatures between 600 and 900°C. At room temperature, the Rene'41 was almost five times stronger than the Ceracarb™ material. However, at 1000°C they were approximately equally as strong. At temperatures above 1000°C, Ceracarb™ was substantially stronger. If one looks at the normalized data, the two materials are nearly identical up to 600°C, after which the Ceracarb™ material is significantly superior to the Rene'41. At 1100°C the strength of the Ceracarb™ material is approximately three times greater than the Rene'41.
