The corrosion and tarnish behavior of new palladium-indium system alloys

Emphasis on reduced costs has led to the greater use of economic alloys. Previous work has designed alloys with physical and mechanical properties similar to those of high gold alloys. Evaluation for the degree of corrosion and tarnish are to followed quantitatively by potentiodynamic and spectrophotometer analysis. In the view of the development in low nobility alloys, it is important that such testing be standardized to characterize the corrosion and tarnish properties of the compositions. But there are concerns with the long term chemical stability of these alloys, the resistance to corrosion and tarnish. Chemical stability is a complex problem involving alloy composition, nobility, microstructure and environment. © 2000 Kluwer Academic Publishers

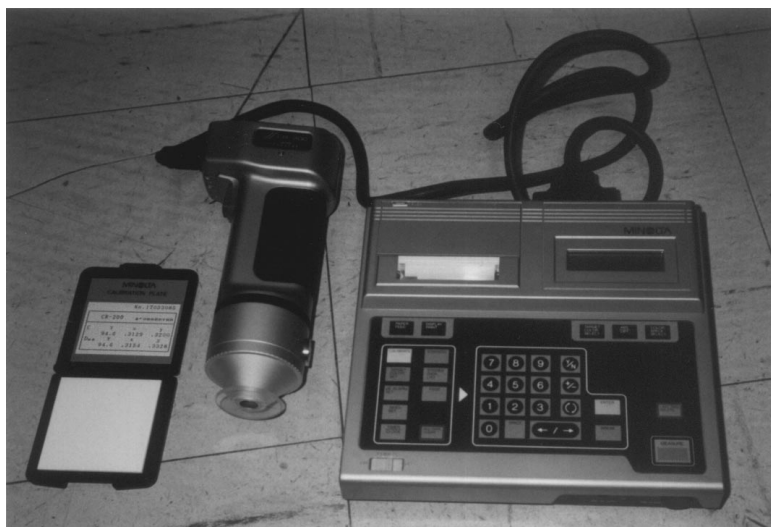
Figure 1 Spectrophotometer (cr-200. Minolta Japan).

(Cr-200, Minolta Japan). The CIELAB(International Commission on Illumination) uniform color scale was used to measure the color coordinates before and after tarnish exposure. The degree of tarnish is expressed in term of the composite color vector between the pre-exposure and post-exposure coordinates. Color information is expressed quantitatively as three parameters: ‘ L^* ’, indicating the light-dark relationship; ‘ a^* ’ giving the red-green values; and ‘ b^* ’, showing the yellow-blue component. The discoloration is expressed quantitatively by the value of ΔE^* calculated from the color vector formula [7].

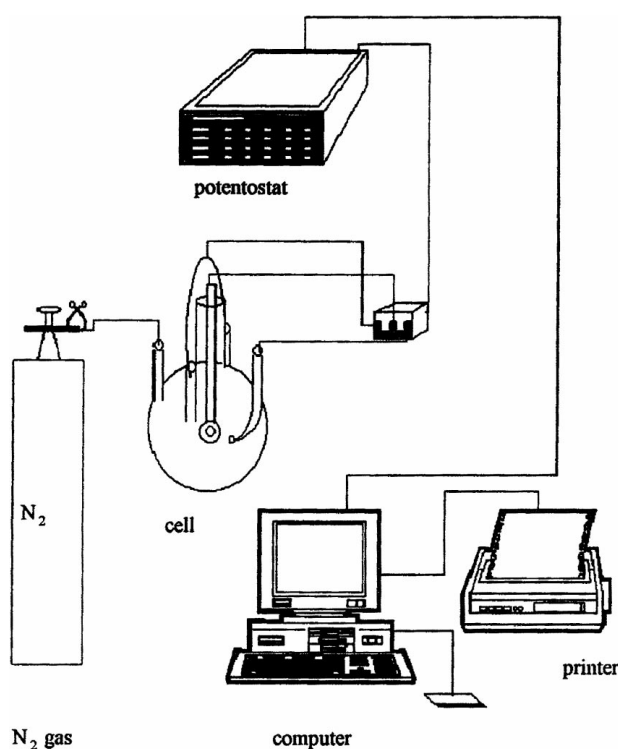
Figure 2 Experimental apparatus for corrosion test.

Corrosion rate, corrosion potential, breakdown potential of designed alloys were measured and compared to commercial Argenco Y^+ alloy. using potentiostat machine (Fig. 2) Experimental apparatus for the corrosion test were connected and controlled with IBM computer. In these days, the great interests are focused on the alternative gold alloy of Pd-In system which has a beautiful gold color. Pd-In has been reported as having a NiAl-type defect structure with Pd site vacancies at the composition in the excess of 50% In.

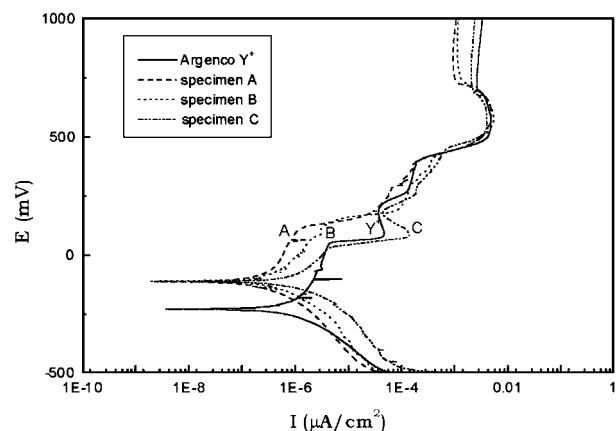
Figure 3 Potentiodynamic plots of new Pd-In system alloys and commercial alloy.

As indicated by the data in Table III and Fig. 3, the degree of tarnish varies with both the exposure time and alloy composition.

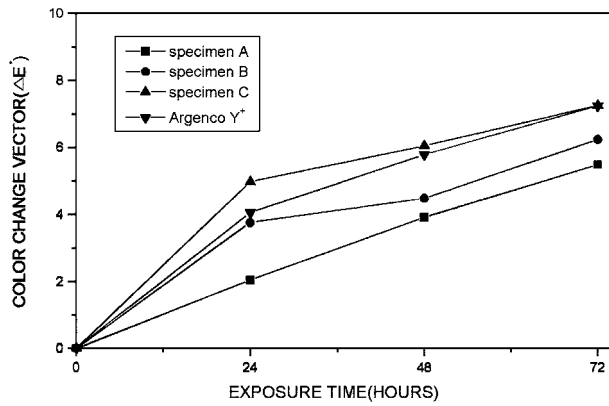
Figure 4 The tarnish color change in 0.5% Na₂S solution vs. exposure time for the as-cast Pd-In system and Argenco Y⁺ alloys at 36.5°C.

time. Such difference suggest that the tarnish products are highly variable; hence, it is important to generalize the tarnish reaction. One concern is with the rate of tarnish reaction. Argenco Y⁺ would be not preferable for the tarnish reaction to rapidly reach a high value for 10 minutes. Fig. 4 indicates the nobility is not sufficient to explain the results of tarnish tests. It appears that proper alloy design is more important to tarnish resistance than nobility. Below approximately 55 (at.%) noble metal content, microstructure play a dominant role in determining tarnish resistance [4].

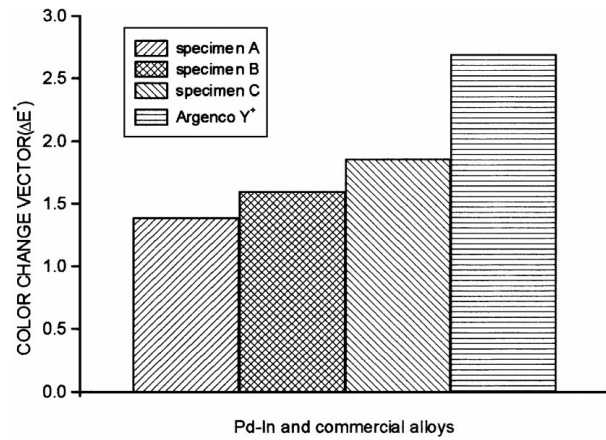
Figure 5 The tarnish color change following 10 minutes exposure to 22% (NH₄)₂S solution at 60°C.

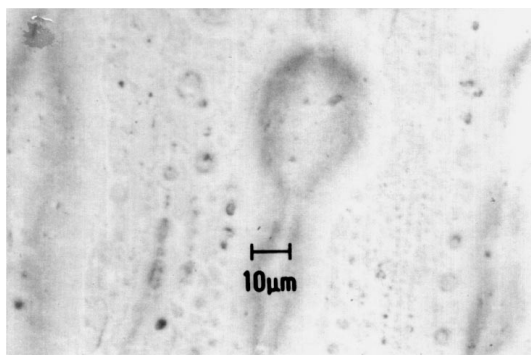
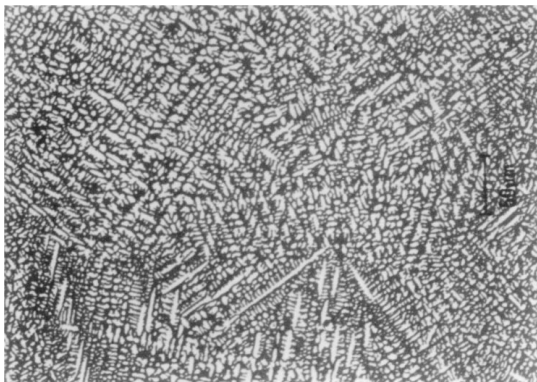
Figure 6 Optical microscopic view of phase observed at breakdown potential of selected alloys (a) 40Pd-29In-26Ag-2Zn-Au-2Cu (wt.%) (b) Argenco Y⁺.

The optical micrographic pictures for cast state and at the breakdown potential are such as Fig. 6. The surface of alloy at the breakdown potential of passivity which is predetermined by the curves obtained from potentiodynamic tests were observed by the optical microscope. The matrix of Pd-In system alloys was corroding acting as anode and secondary phases that were segregate at the grain boundary showed the preferential corrosion. Interdendrite region was found to corrode black in Pd-In system alloys. Normally there is an increased in tarnish with a decrease in nobility. However, it is clear that nobility alone is not a predictor of tarnish resistance. Sometimes it is important in the microstructure and composition of alloys.

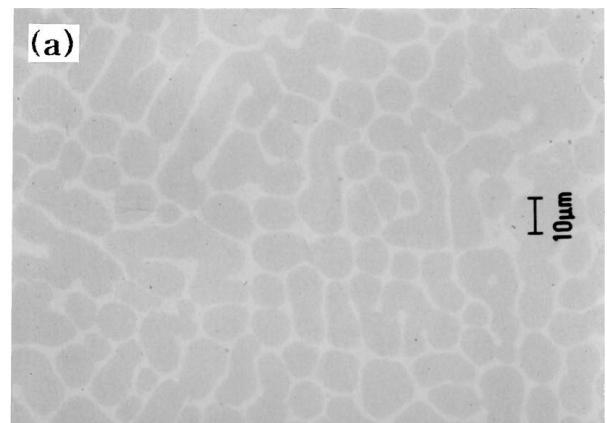
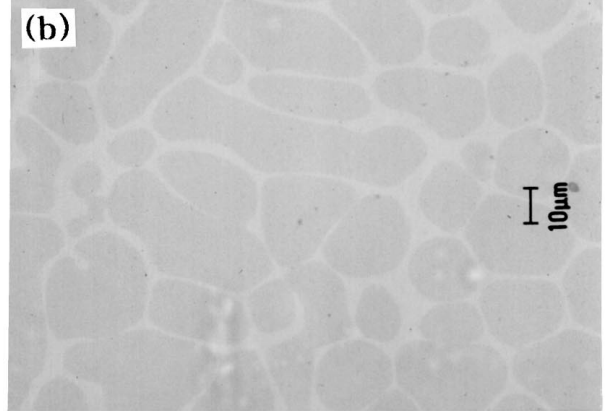
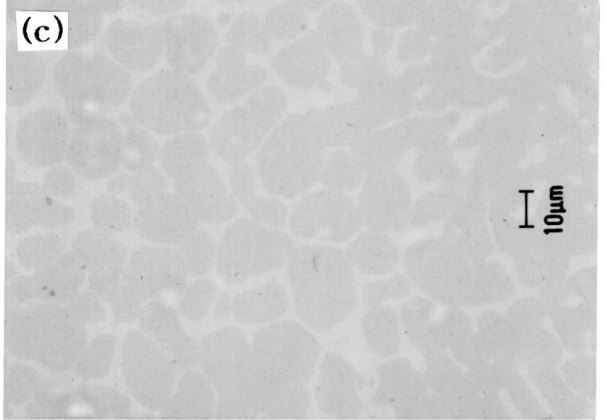
Figure 7 Optical micrographs show the as-cast microstructure of Pd-In system alloy (before the tarnish test) (a) 40Pd-29In-26Ag-2Zn-Au-2Cu (wt.%) (b) 40Pd-29In-25Ag-2Zn-2Au-2Cu (wt.%) (c) 40Pd-29In-23Ag-3Zn-3Au-3Cu (wt.%).

Microscopic examinations are used to determine the degree to which microstructure factors affect tarnish behavior. Before tarnish test is done, the surface of specimens was checked by the optical microscope (Fig. 7).

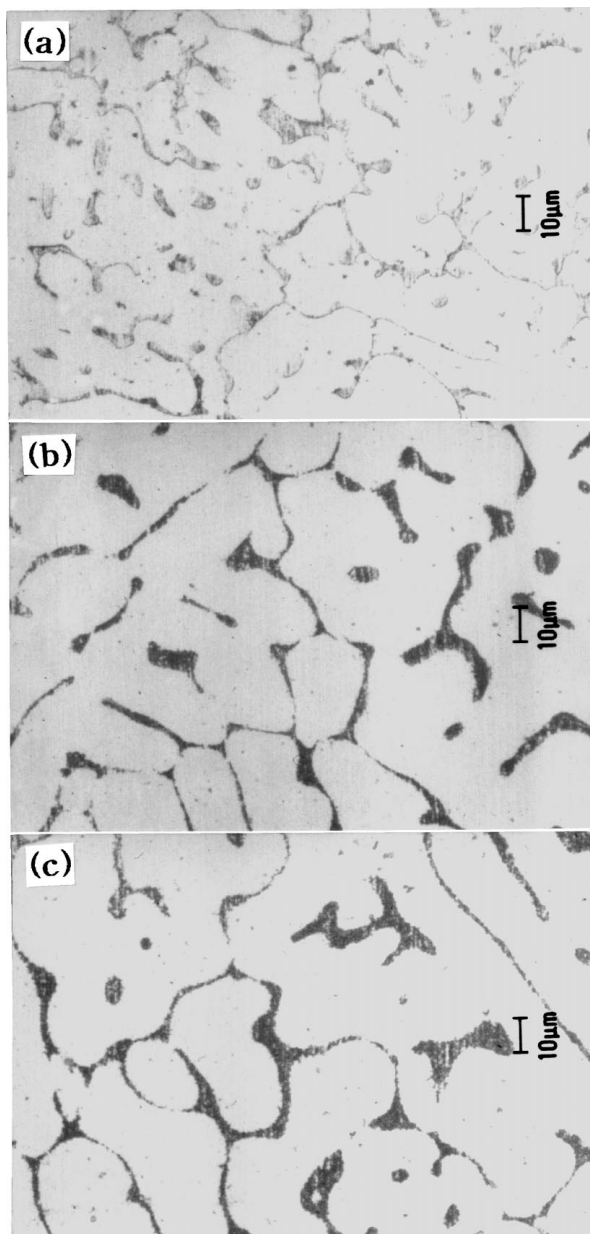
Figure 8 Alloy microstructure following 48 hour exposure to 0.5% Na₂S solution at 36.5°C (a) 40Pd-29In-26Ag-2Zn-Au-2Cu(wt.%) (b) 40Pd-29In-25Ag-2Zn-2Au-2Cu(wt.%) (c) 40Pd-29In-23Ag-3Zn-3Au-3Cu(wt.%).

40Pd-29In-25Ag-2Zn-2Au-2Cu(wt.%) and 40Pd-29In-23Ag-2Zn-3Au-3Cu(wt.%) is more sensitive than 40Pd-29In-26Ag-2Zn-Au-2Cu(wt.%) (Fig. 8) in tarnish. Tarnish compound formation is increased by a two phase's microstructure via micro-galvanic coupling.
