# A Comparison of the performance and wear characteristics of high-speed steel circular saw blades machining Nimonic PK31,\* AISI O1 Tool Steel, Inconel 600L,\* and AISI 1018 Carbon Steel

S. R. BRADBURY

D. B. LEWIS

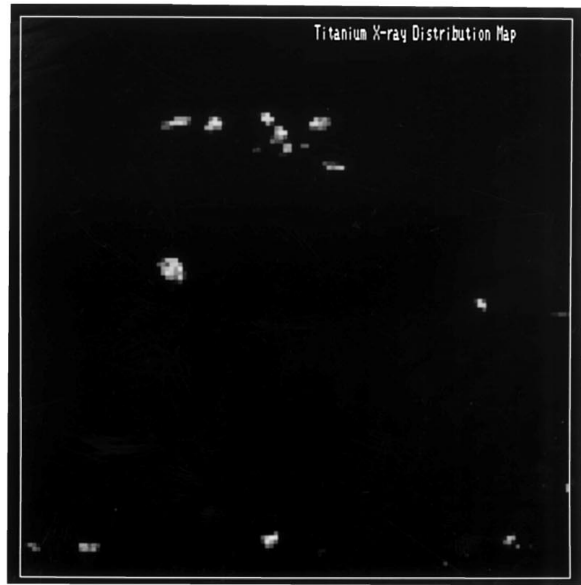
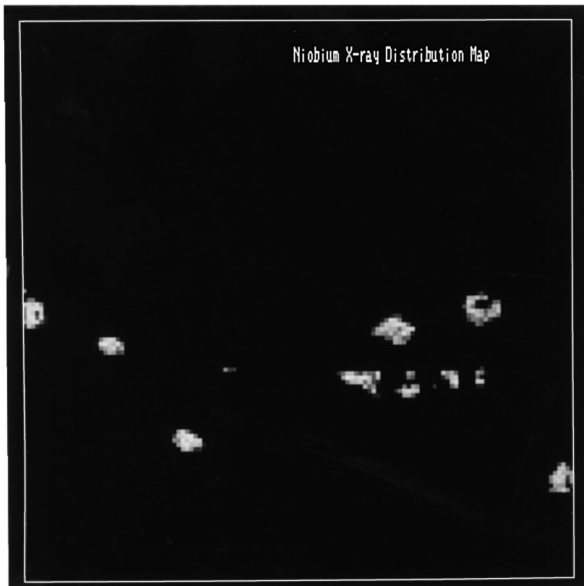
Figure 3 Microstructure of Nimonic PK31 nickel-based alloy (a)  $\times 700$ , (d)  $\times 5000$ ; (b) Ti; and (c) Nb X-ray distribution map  $\times 700$ .

The micrograph in Fig. 3a identifies titanium nitride (dark) and niobium carbides (light) distributed throughout the microstructure of the material. This is confirmed by the X-ray distribution maps shown in Fig. 3b and c, respectively. At higher magnification, the presence of gamma prime within the matrix and carbide precipitation ( $M_{23}C_6$ ) along grain boundaries has also been

identified, Fig. 3d. The presence of these hard particles promotes abrasive wear if conditions allow; however, work hardening and adhesive wear predominate when this material is machined.

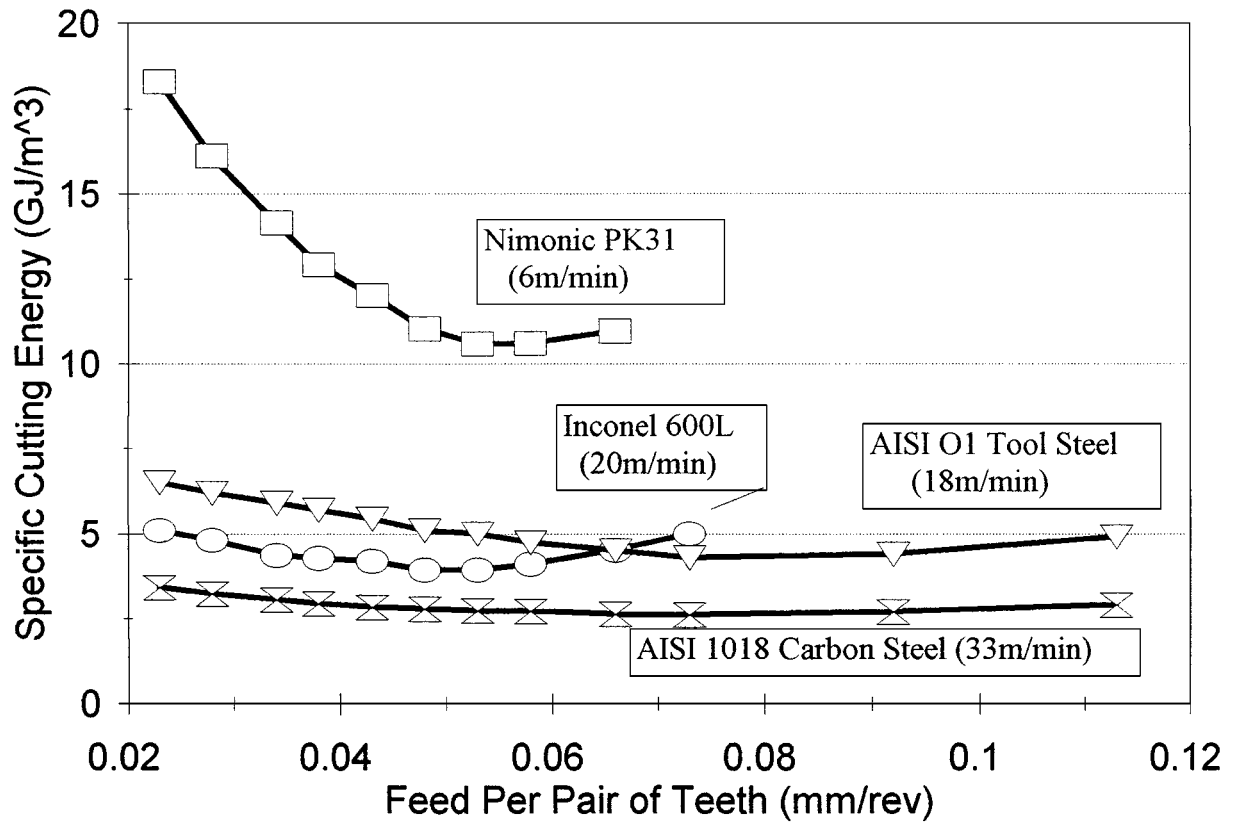
Figure 6 Optimized performance curves.

creased incrementally and the  $E_{sp}$  evaluated at each setting. As the feed rate increased the  $E_{sp}$  initially reduced in value until the effects of gullet congestion caused it to increase again. The combination of cutting parameters at which the energy requirements were a minimum were determined using this method [6]. Curves relating to the materials are given in Fig. 6 with the optimized

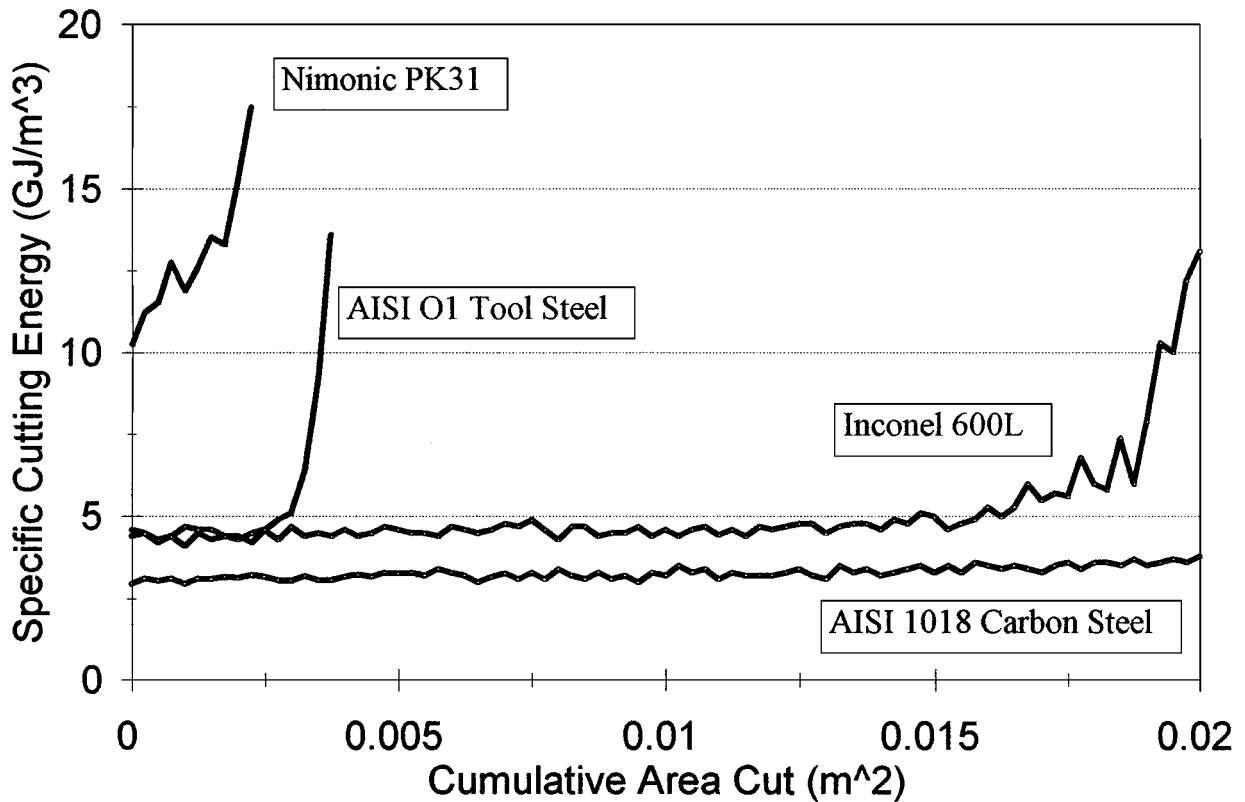
Figure 7 Performance throughout tool life.

machine tool set to the optimum cutting conditions, the results for which are shown in Fig. 7.

From Fig. 7 it is apparent that there is a large variation in energy requirements for machining the different materials. The minimum energy required to machine the nimonic alloy was approximately  $11 \text{ GJ m}^{-3}$ ; this compares with  $6.5 \text{ GJ m}^{-3}$  for the Inconel,  $5.5 \text{ GJ m}^{-3}$  for the tool steel, and  $4 \text{ GJ m}^{-3}$  for the carbon steel. The conversion of a large proportion of the energy into heat results in the rapid failure of the tools. This is in-

dicated by the curves in Fig. 7 that show a massive increase in gradient toward the end of the life of each tool.
