Journal of Nuclear Materials 258–263 (1998) 972–977

Evidence of damage in carbon fibre composite tiles joined to a metallic heat sink under high heat flux fatigue

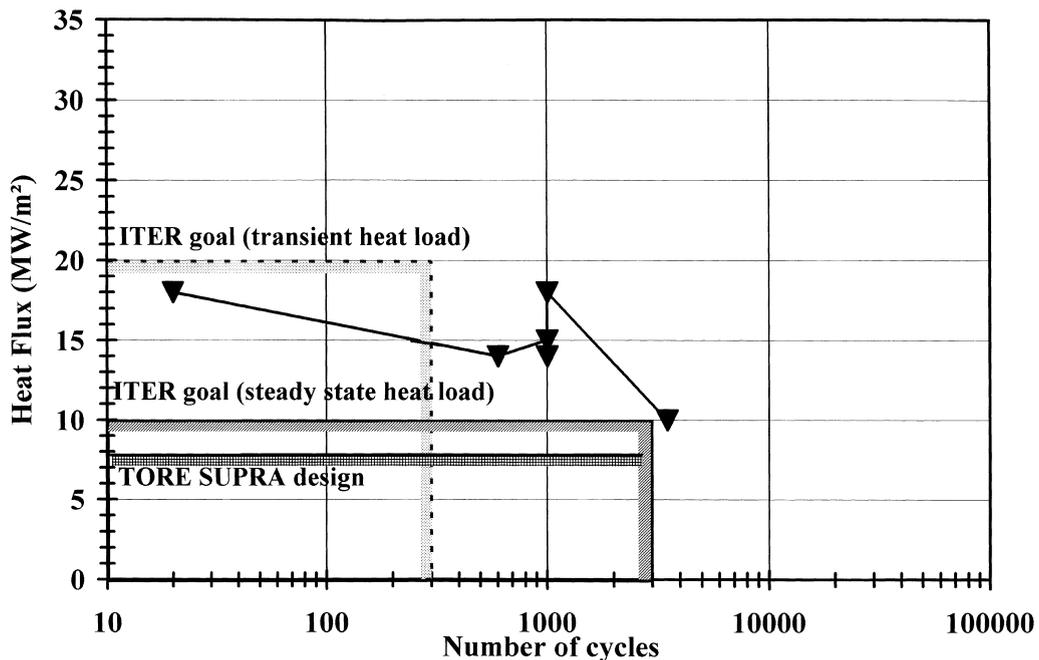
Fig. 1. Results of high heat flux tests of CFC armour to Cu heat sink joints.

Those tests compare well with the literature (Fig. 1, see also Ref. [10]). The AMC bond in flat tile geometry, although less capable in terms of highest heat load, is the second ever tested in terms of number of cycles.

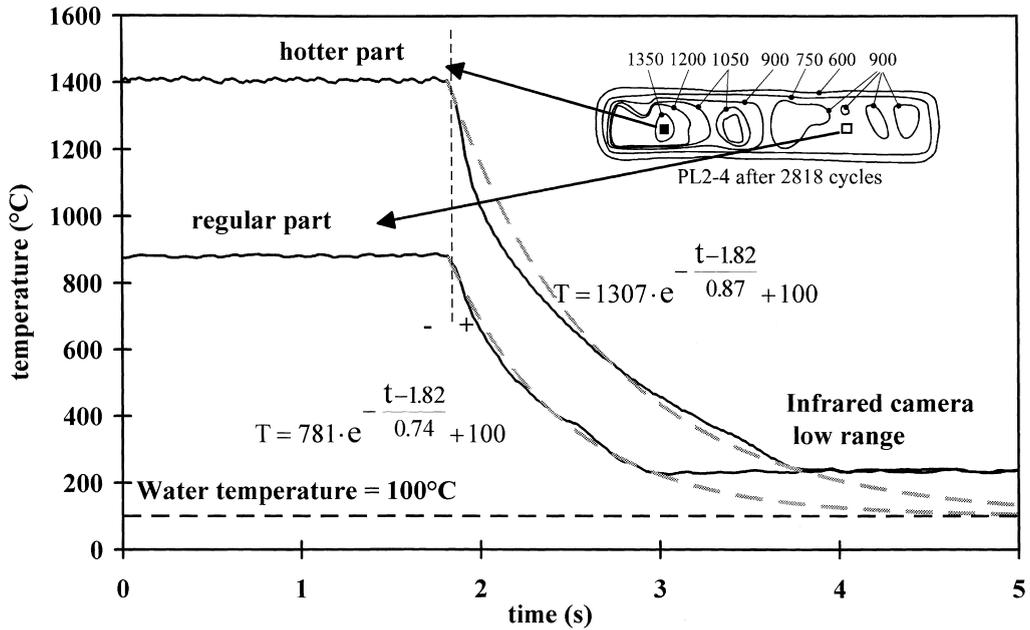
The infrared view shows regular and hotter parts (Fig. 2). The hotter parts can be attributed to numerous effects such as deteriorated bonds, lower tile conductivity, local differences in the surface emissivity and non-evenness of the beam. After the cycling, surface temperature of both parts versus time are extracted by averaging on 10 × 10 pixels zones (Fig. 2).

Fig. 2. Time evolution of the surface temperature after stopping the incident power after 2818 cycles on PL2-4.

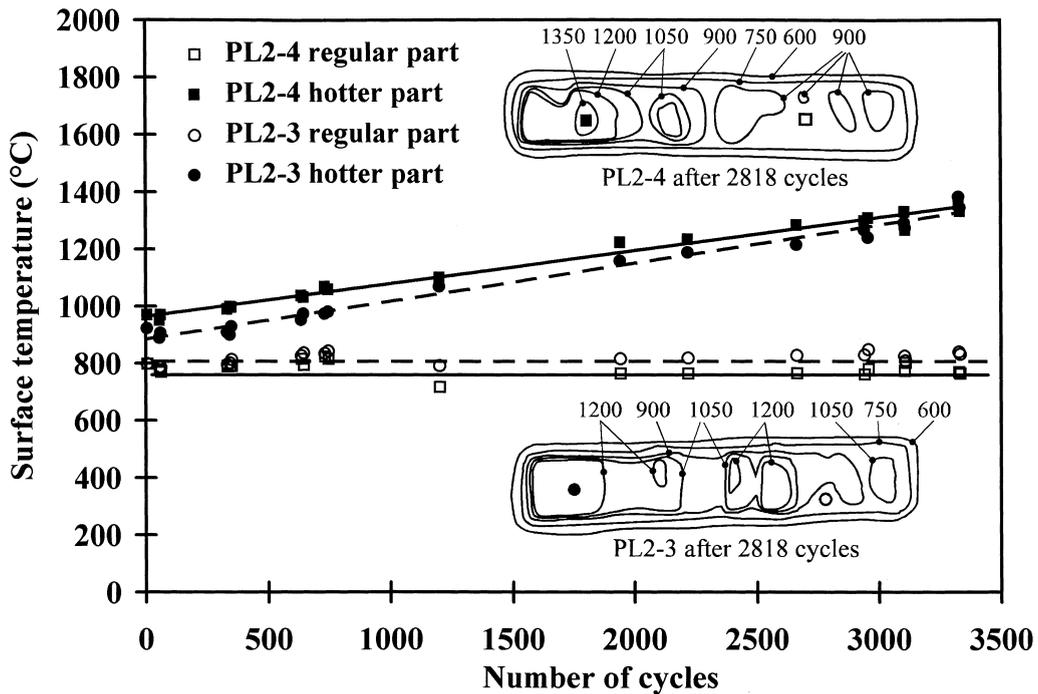
The surface temperature is calculated on the plateau and the time constant during the cooling of the structure. The emissivity of the surface was set to 0.85. Calibration shots before and after the tests showed that the correction coefficient (transmission of the windows, tile emissivity, etc.) did not noticeably change during tests. Only the cycles with a heat flux higher than 10 MW/m² (ranging from 10.6 to 11.5 MW/m²) were taken into account in this study. The surface temperatures were normalised to 10 MW/m² according to finite element calculations to allow comparison. The normalised surface temperature of regular and hotter parts of PL2-3 and PL2-4 are given versus the number of cycles (Fig. 3).

The temperatures of the regular tiles of both fingers are almost constant, around 800°C. Hotter parts on both fingers show a steady increase of the temperature with the cycling, from 950°C to 1350°C. The temperature rise of the hot tiles cannot be attributed to lower tile conductivity or beam profile, which are constant during the test. For this reason, this temperature rise is linked to progressive damage at the interface, either as the progression of a crack or to progressive micro-cracking.

Fig. 3. Evolution of the surface temperature versus number of cycles for TPL prototype elements.

The temperature variation on neighbouring points gives the uncertainty of the method. For 0, 500, 1000 and 3000 cycles where at least two temperatures for close number of cycles are known, the fluctuations can be

evaluated to 30°C. Therefore, the temperature rise of ~400°C of the hotter parts of PL2-3 and PL2-4 is significant.

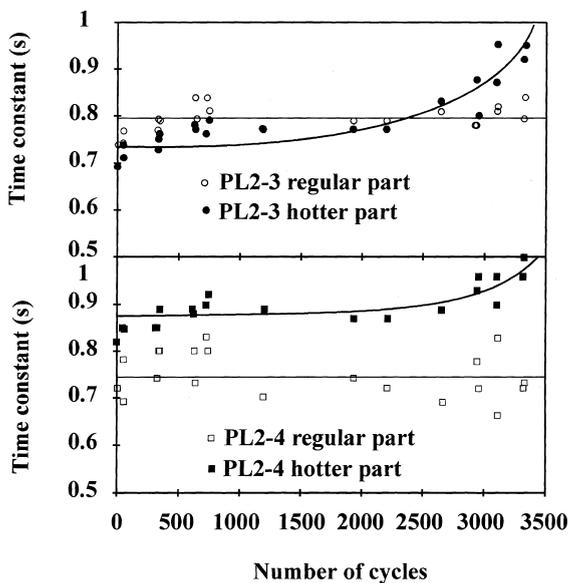
The interface damage is also characterized by a longer time response of the tiles. The time constants of the tiles are calculated during the transients. They are given in Fig. 4 for hotter and regular parts.

Rather big fluctuations are observed, around 0.07 s while the time constant is around 0.7 s. However, different evolutions between the spots are still significant. The time constants of the regular zones are approximately constant, while those of the hotter parts always increase with the number of cycles. The hotter tiles always finish with longer time constants than the regular tiles. For PL2-3, the increase is around 23% of the initial value, and for PL2-4 around 12%. The time constants, although less precise than the surface temperature measurements, confirm the degradation of the heat transfer capability of the structure. However, the damaged tiles remain remarkably actively cooled, with time constants smaller than 1 s and a surface temperature still acceptable for operation.

Fig. 4. Evolution of the time constants.

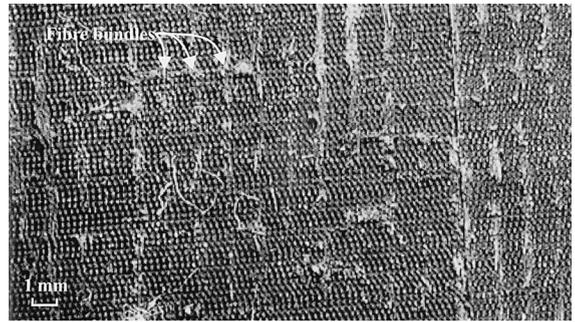
Fig. 5. Macrography of the heat sink after tests at 18 MW/m² (the defective tile was removed in laboratory).

On broken tiles removed from the mock-up after test at 18 MW/m² (Fig. 5), the copper is mainly black, with many cones visible. The cones are made out of copper that has solidified in the laser-machined holes in the CFC during the AMC process. Fibre bundles often remain attached to the copper. Very few copper is visible on the fractured area of the tile. These elements indicate that such cracks propagate mainly in the CFC or just beneath. Moreover, some black dust falls from the tile, suggesting a disintegration of the CFC material in the vicinity of the bond.

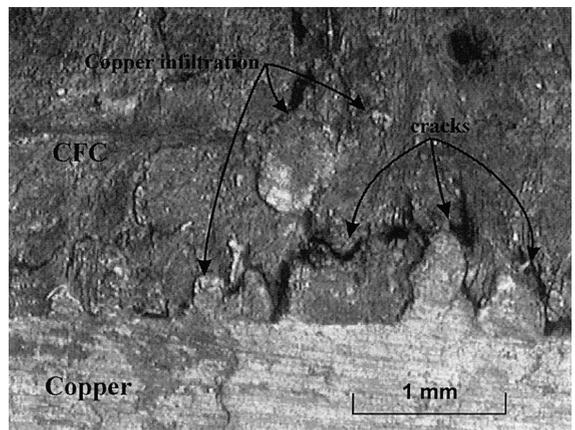
In the CFC (Fig. 6), cracks are observed above the cones, on top of the cones or between cones. On the edges, cracks start in the CFC in front of the cones. Inside the tiles, the cracks begin at the interface to copper or inside the CFC. Cracks can be observed at the interface between the copper and the CFC. More often such cracks are hybrid, that is they propagate indiffer-

Fig. 6. Macrography of cracks in the CFC and at the interface CFC-copper.

ently in the CFC or at the interface of the CFC to copper. In these areas, the cones recede from the CFC, leaving a crack that follows the cones or sometimes goes through the CFC between two cones. On some very damaged tiles, continuous cracks that go straight through the cone and the CFC could be observed.

Internal voids in the CFC near the interface are sometimes filled with copper or carbides. Such inclusions in the CFC are to expand and shrink during thermal cycling. As the CFC has a lower thermal expansion coefficient, it will undergo cyclic compression. This suggests a damage mechanism which could explain the disintegration of the CFC above the bond. In some cases, such inclusions were observed above cracks, showing that the crack was subsequent to the manufacture of the AMC bond.

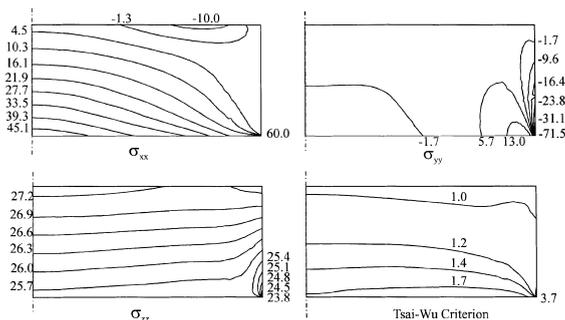
Finite element calculations are done to evaluate the stresses in the structure of a finger. A new nonlinear model was specially developed and implemented for the CFC [11]. Stresses in a CFC tile of the LPT for 10 MW/m² and a computation of the Tsai–Wu criterion are shown in Fig. 7.

In most of the tile, the criterion exceeds 1, showing the CFC material should break. Even if the criterion may be overestimated, the level of stress explains the observed cracks. It explains also the kind of disintegration of the CFC observed above the bond. However, the cracks also allow the CFC to accommodate somehow the imposed deformation, which could explain that

Fig. 7. Stresses (MPa) in a CFC tile under 10 MW/m² (2D generalised plain strain calculation).

damaged tiles still hold to the heat sink. These results also point out the limitation of the Tsai–Wu criterion, which isn't suitable for this configuration. A new criterion is currently under development at Tore Supra to characterize the stress level.
