Non-destructive electrochemical techniques applied to the corrosion evaluation of the liner structures in nuclear power plants

Abstract

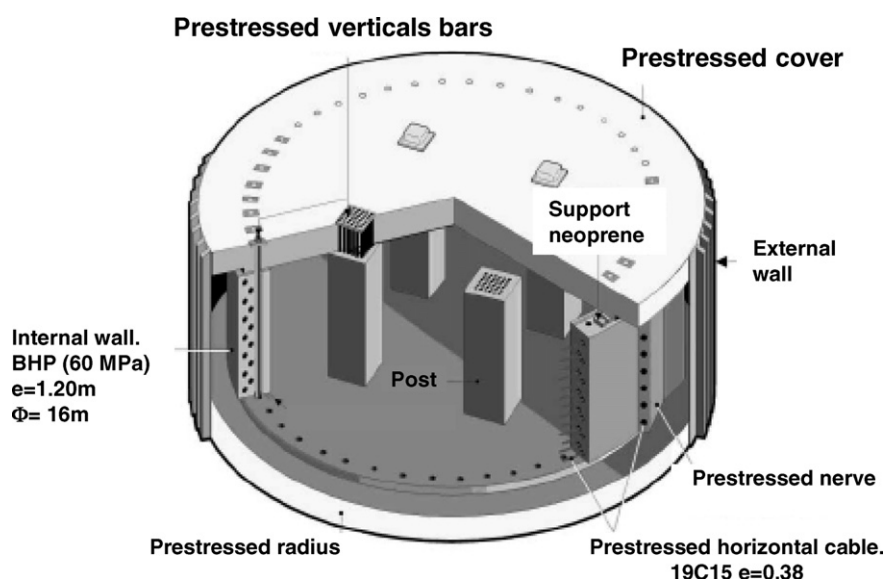
Fig. 1. General containment structure.

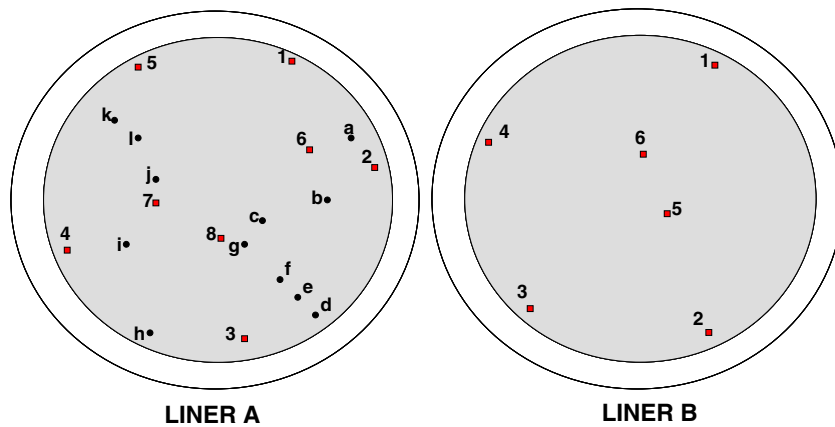
For the water pH determinations, 12 different points were selected under the slab of Liner A. Due to the difficulties of access, these areas are different from the 14 selected for the electrochemical measurements in the two liners (8 points in Liner A and 6 points in Liner B) (Fig. 3). In the areas where corrosion was measured, the external painted covering was removed (a window of 30×30 cm in each area) for a better electrolytic contact of the electrodes with the concrete surface.

Fig. 3. Electrochemical measurement areas and water extracting points indicated in Liner A and Liner B.

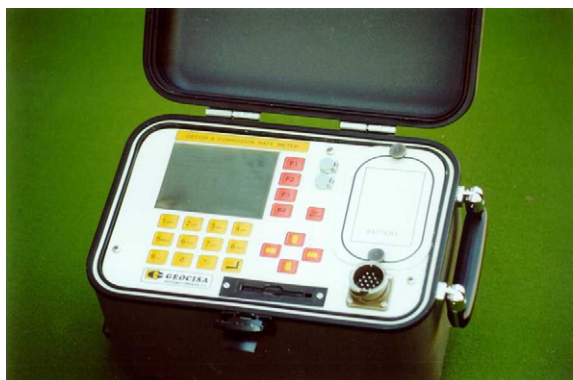
The portable device used for all these electrochemical measurements was the corrosion rate meter Gecor 08 (Fig. 4). It has different measurement options and sensors

Fig. 4. Corrosion rate meter Gecor 8.

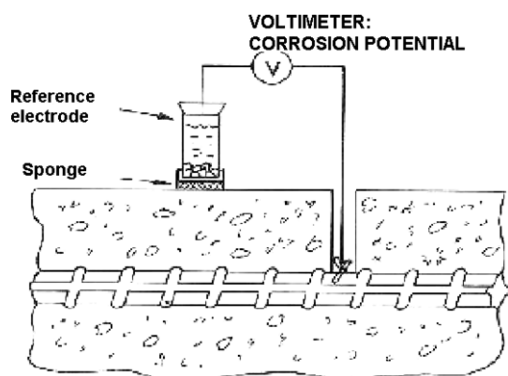
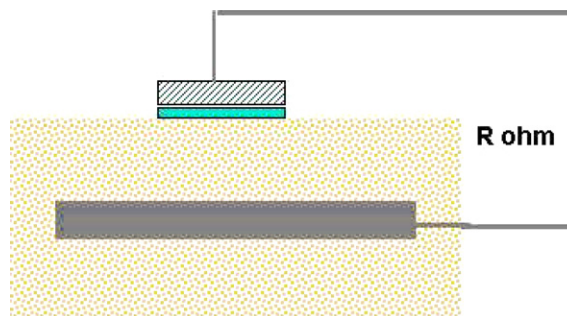
The method used for on-site concrete resistivity determination is the one called ‘Disc method’ (Figs. 5 and 6).

Fig. 5. Potential measurement of concrete reinforcement.

Fig. 6. Disc method.

Based on Newman’s [10] work, and fully developed by Feliú et al. [11], it estimates the ohmic drop from the resistance between a small disc placed at the surface of an electrolyte and a much larger counter electrode placed at infinity. It is demonstrated that electrical resistance is a function of the resistivity of the electrode, and it can be calculated from the expression:

A conductive material disk, a galvanostat and a reference electrode compose the device. Once good contact between electrode and concrete is obtained, a galvanostatic pulse is applied and then, the ohmic drop is recorded from the instant response. Distance between disk and rebar has to be at least two times the disk diameter. Resistivity units frequently used are Ω m or $k\Omega$ cm. The range of values frequently measured in concrete and its relation with corrosion risk is presented in Table 1.

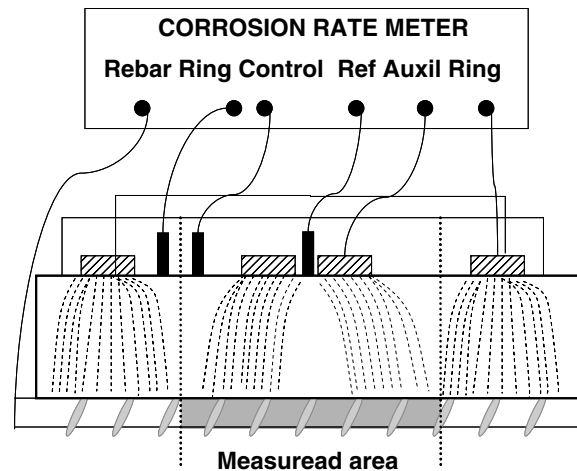
2.2.3.1. Modulated confinement of the current: guard ring method. There are several ways of accounting for a true I_{corr} value when measuring on-site, among which the most extended one (and used for present experimentation) is the use of a guard ring [15] aimed at confining the current in a particular rebar area, as Fig. 7 depicts. The measurement is made by applying a galvanostatic step (minimum of 5 μA), lasting 30–100 s, from the central counter. Then, another counter current is applied from the external ring, and this external current is modulated by means of the two reference electrodes called ‘ring controllers’ in order to equilibrate internal and external currents, which enables a correct confinement, and therefore, calculation of R_p . By means of this electrical delimitation to a small zone of the polarized area, any localised spot or pit can be localised.

As this parameter is measured as a current density ($\mu\text{A}/\text{cm}^2$) it is necessary to determine the metal area affected by the electrical signal applied. The confinement system concentrates the measurement area into a cylinder projected under the sensor of 10.5 cm in diameter. That is, all metallic components embedded in the concrete and situated in

Fig. 7. Modulated confinement system.

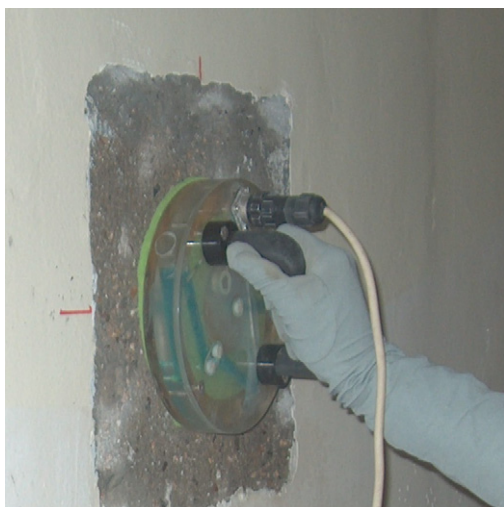
The technique is based on electrochemical impedance spectroscopy (EIS) in a low range of frequencies (from 100 to 0.01 Hz). The PVT technique is applied by means of the commercial portable corrosion rate meter (Gecor 8), that gives an indication on the passivity based in a percentage of protection. The mode that the PVT operates in is that it detects whether a semicircle appears or not over the range of frequencies of 0.1–0.01 Hz. If no semicircle appears, the passivity is considered (conventionally) higher than 90% and classified as WELL PROTECTED. If a semicircle appears, depending on the phase angles measured in that frequency range, the classification decided for practical purposes is MODERATELY PROTECTED or NON-PROTECTED. An external circular sensor with a current confinement system is placed on the concrete surface over the metal to be tested (rebar is located prior to positioning the electrode), assuring the electrolytic contact

Fig. 8. Arrangement used for PVT and corrosion rate measurements.

Both techniques, corrosion rate measurements by modulated confinement and PVT, were performed with the same arrangement, as is shown in Fig. 8.

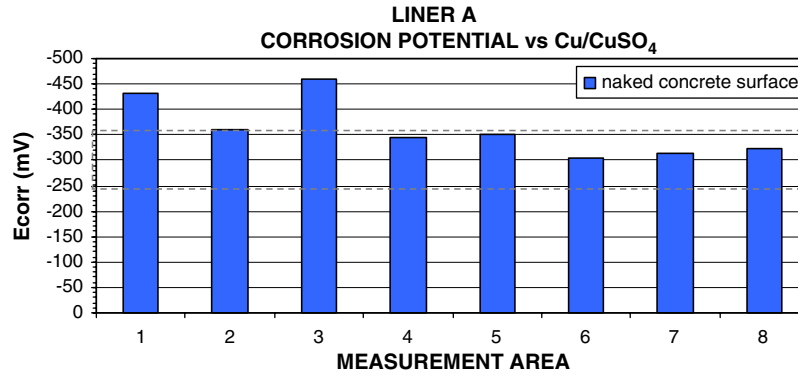
Fig. 9 presents the corrosion potential values (vs Cu/CuSO₄) measured in the eight areas evaluated in Liner A. Almost all values are in the range between –250 and –350 mV. In this range, information about corrosion risk is not clear, as it was explained previously in this paper. Points 1, 2 and 3 presents a corrosion potential value more negative than –350 mV, so, these areas are the most susceptible for suffering corrosion.

Fig. 9. Liner A: corrosion potential vs Cu/CuSO₄.

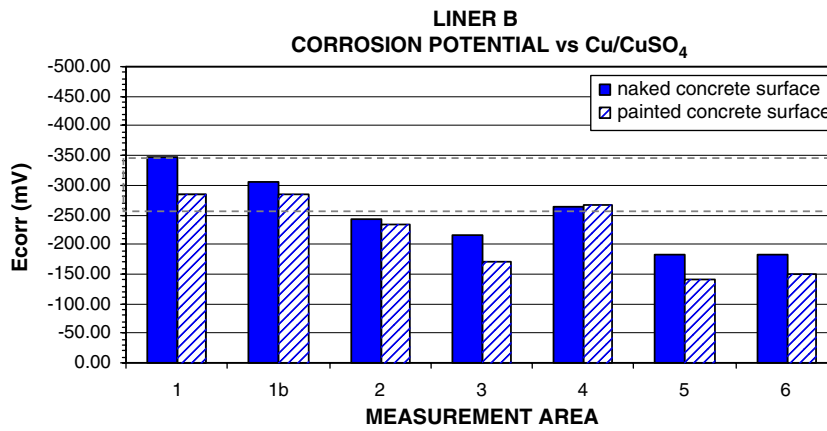
Fig. 10 presents the corrosion potential values (vs Cu/CuSO₄) measured in the six areas evaluated in Liner B. In this case, a comparison about the influence of the paint over the concrete surface in the corrosion potential measurement has been done. In general, slightly more negative potentials are measured when placing the reference electrode over the

Fig. 10. Liner B: corrosion potential vs Cu/CuSO₄.

non-painted concrete surface. The registered values indicate that there is not a high corrosion risk (as no values more negative than -350 mV are found) (Table 4).

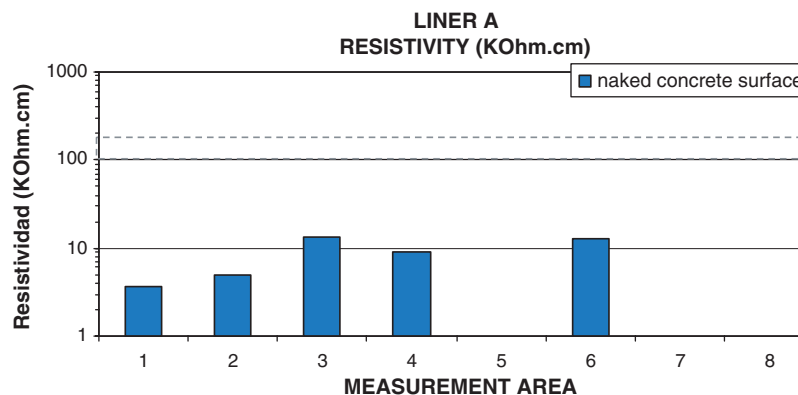
Fig. 11 shows the resistivity values measured in the slab over Liner A. They are between 3.6 and 13.5 k Ω cm (under the threshold value of 100 k Ω cm) (Table 4), which

indicates that the concrete was wet when taking the measurements.

Fig. 11. Liner A: concrete resistivity measurements.

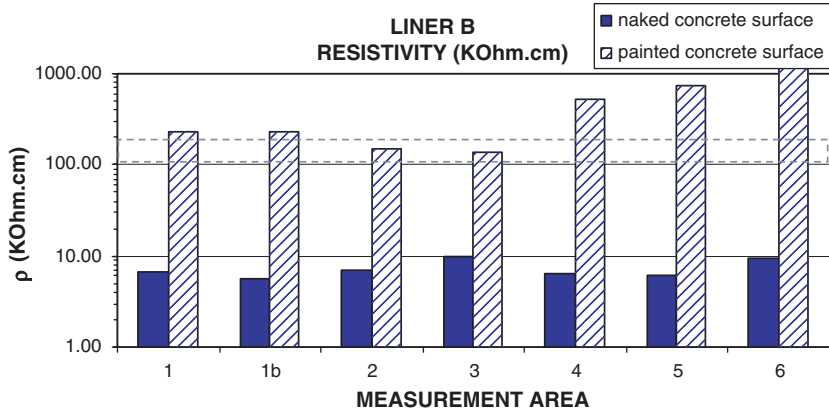
As in the previous parameter, a comparison between resistivity measurements made in the naked concrete surface and in the painted concrete surface was made in Liner B. Fig. 12 shows that when measuring through the paint, resistivity values are higher than when measuring in the naked concrete surface (it seems logical, as the paint always acts as an extra resistance layer). When measuring in areas

Fig. 12. Liner B: concrete resistivity measurements.

without paint, resistivity values are in all cases lower than 10 kΩ cm, which indicates that, as in the previous case, the concrete attached to the liner is quite wet.

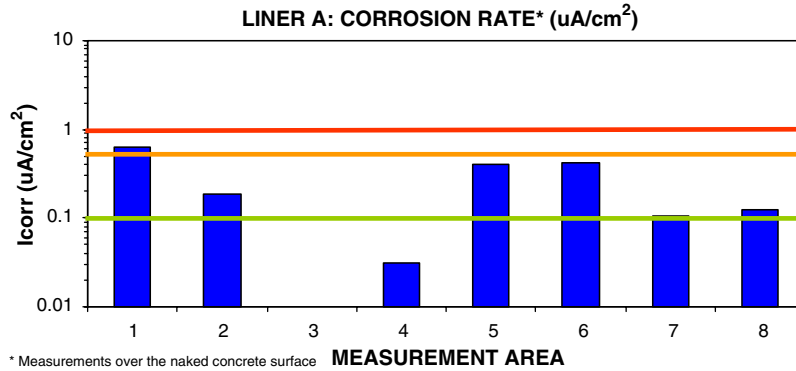
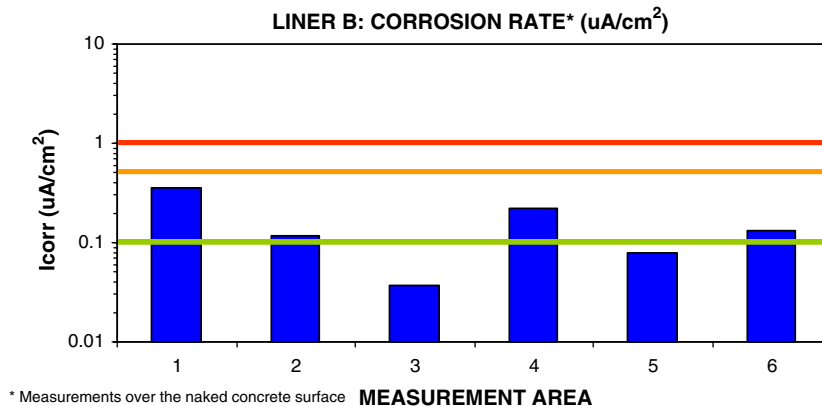
Figs. 13 and 14 show the quantitative corrosion rate values measured in Liner A and Liner B, respectively. Following the criteria presented in Table 2, only one (measurement area number 1 in Liner A) of the 14 areas evaluated in both

Liner A and Liner B has a moderate corrosion value (between 0.5 and 1 $\mu\text{A}/\text{cm}^2$). Remaining points show negligible or low corrosion rate values.

Fig. 13. Liner A: corrosion rate measurements.

Fig. 14. Liner B: corrosion rate measurements.

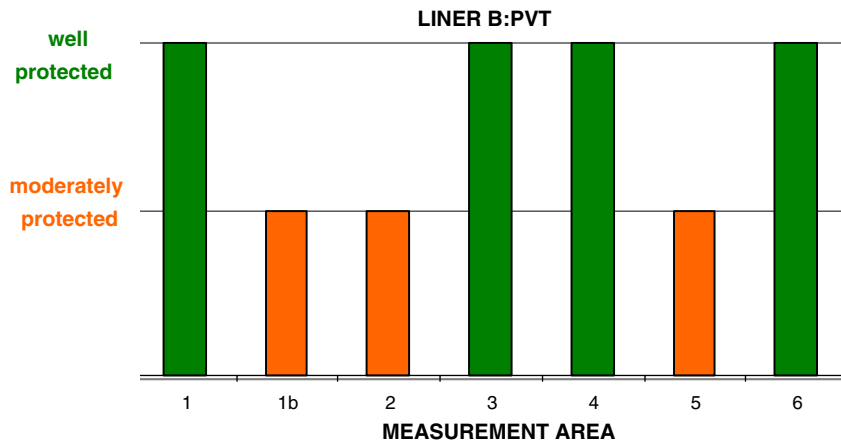
As a complement to the rest of the electrochemical measurements already described, the passivation verification technique was also applied in some areas of Liner B. Results presented in Fig. 15 indicate that none of the six

Fig. 15. PVT measurements taken during the inspection.

areas evaluated with this technique have high corrosion activity, because all are ‘well protected’ or ‘moderately protected’.

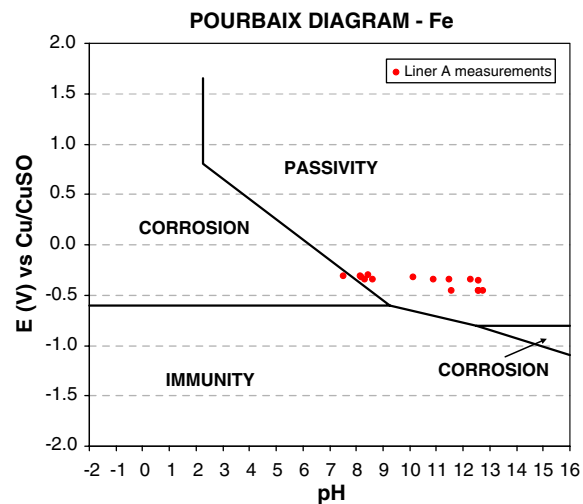
The pH is an important parameter to determine whether the metals in contact with the aqueous solution are at corrosion risk or not. This information can be obtained from Pourbaix diagrams [8]. These diagrams represent pH of the electrolyte vs the corrosion potential of the metal at a certain temperature. Even when these are thermodynamic diagrams, they allow for different areas in which the metal is in a corrosion, passivity or immunity state to be identified.

The corrosion potential values measured are all between –300 and –450 mV (Table 4), and the pH values went from 7.5 to 12.8 (Table 3). As shown in Fig. 16, for the corrosion potential range measured in Liner A, Fe will be corroded if pH is below 8. For more alkaline pH, Fe will remain passivated unless the corrosion potential reaches values of around –600 mV or more negative. Then, it is expected that the liner is passive except at the points where the pH has decreased below 8. However, that point shows a corrosion rate of 0.11 $\mu\text{A}/\text{cm}^2$, which although is above the threshold of passivity (Table 2), it is not the highest value measured. This is not an unexpected consideration, because the E_{corr} is only giving qualitative indications and the oxides formed and their aging plays an important role in its

Fig. 16. Pourbaix diagram for Fe at 25 °C.

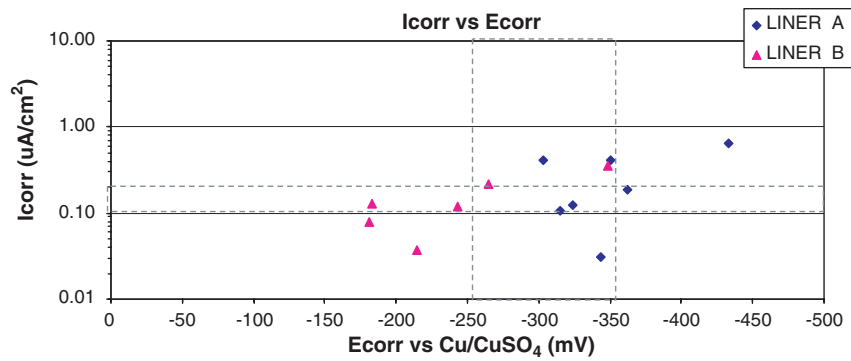
Fig. 17 shows the plotting of the E_{corr} and I_{corr} values measured in the 14 points selected. Then, both parameters are taken in the same place.

In this figure, the criteria given in [9] are shown with dotted lines, which indicate that the corrosion rate values are ‘negligible’ when corrosion potential are less negative than –250 mV(vs Cu/CuSO₄), and are ‘moderated’ when the corrosion potentials are more negative than –350 mV. In the range between –250 and –350 mV negligible, low and moderate corrosion rate values are expected.

Fig. 17. I_{corr} vs E_{corr} .

So, there are some points showing I_{corr} values $< 0.1 \mu\text{A}/\text{cm}^2$, while the E_{corr} is more cathodic than -250 mV . Thus, even when measured at the same point, the E_{corr} is not a suitable parameter to distinguish between activity and passivity. Only the I_{corr} provides a quantitative indication.

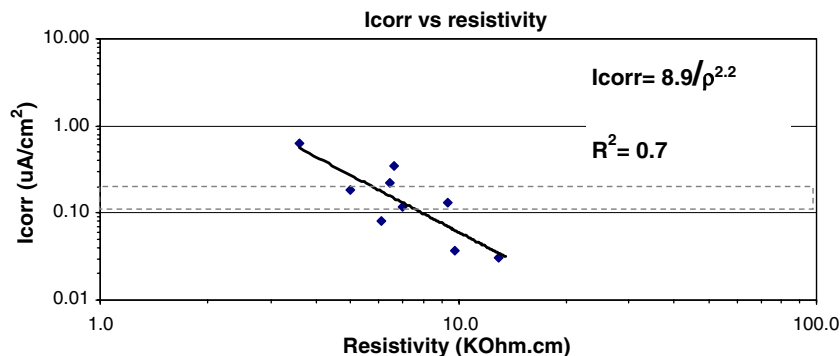
Considering that concrete resistivity (measured at the nude concrete surface) is in all cases between 3 and 13 $\text{k}\Omega \text{ cm}$, the possibility of a certain corrosion risk is high as the concrete seems to be very wet. To confirm whether this wet condition is or is not inducing corrosion, a graphic correlation of both parameters is given in Fig. 18. This plot indicates that the threshold in corrosion current of $0.1 \mu\text{A}/\text{cm}^2$ is related to resistivity values of 9–10 $\text{k}\Omega \text{ cm}^2$, one order of magnitude smaller than the measured in normal concrete structures [18]. This non-usual behaviour can be due to the fact that here the metal is a plate and not only a longitudinal bar, and therefore the normal ranges of correlation can be different due to the different geometry of the liner with respect to reinforced concrete with bars.

Fig. 18. I_{corr} vs resistivity.
