Cavitation damage experiments for mercury spallation targets at the LANSCE – WNR in 2005

B. Riemer^{a,*}, J. Haines^a, M. Wendel^a, G. Bauer^b, M. Futakawa^c, S. Hasegawa^c,
H. Kogawa^c

In-beam experiments investigating cavitation damage in short pulse mercury spallation targets were performed at the Los Alamos Neutron Science Center – Weapons Neutron Research (LANSCE – WNR) facility in 2005. Two main areas were investigated. First, damage dependence on three mercury conditions – stagnant, flowing, and flowing with bubble injection – was investigated by employing a small mercury target loop with replaceable damage test specimens. One hundred beam pulses were passed through the loop mercury and specimen pair for each test condition. Damage with flowing mercury ($V = 0.4$ m/s) was less than half that which was incurred with stagnant mercury. Gas bubble injection added into the flow further reduced damage to about one-fourth that of stagnant mercury. Acoustic emissions from cavitation bubble collapse were concurrently measured on the exterior of the loop using a laser Doppler vibrometer and were correlated to the observed damage. The second area of experimentation was erosion rate d

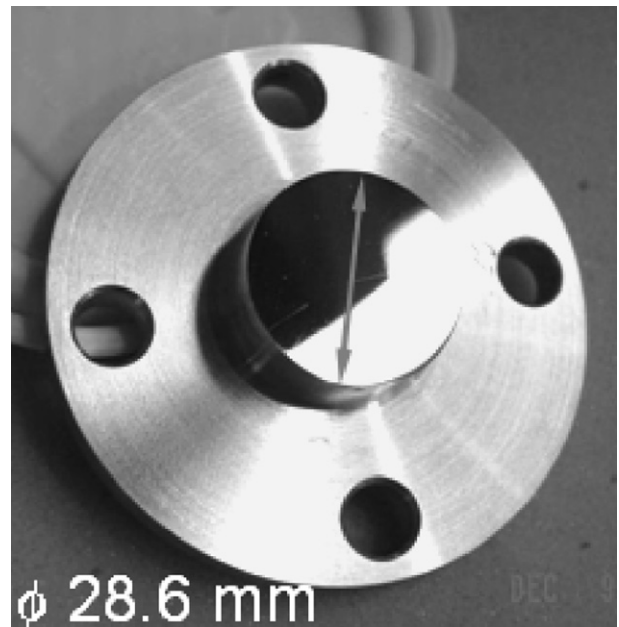
Fig. 3. Damage test specimen showing polished test surface.

The DTS were made of type 316L stainless steel and were designed so that their test surfaces were flush with the interior walls of the loop; an example is shown in Fig. 3. The material was fully annealed to maximize damage sensitivity to varying test conditions. Test surfaces were carefully polished, micro indented to establish a 5×5 array of fiducial marks (spaced 4 mm apart) and inspected for flaws before irradiation using a scanning electron microscope (SEM, Phillips XL30). Two specimens were employed from each test condition: one at beam entrance and at beam exit.

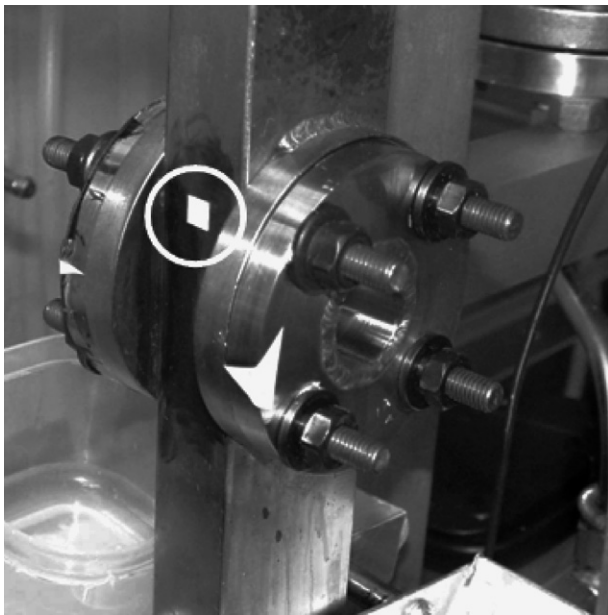
Fig. 6. IBBTL location monitored by LDV.

Experiment collaborators from the JSNS brought their experience and equipment to this test to obtain acoustic emission data associated with cavitation intensity and as well as structural response data from the beam induced pressure pulse. Using a laser Doppler vibrometer (LDV, Ono Sokki LV-1720) the normal velocity of a point on the target loop exterior surface was tracked at a high sampling rate; in this case the laser spot was aimed at a location on the side of the IBBTL leg between the DTS flanges (Fig. 6). The response was filtered either above or below 15 kHz and processed. Localized impacts from cavitation

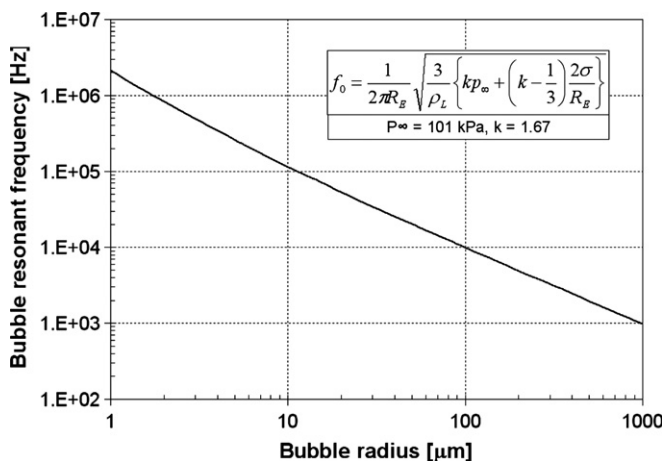
Fig. 12. An example of helium bubble in mercury resonance dependence on size. Adiabatic conditions are assumed.

Helium bubbles in mercury with a resonance of 100 kHz are small. Fig. 12 shows the dependence of bubble resonant frequency with size; 100 kHz corresponds to a bubble diameter of about 20 μm, which is desirable but quite small. In hindsight there seems to be less value in probing with frequencies much higher than 100 kHz. Conversely, not having interrogated the bubbly mixture at frequencies below 50 kHz probably missed evidence of larger bubbles. 50 kHz corresponds to a diameter of about 40 μm and it is plausible that mostly bubbles larger than this were generated.
