## Letters to the Editor

### A Case Report: dislodgement of an orthodontic bracket into a sagittal split site

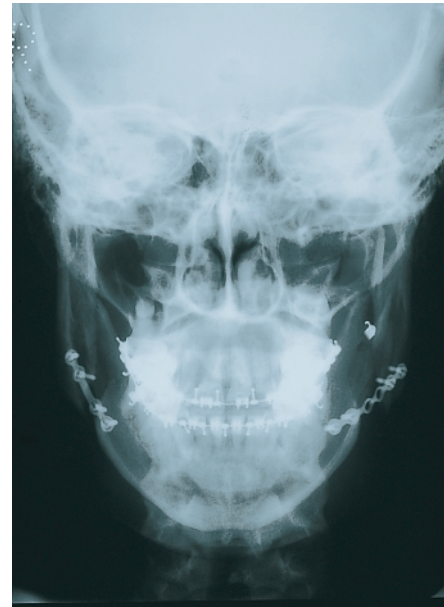
Two days later, however, prior to discharge, a postero-anterior radiograph revealed a dislodged orthodontic bracket lying in the superior aspect of the left sagittal split osteotomy site (Figure 1) and intra-oral examination confirmed absence of the lower left second molar bracket. The patient was informed, placed on a 5-day course of amoxycillin and a second general anaesthetic arranged for retrieval of the bracket, 28 days after the original surgery.

FIG. 1 Posteroanterior view of the jaws showing dislodgement of a second molar orthodontic bracket lying in the left osteotomy site.

During this procedure, careful dissection of the soft tissues overlying the left osteotomy site revealed the position of the second molar bracket, which was subsequently retrieved.

- (1) placing bands rather than brackets on the terminal molars;
- (2) checking all the fixed appliance components during the procedure and especially before the surgical site is closed.
