Nance palatal arch: a cautionary tale

Parmjit Singh and Shirley Cox

Orthodontics, Barts and the London NHS Trust, The Royal London Dental Hospital, London, UK

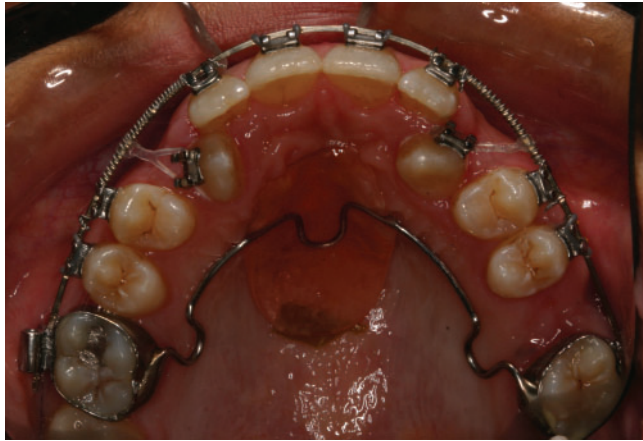
Figure 1 Nance palatal arch in place. Note food debris trapped around the posterior border of the acrylic button

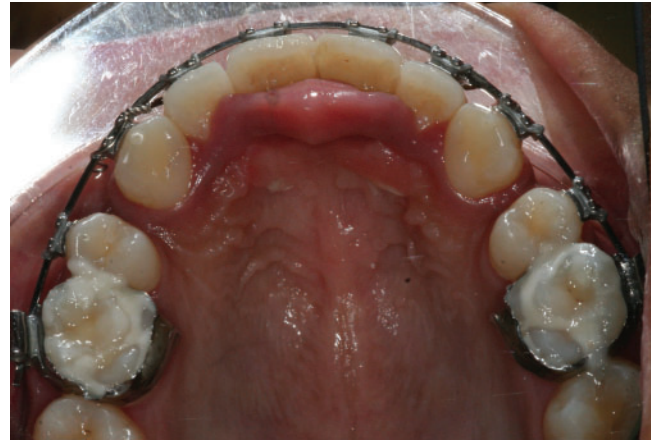
Figure 2 Bunching of gingival behind the incisors and erythema after a Nance palatal arch was removed

Nance in place, either as the molars come forward or as the incisors are retracted. The consequence of the latter can result in bunching of the gingival tissues behind the upper incisors (Figure 2). More commonly it causes an imprint of the acrylic button on the palatal mucosa when the appliance is removed, which quickly resolves once the appliance has been removed and good oral hygiene instituted.

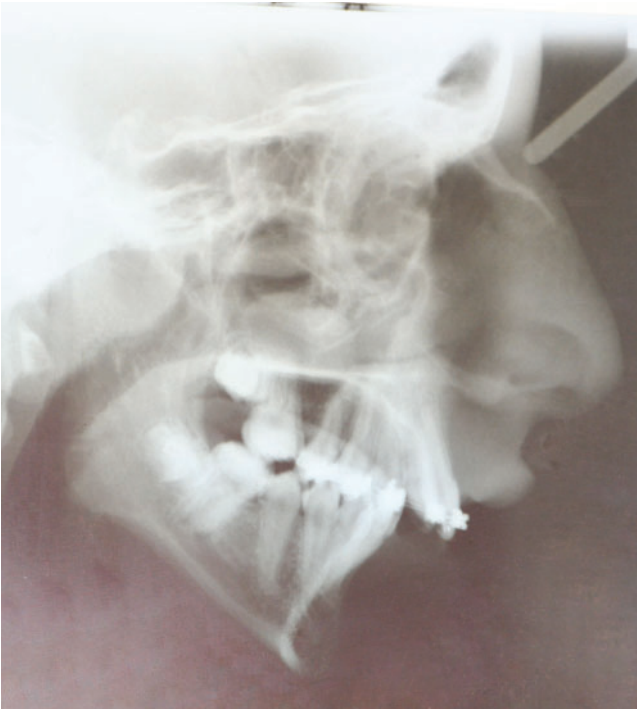
Figure 4 Lateral cephalogram taken in March 2005, six months into treatment showing a significant overjet

Treatment was undertaken by a clinical assistant in the hospital setting and began around September 2004. At the start of treatment the patient recalled that he experienced pain from the appliances and in particular a lot of soreness around the Nance palatal arch. In March 2005, approximately six months into treatment, a lateral cephalogram was taken showing normal inclination of the upper incisors, but a significant overjet (Figure 4 and Table 1).

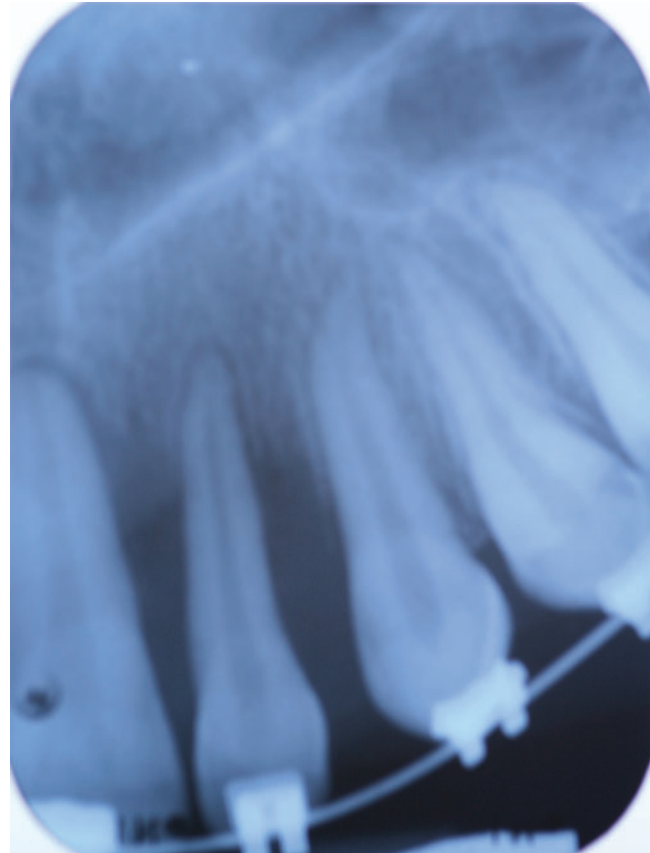
Figure 5 Periapical radiograph showing the degree of bone loss around the upper left central and lateral incisors

the anterior part of the palate. The Nance palatal arch was immediately removed. A periapical radiograph was taken and revealed significant alveolar bone loss around the upper left central and lateral incisors (Figure 5). The patient was prescribed a course of Amoxicillin and referred on to his community dentist for follow-up of the swelling.

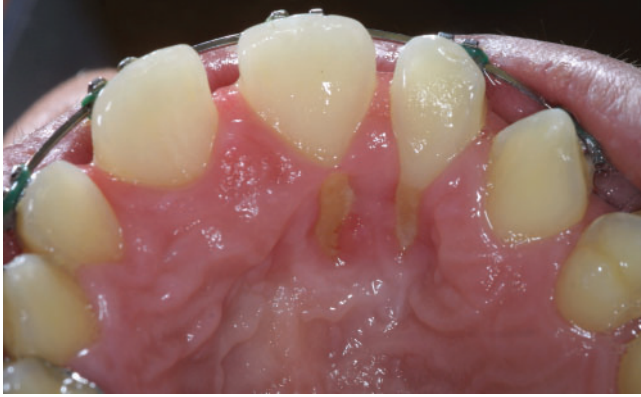
The community dentist reviewed the patient two weeks later and although the swelling had resolved, a large defect in the palatal mucosa was present exposing bone and the roots of the upper left central and lateral incisors. Figure 6 shows the extent of the exposure after resolution of the swelling. Metronidazole was prescribed and root surface debridement under local anaesthetic was carried out around the affected teeth.

Figure 6 Extent of bone and root surface exposure around the upper right central and lateral incisors after the swelling had subsided

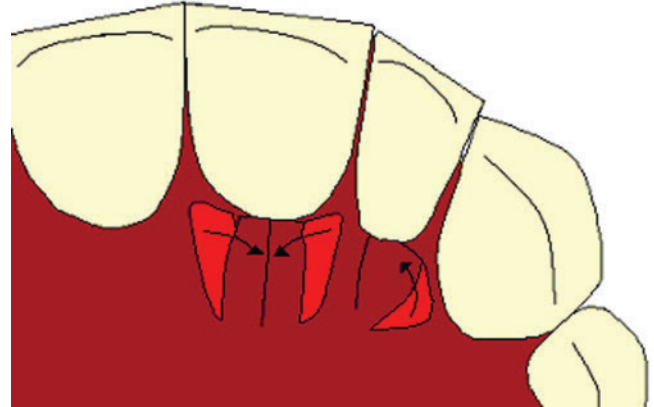
Figure 7 Diagrammatic representation of double papilla and laterally positioned split-thickness palatal flaps

with the upper left central and lateral incisors and this was carried out in May 2006 under local anaesthetic. The defects were repaired with sliding pedicle flaps using a combination of double papilla and laterally positioned split-thickness palatal flaps as shown in Figure 7.
