A DISCUSSION OF THE CAUSES OF BLISTERING OF SINTERED NICKEL HYDROXIDE ELECTRODES

D. H. FRITTS

Department of the Air Force, Wright-Patterson Air Force Base, Ohio 45433 (U.S.A.)

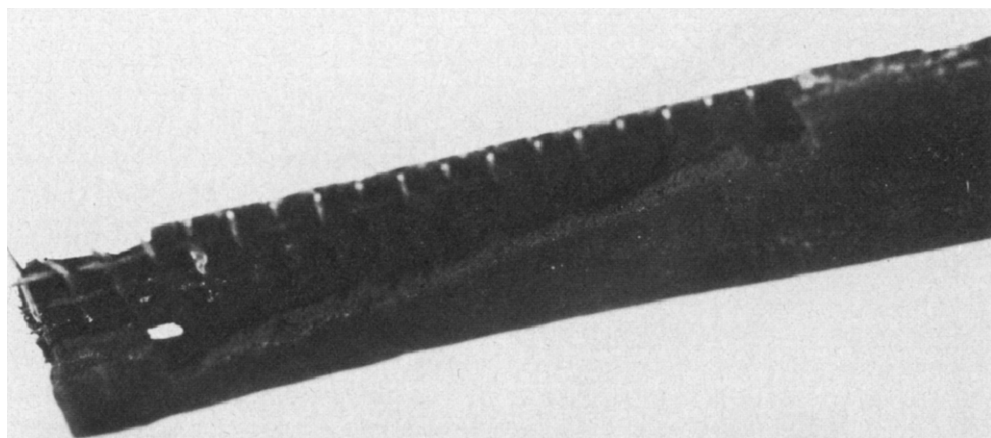
Fig. 1. Blister damage done to electrode loaded at 1.68 g/cm³ void.

The results for the three conventional electrodes with the modified impregnation process are shown in Figs. 1, 2 and 3. These electrodes were each

cycled for less than 30 cycles, and were accompanied by comparatively dramatic damage, as is evident from the Figures.

The damage done to the three conventional electrodes, Figs. 1, 2, and 3, is important, because a mechanism for a blister in formation is suggested. This proposed mechanism is shown in Fig. 4(a) and (d). In Fig. 4(a), it is supposed that a zone of severe shear stress exists next to the current collector. This is due to the large difference in rigidity between the current collector region and the unsupported sinter [4]. Thus, as the electrode is charged

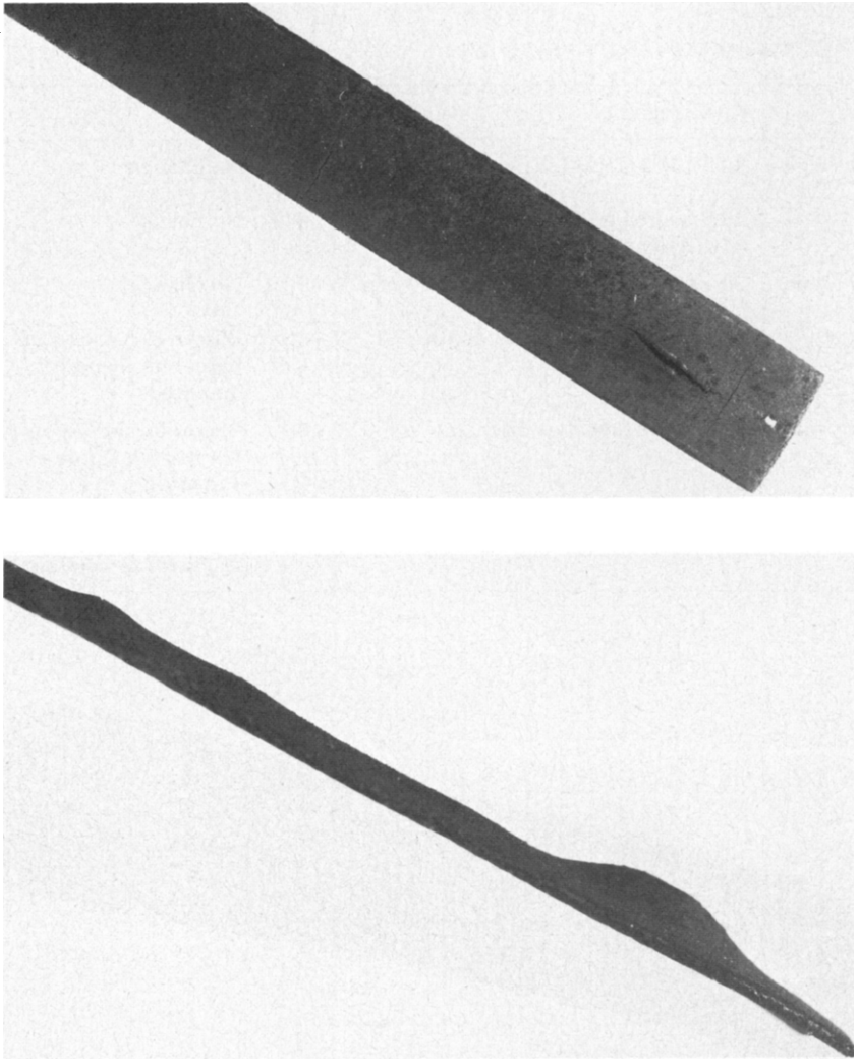
Fig. 2. Blister damage done to electrode loaded at 1.89 g/cm^3 void.

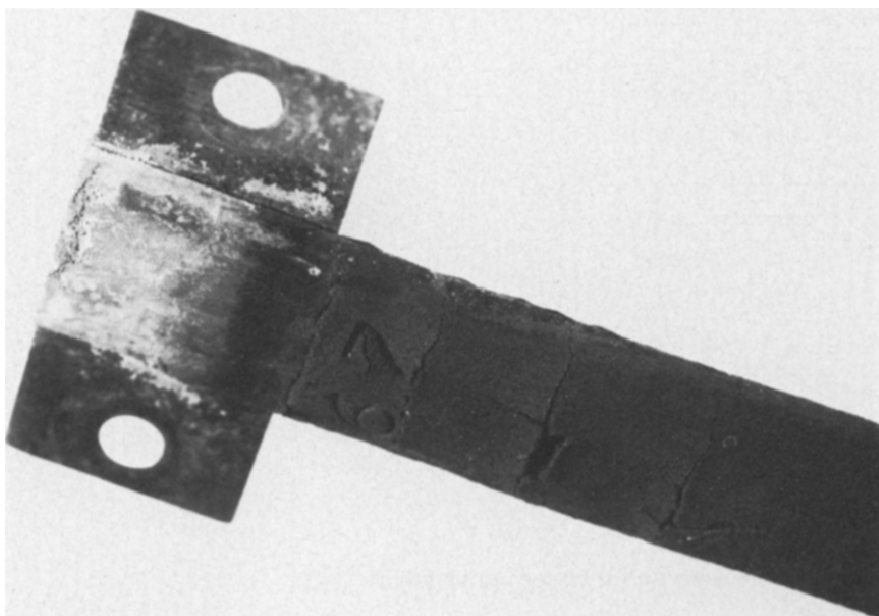
Fig. 3. Blister damage done to electrode loaded at 2.05 g/cm^3 void.

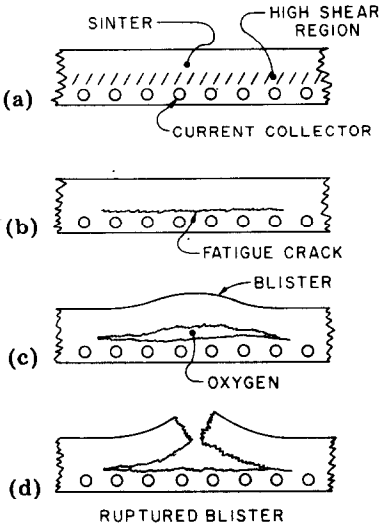
Fig. 4. Schematic of mechanism for blister formation.

and discharged, the sinter undergoes larger cyclic strains [5] (due to active material molar volume changes) than the current collector region. The resulting difference in strains results in a fatigue failure by shear, Fig. 4(b), of the sinter in the shear zone, thus forming a macropore. Conceptually, the

next step in the process is shown in Fig. 4(c), where the oxygen pressure from overcharge causes the fatigue crack to open, thus lifting the surface into a blister. The final step, Fig. 4(d), is the rupture of the blister such that no further damage by oxygen pressure can take place. The breakup of nickel sinter due to internal gas pressure has previously been considered by Gross [6], but his proposed mechanism is on a sinter particle scale and substantially different from that proposed here.

electrode shown had a loading of 1.09 g/cm^3 void. The mechanism of Fig. 4 seems consistent with the blisters formed provided certain assumptions about precursor steps are true. These assumptions are: (1) hydrogen-oxygen recombination occurs locally diluting the electrolyte; (2) over long term cycling, the nickel hydroxide is locally hydrated by the recombination process. Assumption number one is supported by the observation that the separator material had a burn spot at the blister location. This indicates that hydrogen-oxygen recombination was occurring here. The second assumption was established as being correct by determining the amount of coordinated water in the electrode shown. This was done by heating portions of the electrode in a differential thermal analyzer until after the dehydration peak, and recording the weight loss due to the dehydration. From the weight loss and loading, the number of water molecules coordinated with each nickel

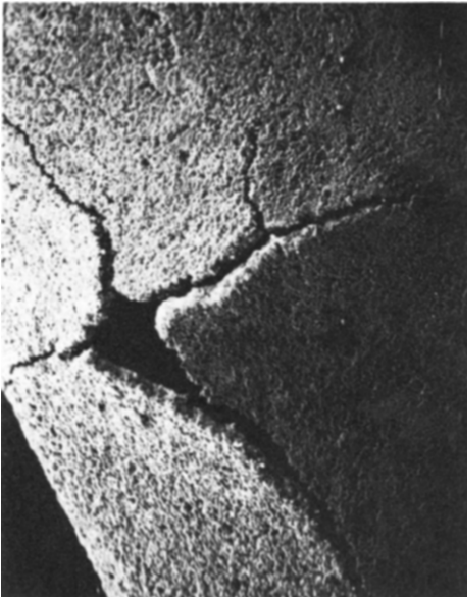
Fig. 5. Fully developed blister from Fig. 3, X6.

In Figs. 5 and 6, one of the blisters of Fig. 3 is examined in more detail. The full blister is shown in Fig. 5. In Fig. 6, one of the blister sections has been removed to demonstrate the uniformity of the blister thickness. The "fracture zone" for this blister was about 0.3 mm beneath the electrode surface over the entire region affected. This is taken as additional evidence that the blister process is the result of the existence of a shear zone that is due to nonuniform properties in the thickness direction, that is, the uniform blister depth would not be expected unless a depth dependent stress mechanism existed. All the blisters shown in Figs. 1 - 3 had the same uniform depth property.

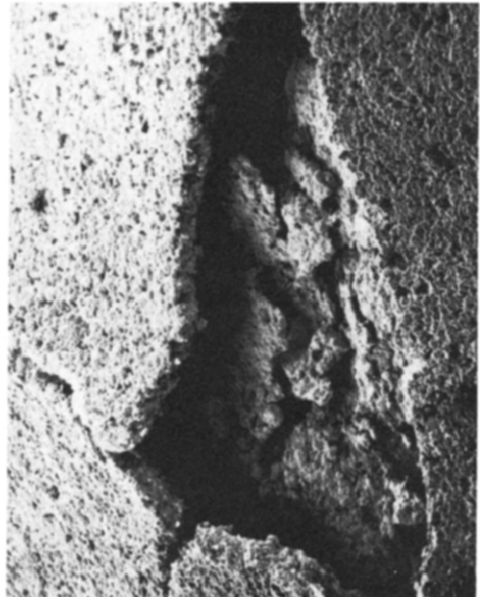
Fig. 6. Sectioned view of blister from Fig. 5, X15.

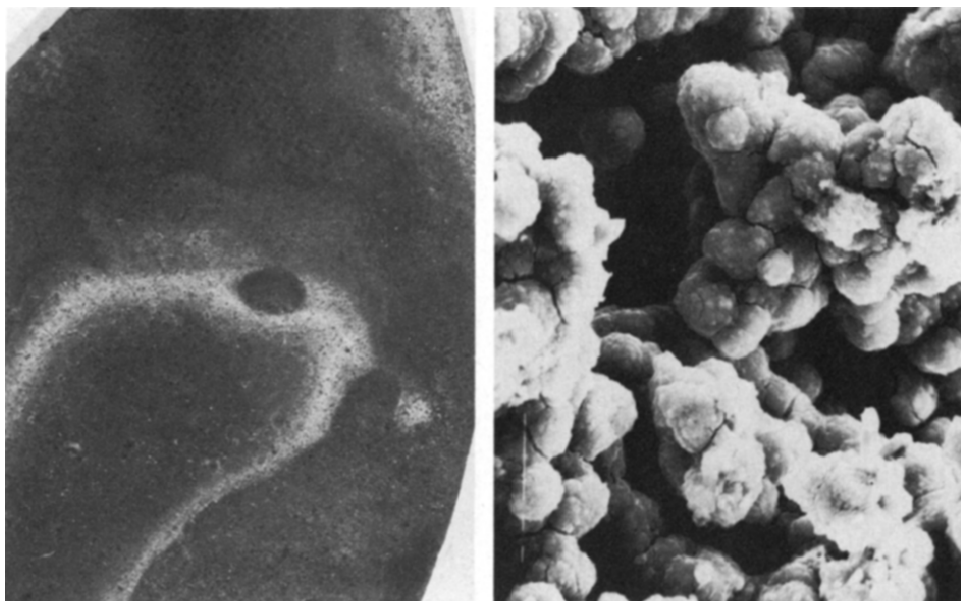
Fig. 7. Blister formed in nickel-hydrogen cell.

The proposed shear model of blister formation appears to be valid in the actual cells, as evidenced by the results of this laboratory's investigation of nickel-hydrogen cells [3]. In the test cell reported on, blisters were formed on the nickel electrodes as shown in Fig. 7. The electrodes used in this cell were impregnated by the Pickett Process [1], and the particular

The blister of Fig. 7 was broken away at one end, and a cross-sectional view taken. The result is shown in Fig. 10. Note that the fracture occurred at the current collector, which is where shear forces are expected to be maximum for a uniformly loaded electrode. Thus, the complete blister model for the nickel-hydrogen electrode is

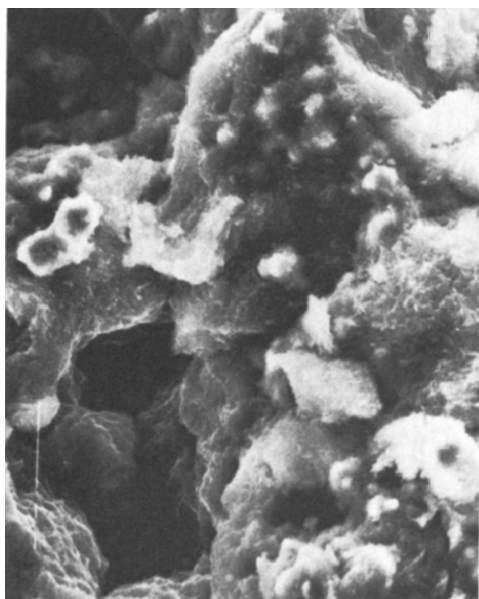
Fig. 9. Crystalline morphology of $\text{Ni}(\text{OH})_2$ in nickel-hydrogen cell after 1200 cycles.Fig. 10. Sectioned view of blister from Fig. 7, $\times 25$.

hydroxide molecule was calculated. The results are shown in Table 2. It is apparent from Table 2 that the blistered electrode was being hydrated during cycling. Before and after micrographs of this electrode, Figs. 8 and 9, show a marked morphological change of the active material, further supporting the validity of the second assumption.
