Pull-apart stepover structures in an asphalted road surface—a geological curiosity

David Roberts

Geological Survey of Norway, N-7491 Trondheim, Norway

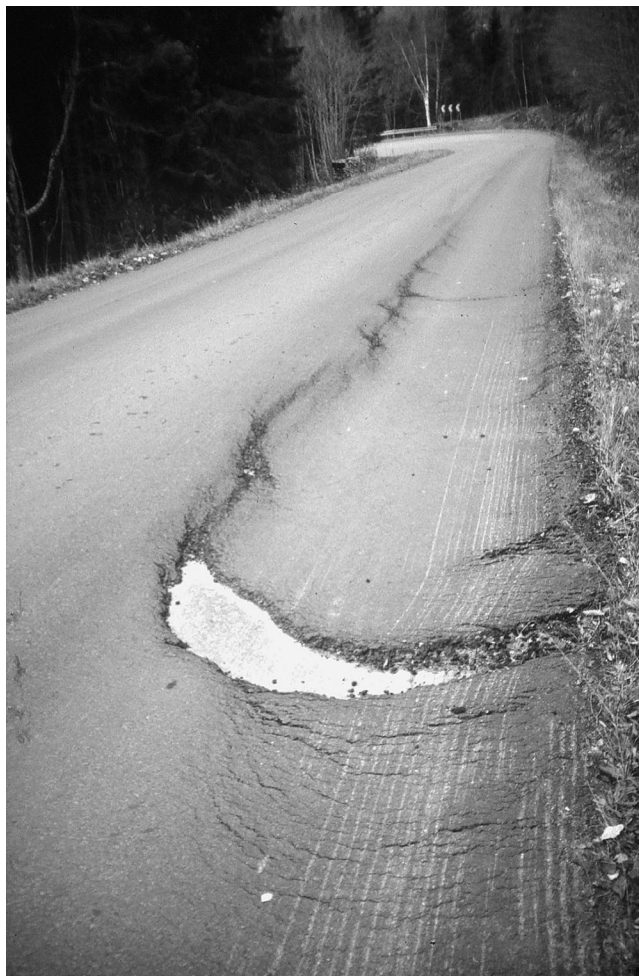
Fig. 1. The asphalted road ca. 500 m east of the E6 junction at Snøan, looking downhill towards the northwest, showing the structures that had developed arising from sinistral strike-slip movement caused by gravitationally induced creep of the 'right-hand' strip of asphalt below the prominent concave-down, rupture scar. The maximum downhill displacement of asphalt at the rupture scar is ca. 35 cm. The white stripes are scratch marks made by a snowplough.

cation along the longitudinal line between the creeping asphalt and the 'fixed' asphalt layer (Figs. 1 and 2); and simultaneously, a series of small 'faults' developed at 23–26° to the main sinistral shear structure. In three cases, small rhombohedral, transtensional areas reminiscent of pull-apart or fault-bend 'basins' had been developed (Figs. 3–5), but at the time of observation these were less than perfect in view of the wear and tear of traffic. Nevertheless, the fault patterns represented along the main line of sinistral shear are remarkably similar to those documented in many of the natural and experimental examples cited above.

In addition to the intra-asphalt, left-lateral shear component, complementary tensional features reminiscent of right-lateral offset can be detected along the edge of the road where the asphalt meets the grass verge (Figs. 1 and 2). In this case, however, and contrary to the intra-asphalt, left-lateral dislocation, the asphalt seems to have been fairly well attached to the rough edge of the road and grassy verge, and the tensional features there are the result of drag rather than dislocation. This is also evident from the fact that the asphalt has slipped downhill by 33–35 cm closest to the prominent, intra-asphalt offset, whereas the slippage diminishes to 3–5 cm adjacent to the grass verge.

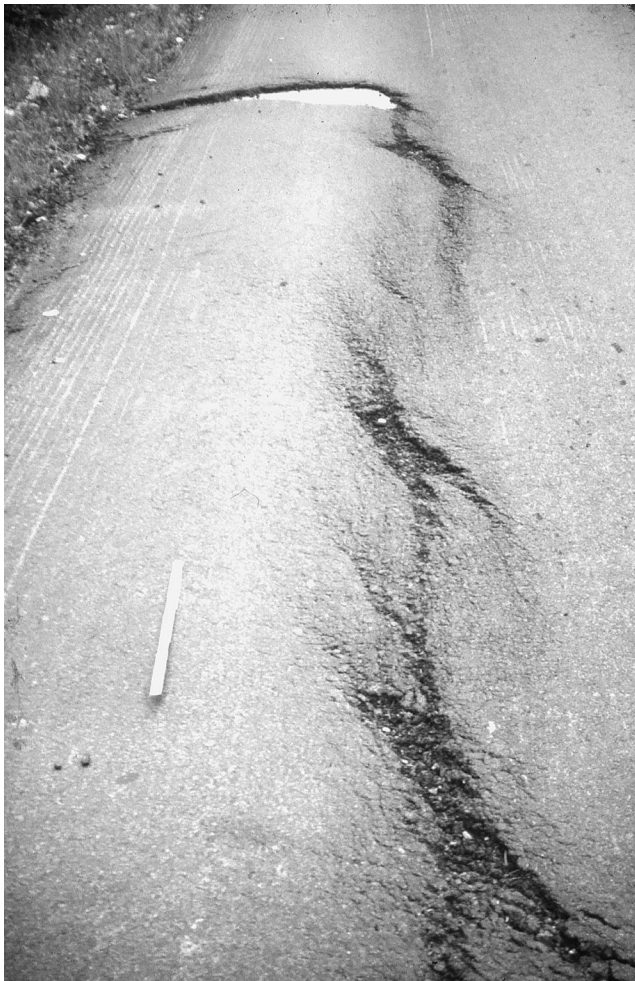
Fig. 3. The same structures as in Fig. 1, but looking uphill towards the rupture scar. The oblique 'faults', at a moderate angle to the sinistral principal deformation zone, and the dark, rhombohedral, transtensional areas akin to pull-apart basins, are easier to recognise as such from this photographic angle.

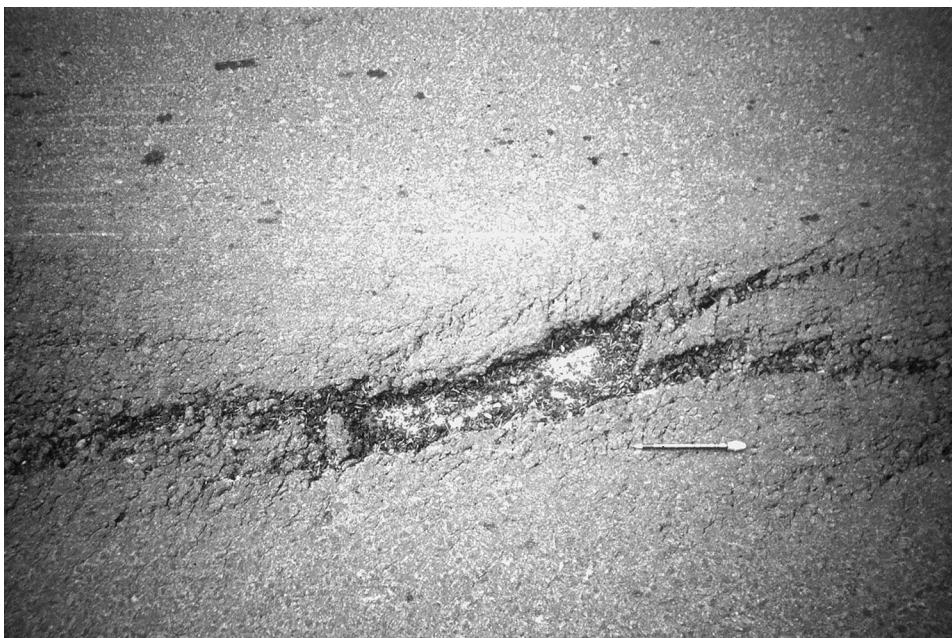
Fig. 5. A close-up of one of the pull-apart 'basins' that developed along the sinistral, strike-slip dislocation in the asphalt. The pencil measures ca. 15 cm.
