TBC Experience in Land-Based Gas Turbines

W.A. Nelson and R.M. Orenstein

This paper summarizes prior and on-going machine evaluations of thermal barrier coatings (TBC) for power generation, that is large industrial gas turbine applications. Rainbow testing of TBCs on turbine nozzles, shrouds, and buckets are described along with a test of combustor liners. General Electric Power Generation has conducted more than 15 machine tests on TBC turbine nozzles with various coatings. TBC performance has been quite good, and additional testing, including TBCs on shrouds and buckets, is continuing. Included is a brief comparison of TBC requirements for power generation and aircraft turbines.

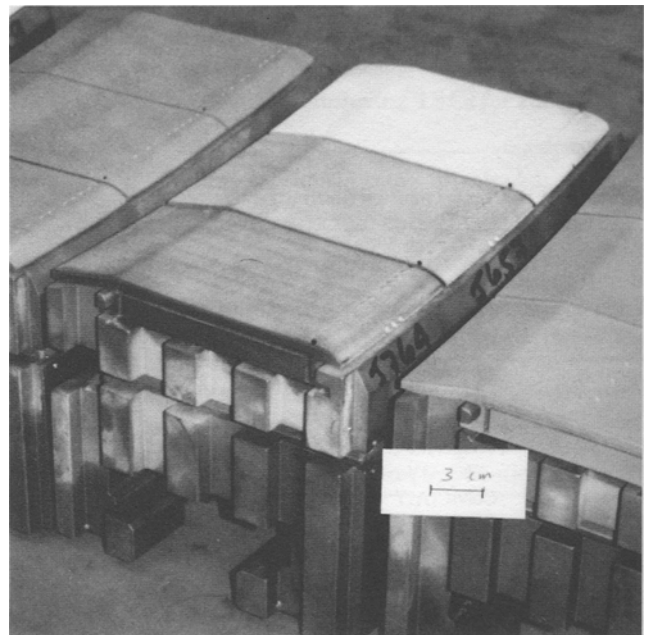
Fig. 4 Photograph of thermal barrier coated MS7001FA shrouds in outer shroud hangar prior to installation into machine

shroud cooling was used for this test, which ran for approximately 24,000 h. The shrouds were coated by two different sources. Coating variables included (a) the bond coat composition, NiCrAlY and CoNiCrAlY, (b) bond coat fabrication method, air plasma spray and shrouded arc plasma spray, and (c) top coat density and microstructure. Bond coats were 0.2 to 0.29 mm (8 to 12 mils) thick, while the ceramic topcoats were sprayed to 1.4 mm (55 mils) and ground back to approximately 1 mm (40 mils). Figure 4 shows the shrouds prior to installation.

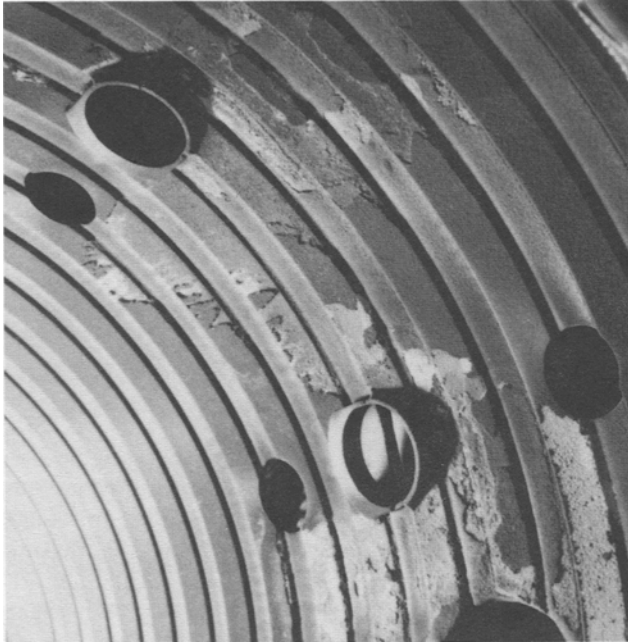
Fig. 6 Photographs of TBC coated combustion liners after more than 6000 h in MS7001E machine. (a) 0.5 mm (20 mils) thick porous coating and (b) 1.1 mm (45 mils) thick dense coating. The dilution holes are approximately 3 cm in diameter.

TBC spallation occurred in nine of the ten liners, with significant differences in the size and morphology of the spalled regions (Fig. 6). In all cases, spallation resulted from the impingement of water onto the TBC. The differences in spallation were attributed to differences in TBC microstructure and thickness. The results are summarized as follows: (a) thinner coatings, 0.3 and 0.5 mm (12 and 20 mils) thickness, all showed approximately 77 cm^2 (12 in.^2) of coating loss; and (b) thicker coatings, 0.75 and 1.1 mm (30 and 45 mils), had considerably less spalling, approximately 6 cm^2 (1 in.^2). Coating loss was less than 20% of the entire surface area of the combustor. Porous coatings tended to fail adjacent to the bond coat/top coat interface, while the denser coatings failed higher within the ceramic layer. The thicker coatings had less porosity and a more oriented microstructure, which is stronger, as evidenced by higher through thickness tensile strengths, and is more strain tolerant due to low in-plane modulus (Ref 4).
