Insulated Piston Heads for Diesel Engines

A. Tricoire, B. Kjellman, J. Wigren, M. Vanvolsem, and L. Aixala

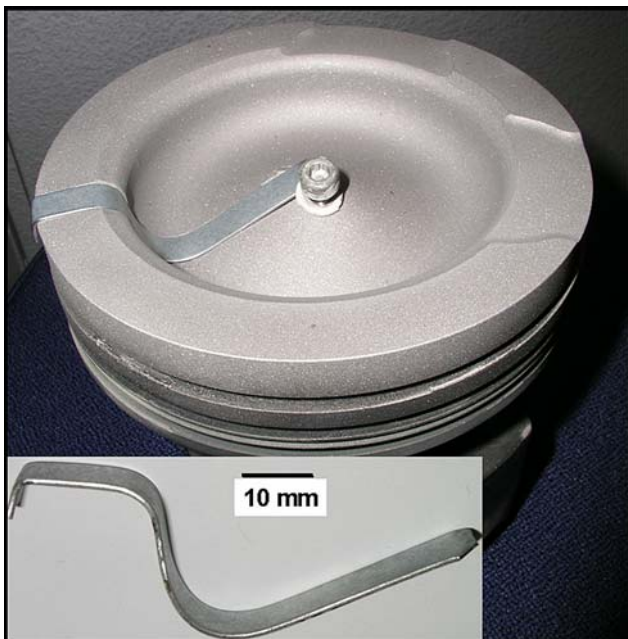
To improve the homogeneity of the coating thickness, the coatings were made on steel plates (8 mm wide, 1 mm thick) having the same shape as the piston head (Fig. 1) using a specially developed fixture. This configuration allowed an easy development of the robot program that was used for the final coating, since there was no need to cut a piston after each trial, and the shape of the sample was representative of the real piston; thickness was measured directly on the plates.

Fig. 1 Example of test plate used for coating thickness measurement

The fear of galvanic corrosion that was observed on the small test plates shown in Fig. 1 was not justified. Because of the too-high nobility of the bondcoat (high chromium content) compared to the steel-based piston, some rust problems had been noticed. This was overcome by giving special care to the packaging of the piston for storage before engine test. The atmosphere in the combustion chamber, during testing, did not allow the formation of water vapor that could condensate on the coating during engine stops.

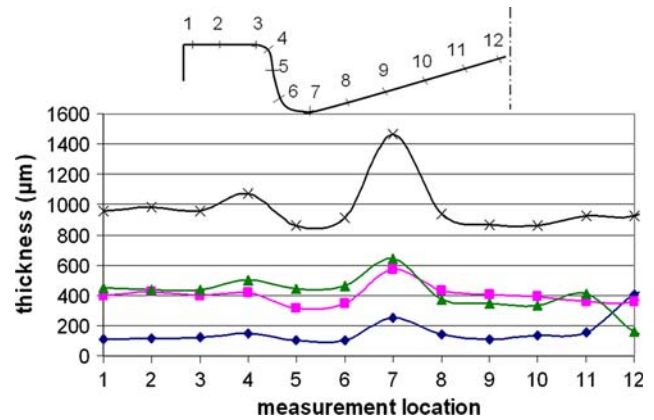
The coating thickness varies slightly from the targets, especially in the lower radius (area 7 in Fig. 4) of the piston because of rebounds of the particles on the upper radius (area 4 in Fig. 4). This results in a nonoptimized coating structure at that location.

Fig. 4 Thickness distribution of the coating along the piston profile. Note that “graded transition: includes the three mixed layers

The coating microstructure did not exhibit any modification compared to the microstructure before coating. Even in the warmest zone, on the rim in front of the flames (marked 4-5 in Fig. 4), no alteration of the coating microstructure could be observed.

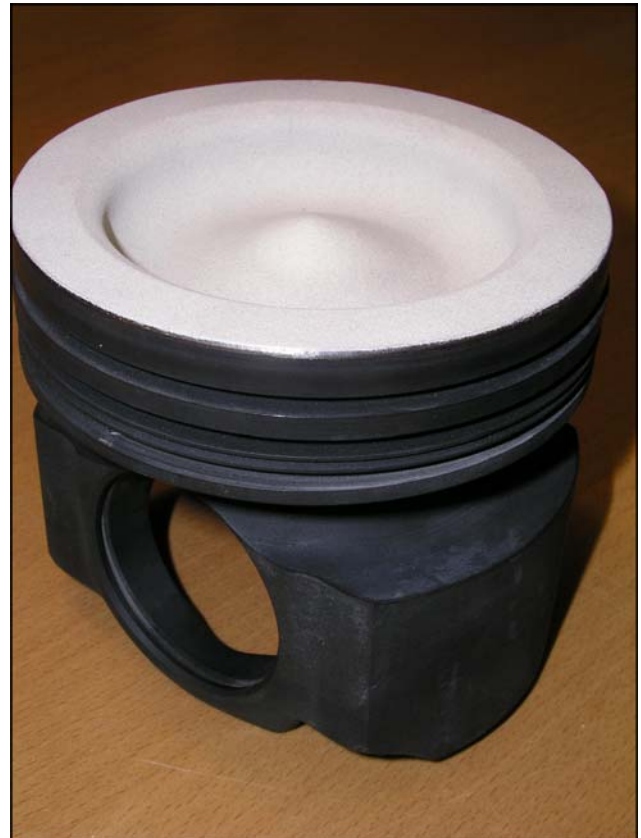
A coated piston as used in the engine test is shown in Fig. 5.

Fig. 5 Piston after coating

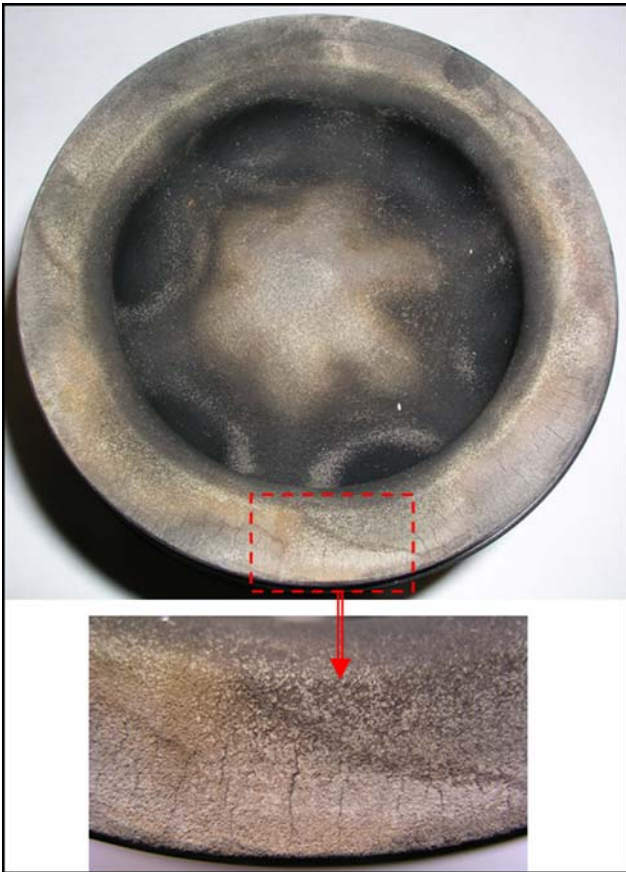
It revealed a coating surface covered with soot especially on the rim in front of the burner flames. Some cracks caused by piston expansion and bending in the engine were observed, but did not affect the coating properties (no spalling) (see Fig. 6).

Fig. 6 Piston head after engine test with TBC coating showing soot and cracks
