# Microstructure, Strength and Fracture Characteristics of a Free-Standing Plasma-Sprayed Alumina

*Plasma spraying, commonly used to apply wear and heat-resistant barriers, can be adapted to produce free-standing bulk ceramic parts. In this work the strength and fracture characteristics of a bulk plasma-sprayed alumina material with a highly aligned quasi-layered microstructure and about 14% porosity, are investigated for both the as-sprayed and annealed material conditions. It is found that strength and toughness for fracture normal to grain (splat) alignment are three times higher than for fracture parallel to the alignment. Subsequent annealing increases strength and toughness further by a factor of about three in both directions. The porosity change on annealing is low, despite a 9% volume shrinkage. Both material conditions exhibit pronounced R-curve behaviour. The marked strength and fracture anisotropy is clearly a consequence of the pronounced alignment of microstructure itself, and the occurrence of a splat-internal microcrack sub-structure in the as-sprayed condition. The fracture path observed in the as-sprayed material is primarily transgranular (i.e. through the splat

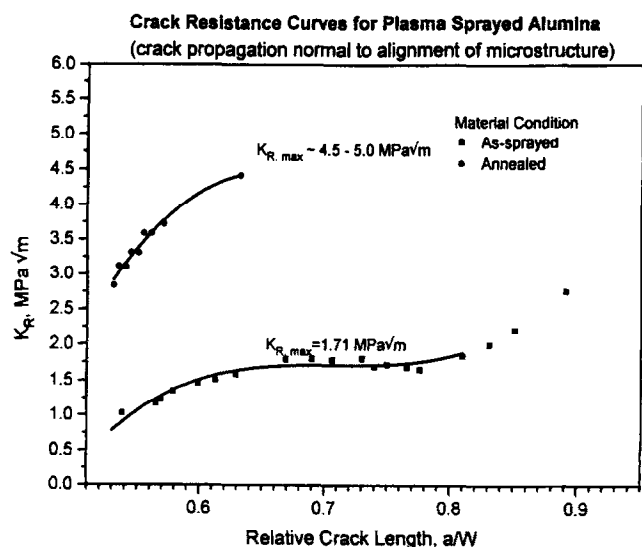
The results and standard deviations of the mechanical tests are summarized in Table 1. The bending strength and fracture toughness were measured in three-point bending. The crack resistance curves ( $R$ -curves) shown in Fig. 4 were determined with CT-samples and the plateau value,  $K_{R}^{max}$ , for loading normal to splat alignment is presented in the table below. No stable crack growth was observed for loading parallel to splat alignment.

Fig. 4. Crack resistance behaviour of plasma-sprayed alumina.

In the as-sprayed CT  $R$ -curve specimen the crack propagated stably and in the direction normal to loading, as was desired. The crack path was primarily straight with only slight deviations and branching (relative to the heat treated sample) (Fig. 6(b)). The crack path was primarily transgranular. The resulting  $R$ -curve is also presented in Fig. 4.

Unfortunately, due to the many large pores it was not possible to detect the very beginning of crack growth in these in-situ tests, so the initial values of  $K_R$  presented correspond to  $K_R$  values after approximately 1 mm of crack growth. At this point the  $K_R$  curves are already highly developed. For both the as-sprayed and the annealed material conditions, since the  $K_R$  plateau value is approximately equal to the corresponding fracture toughness values from the three-point bend tests, it may be assumed that any process zone was fully developed before complete fracture even in those tests. In fact, from the  $R$ -curves it can be seen that the maximum toughness is reached after crack extension of about 5 to 6 mm.
