# Surface Finish and Mechanical Properties of Commercial Aluminas

*In this work the influence of two different grinding procedures, longitudinal and planetary, on the mechanical properties of two commercial aluminas has been investigated. In order to check if the technological history, as a consequence of the grinding procedures, can be reduced and/or eliminated, the investigation has been extended also to sample batches in which the surface subjected to tensile stress was finished by lapping. The experimental results, discussed in terms of machining parameters, have been analysed from the point of view of roughness, microstructure and flexural strength. In addition, an extensive microscopic examination of fracture surfaces has been performed in order to establish the relationship between failure, pre-existing flaws and machining induced surface damage. © 1996 Elsevier Science Limited.*

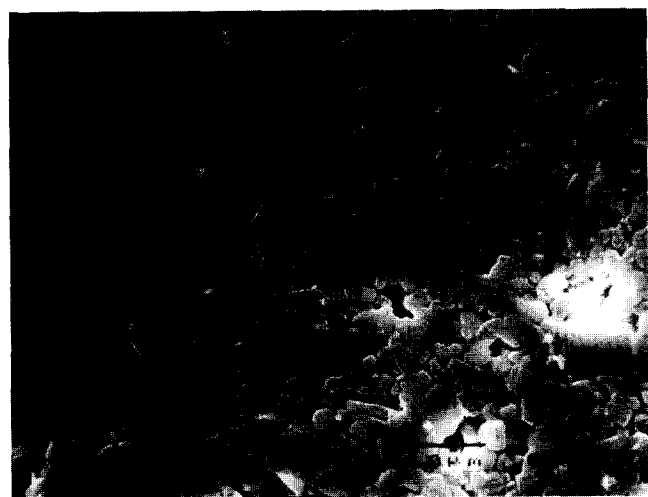
**Fig. 1.** SEM micrograph showing the thermal etched surface of (a) alumina A, and (b) alumina B:  $[-]$  is 1.5 $\mu\text{m}$ .

Alumina A is a compacted material, characterised by a dishomogeneous microstructure with small slightly elongated grains and occasional large grains, more than 10 $\mu\text{m}$  in size (Fig. 1(a)). Alumina B is a low purity alumina, 90wt%, with many intrinsic defects, characterised by the presence of agglomerates and porosity; the grains are very small and elongated, with average dimensions grouped in a narrow range (Fig. 1(b)). Reported in Fig. 2 are the histograms of the grain size

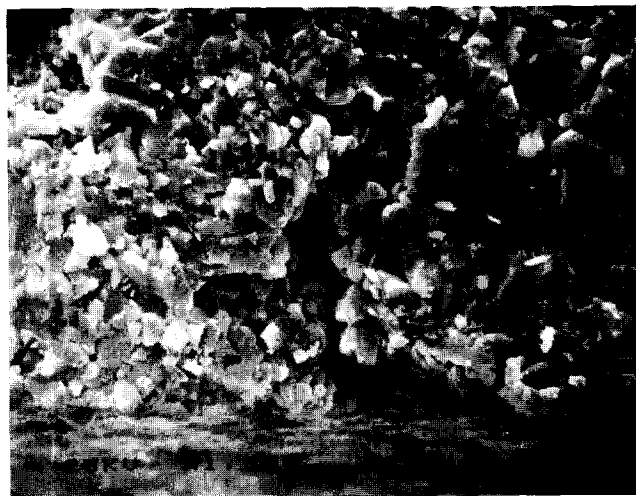
Fig. 11. SEM micrograph, (a) defects present inside the alumina B, and (b) fracture surface of a bar of alumina B, ground following the M1 procedure, the porosity acted as failure origin.
