Oxidizing Environment Influence on the Mechanical Properties and Microstructure of 2D-SiC/BN/SiC Composites Processed by ICVI

M. Leparoux,^a L. Vandenbulcke,^a V. Serin,^b J. Sevely,^b S. Goujard^c and C. Robin-Brosse^c

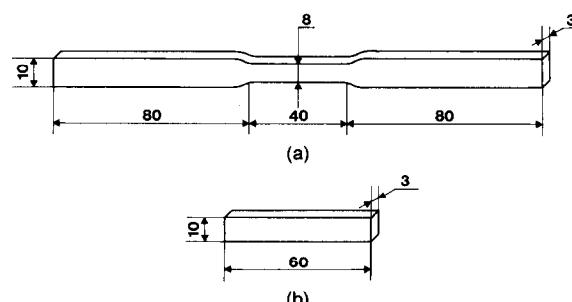
Fig. 1. Geometry and dimensions, in mm, of the (a) tensile and (b) bending specimens.

The mechanical behavior of the 2D composites was evaluated at 600°C in air by static bending and tensile tests as well as dynamic tension–tension fatigue tests. For these tests, bars were machined with their main direction parallel to one of the fiber orientation. The geometry and dimensions of the tensile and bending specimens are presented in Fig. 1. The static fatigue tests were performed on a 4-points bending machine prototype having major and minor spans of 5.08 and 2.54 cm. The tensile fatigue behavior was studied with a hydraulic machine (Inströn Dynamic 8501) equipped with hydraulic grips cooled with water. These characterizations were performed within a furnace (AET) in ambient air. The tensile strain was measured with an extensometer (2620-603 Inströn) with a 25 mm gauge length. For the dynamic tests in tension–tension, the frequency was adjusted at the desired value, 2 or 20 Hz in the present case, after few cycles at 0.02 Hz.

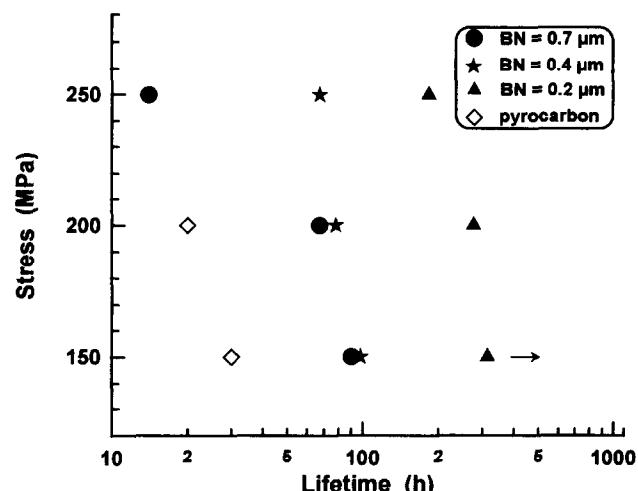
Fig. 2. Static fatigue behavior in flexion for 2D-SiC/SiC composites with various interphases deposited on treated NicalonTM fibers (the arrow indicates that the specimen was not fractured when the test was stopped; the pyrocarbon thickness was in the 0.1–0.2 μm range).

The 2D-SiC/BN/SiC composites were made with treated NicalonTM fibers and various interphase thicknesses of 0.7, 0.4 and 0.2 μm . They were submitted to a static flexion fatigue testing in air at 600°C . Two specimens of each composites, including different BN thicknesses as well as a pyrocarbon interphase, were tested using a constant applied load to determine the time to cause fracture as a function of the applied stress. The values for the first specimen to fail are plotted in Fig. 2. Both samples of the composite made with a 0.2 μm BN interphase were not fractured after more than 300 h at 150 MPa. It must be noted that the ultimate tensile strength at room temperature was about 300–320 MPa for all materials.

The static fatigue tests in air at 600°C show that the oxidation resistance of the SiC/SiC composites is greatly improved when a BN interphase is used instead of the pyrocarbon one. Moreover the failure of the composite appears later when the applied stress and the interphase thickness are low.

the thinnest BN interphase could be explained. For the same reasons, also when considering the very thin carbon sublayers (when compared to the pyrocarbon interphases) and some possible protection by oxide formers, SiC/BN/SiC composites are more oxidation resistant than SiC/C/SiC materials under static loading (Fig. 2).

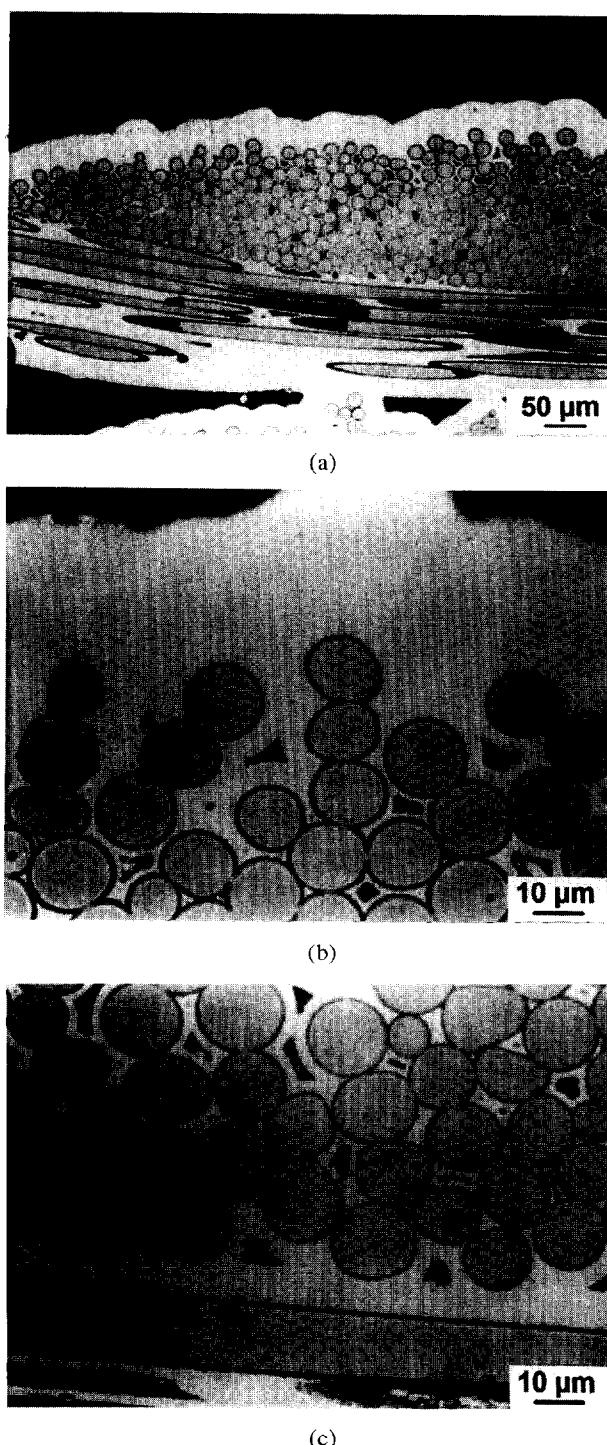
Fig. 3. (a) Cross-section of a 2D-SiC/BN/SiC composite, (b) in the external part and (c) in the middle of a fibers tow.

SEM micrographs of polished cross-sections show that the BN coating is uniformly deposited inside the preform [Fig. 3(a)–(c)]. The fiber/matrix interfacial zone either appears smooth or presents some crystalline or amorphous masses [Fig. 4(a) and (b)]. Microcracks are observed at the fiber/BN interface but also in the interphase itself and at the BN/matrix interface [Fig. 5(a) and (b)]. They propagate randomly in these three regions, on the contrary to the results obtained at room temperature where these cracks mainly propagate at the fiber/BN interface.¹² Many links that present a vitreous appearance are seen between BN and the fiber (Fig. 6) and between BN and the matrix. These particular glassy phases are also observed in cracks that propagate into the matrix between two neighboring fibers (Fig. 7). The fracture surface shows generally a short pull-out length [Fig. 8(a) and (b)]. Moreover, it appears that the BN coating adheres both to the fiber and the matrix [Figs 5(b) and 8(c)].

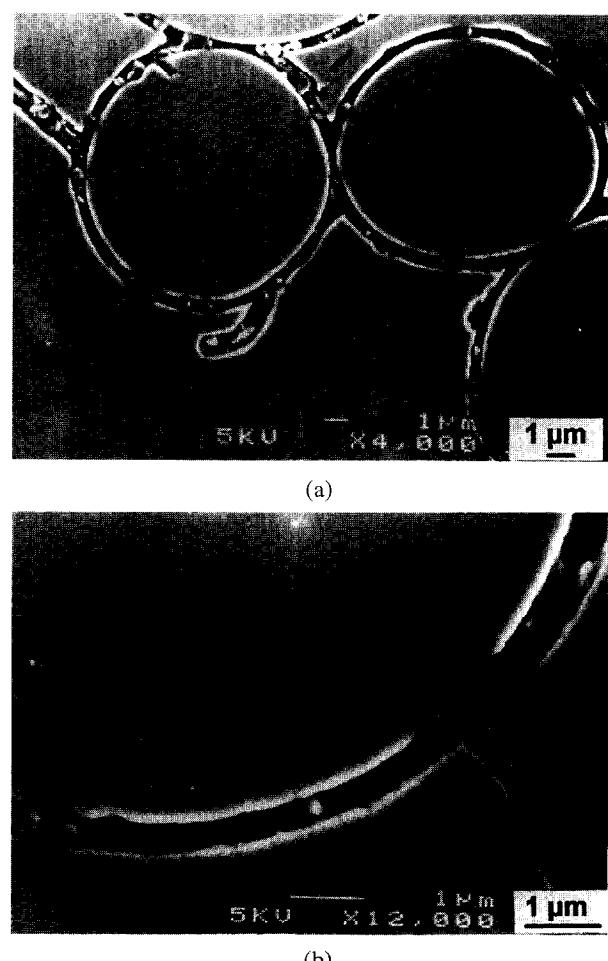
Fig. 4. Interfacial zone showing crystalline or amorphous masses after a tensile test of 70 h, at 600°C in air.

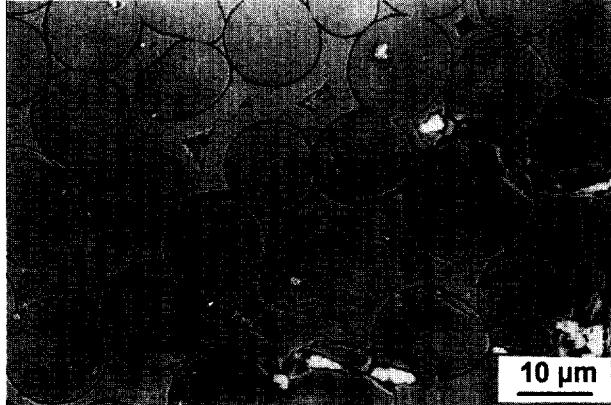
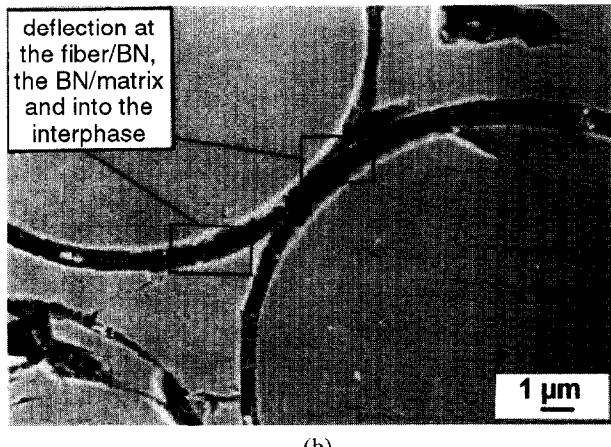
Fig. 5. Cracks deflection in a 2D-SiC/BN/SiC composite tested in tension at 600°C in air.

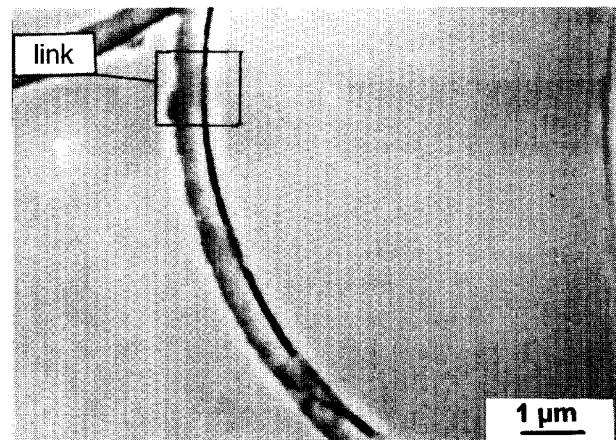
Fig. 6. Vitreous phase linking the treated Nicalon® fiber and the BN interphase.

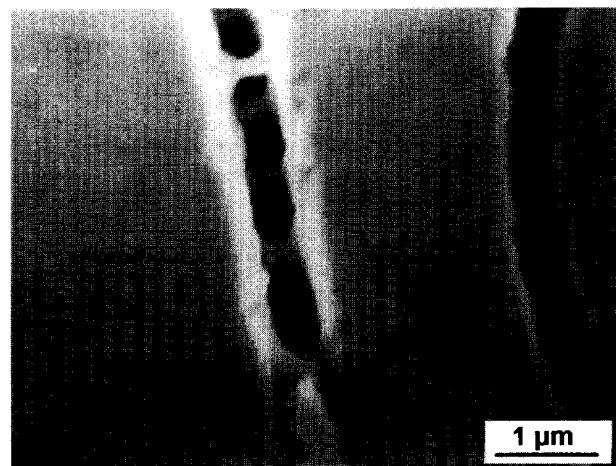
Fig. 7. Glassy phase in a crack propagating between two neighboring fibers.

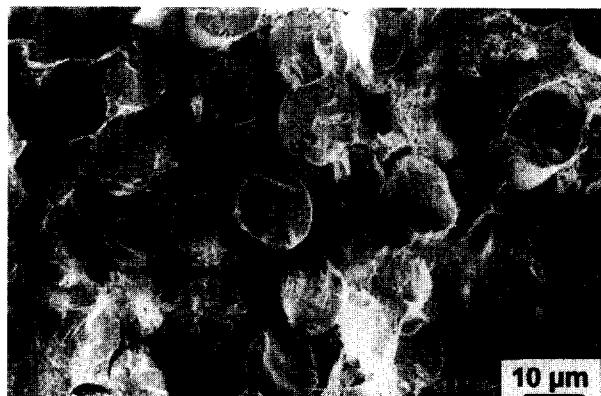
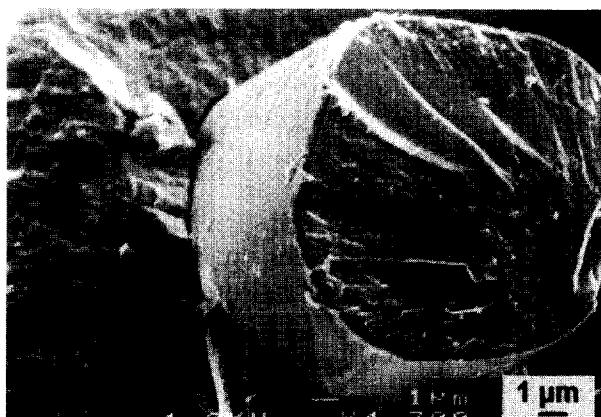
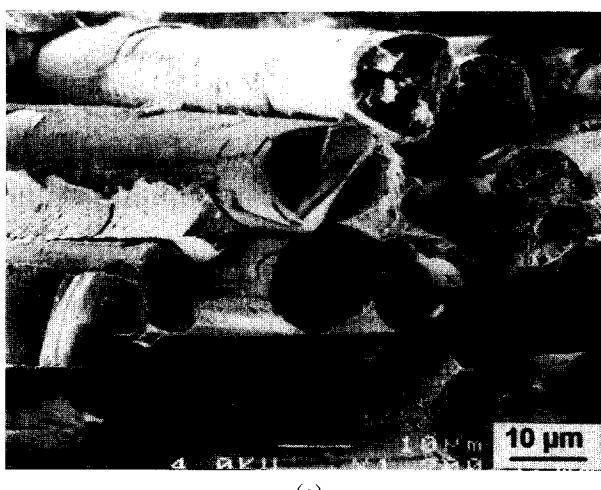
Fig. 8. Fracture surface of a 2D-SiC/BN/SiC tested in tension at 600°C in air. Rupture occurred at 170 MPa after 70 h.

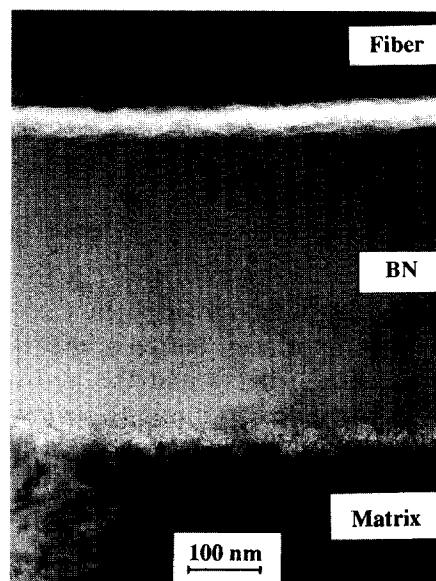
Fig. 9. Micrograph of the BN interphase and its interface with the treated Nicalon® fiber and with the SiC matrix.

3.2.2.1 The BN interphase. The thickness of the BN interphase is homogeneous (about 0.5 µm) and no voids are observed (Fig. 9). The EELS spectra of this region show boron and nitrogen edges (Fig. 10) typical of these elements involved in hexagonal boron nitride.²⁰ In addition, they evidence significant amounts of carbon and oxygen in the BN phase. Silicon was not detected, however it could be below the detection limit of EELS (<1 at%). The concentration of B, C, N and O was determined by a classical quantitative analysis technique.²¹ The average atomic composition was 40% N, 48% B, 7% C and 5% O. In comparison with the average composition measured on the same composite tested at room temperature (41.5% N, 39% B, 10% C and 9.5% O),¹⁵ we note a decrease of the O, C and N contents.

3.2.2.2 The fiber/BN interface. The TEM micrographs show many large decohesions at this interface as clearly shown in Fig. 9. Otherwise, when the fiber and the interphase are still bonded, a bright zone of about 10 nm thick borders the fiber. This sublayer is mainly composed of silicon and oxygen with traces of boron and carbon. The near-edge fine structure of the Si-L_{2,3} edge (double peak at 109 and 116 eV) (Fig. 11) and the dissymmetrical plasmon peak at 22.5 eV in the range of low energy loss (Fig. 11, inset) are consistent with the presence of silica at this interface. The quantitative analyses give an average Si/O atomic ratio of 0.53. It can be recalled here that the treated Nicalon® NLM 202 fiber presented a carbon-rich surface which was maintained at the fiber/BN interface, at the end of the composite manufacturing.¹⁵

3.2.2.3 The BN/SiC-matrix interface. Figure 9 shows the interface between the SiC matrix and the BN interphase. It is coarse and porous with a thickness of about 35 nm. Although the feature of this zone appeared similar to the interface observed on the same composite tested at room temperature, the composition is significantly modified. EELS analyses have revealed high concentration of oxygen (50 at%), silicon (34 at%) and carbon (16 at%), instead of carbon in the original composite.¹⁵ Additionally, the damped two pre-peaks in

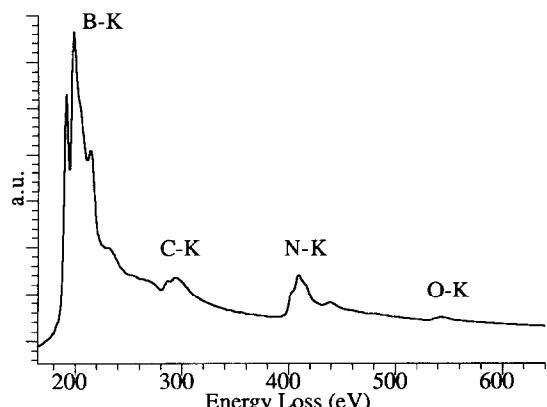
Fig. 10. EELS spectrum of the BN interphase.

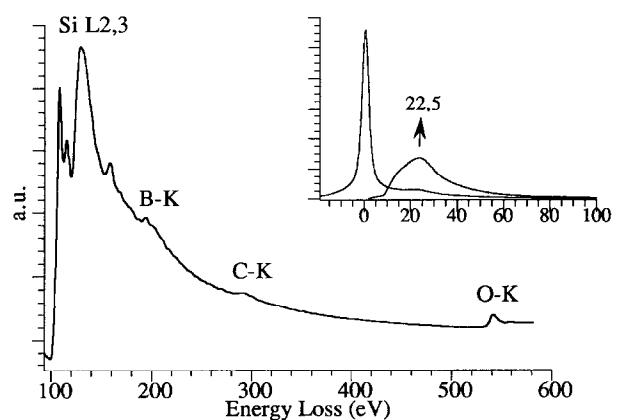
Fig. 11. EELS and plasmon (inset) spectra of the treated Nicalon® fiber/BN interface.

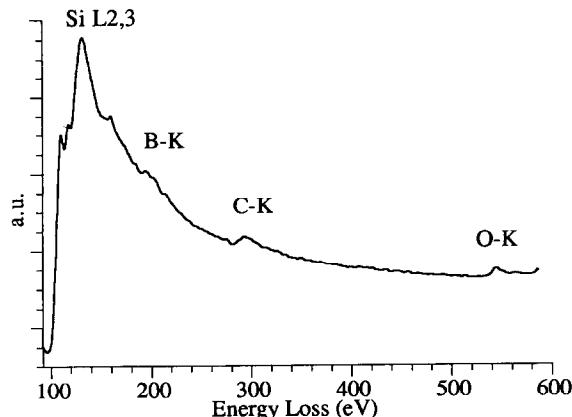
Fig. 12. EELS spectrum of the BN/SiC-matrix interface.

the near-edge fine structure of the Si-L_{2,3} edge may suggest that Si atoms are involved in both SiC and SiO₂¹⁵ (Fig. 12). An additional HREM study could permit to afford more information about the relative organization of SiC, SiO₂ and C. Furthermore, close to this interface, inside the boron nitride, some silica has also been detected.
