A procedure to evaluate the resistance to biological colonization as a characteristic for product quality of ceramic roofing tiles

Ceramic roofing tiles suffer deterioration through time due to environmental exposure. Biological colonization affects the appearance and integrity of building materials, such as roofing tiles. The resistance to biocolonization represents an important property affecting the product quality of ceramic roofing tiles. While natural colonization of roofing tiles by organisms is a progressive, heterogeneous, and slow process, laboratory assessment of this phenomenon requires a sensitive procedure that can be carried out within a reasonable period of time. Different microorganisms have been evaluated and the use of phototrophs, specifically the cyanobacterium *Oscillatoria*, presented several advantages such as good adherence, homogeneous growth on surfaces, and the chlorophyll-autofluorescence which can be used for a sensitive detection. Colonization by *Oscillatoria* on roofing tiles was assessed by measuring the autofluorescence of cells. This study proposes the use of specific cyanobacterial cells and a simple method for monitoring biofilm formation and

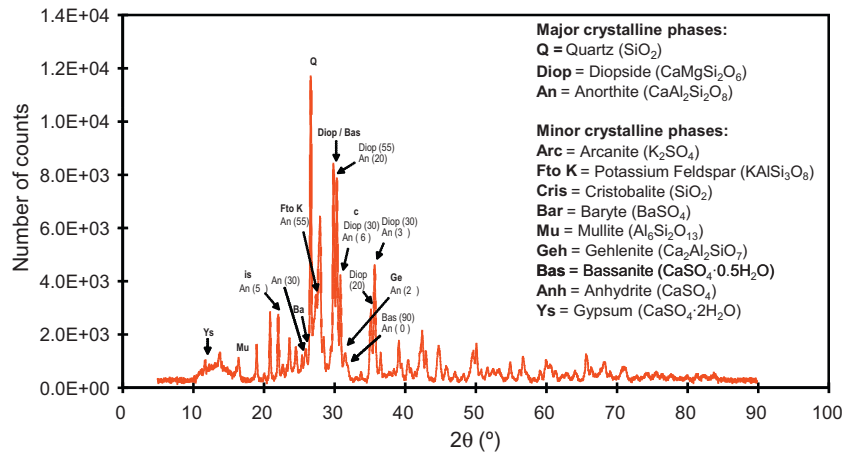
Fig. 1. Crystalline phases in the unglazed ceramic roofing tiles.

Five different ceramic roofing tiles were used. Among them one was unglazed and another one glazed (hereinafter named unglazed and glazed roofing tile). The chemical composition of the unglazed roofing tiles and the layer of the glazed roofing tiles are shown in Table 1. The characteristics of these two ceramic roofing tiles, such as porosity and roughness, are described in Table 2. The mineralogy of the unglazed roofing tile is shown in the diffractogram of Fig. 1 where the major and minor crystalline phases are detailed. The other ceramic roofing tiles were repre-

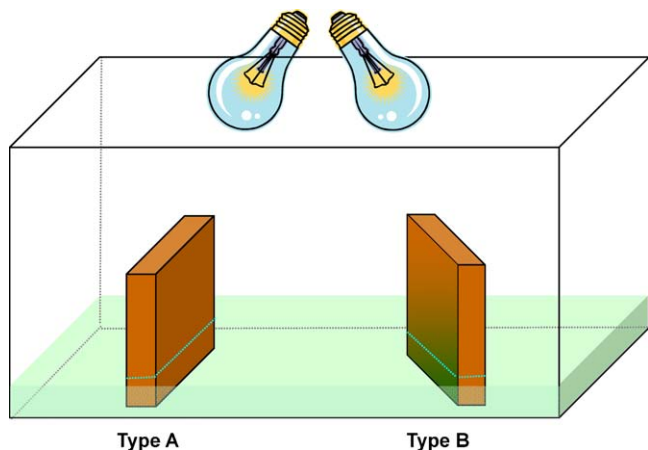
Fig. 2. Assembly scheme used in the bioreceptivity tests.

To comparatively evaluate the bioreceptivity of ceramic roofing tiles, the coupons were placed vertically in a covered glass container in which the medium covered up to 0.5 cm of the lowest side of the roofing tiles (Fig. 2). These tests were repeated twice. The same conditions described above were used in these bioreceptivity experiments except that in this case the incubation was allowed to continue for one month. *Oscillatoria* sp. PCC 9325 was used in these experiments. After the incubation period, the development of the cyanobacteria was monitored by 2D scanning of the surface of the roofing tiles quantifying the fluorescence from the chlorophyll of *Oscillatoria* using a pulse-amplitude modulated chlorophyll fluorometer (Heinz Walz GmbH, Effeltrich, Germany) as previously suggested.¹⁷ The fiberoptic was placed perpendicular to the surface at 2 mm above the coupon. Chlorophyll fluorescence over the scanned area was plotted using the analytical

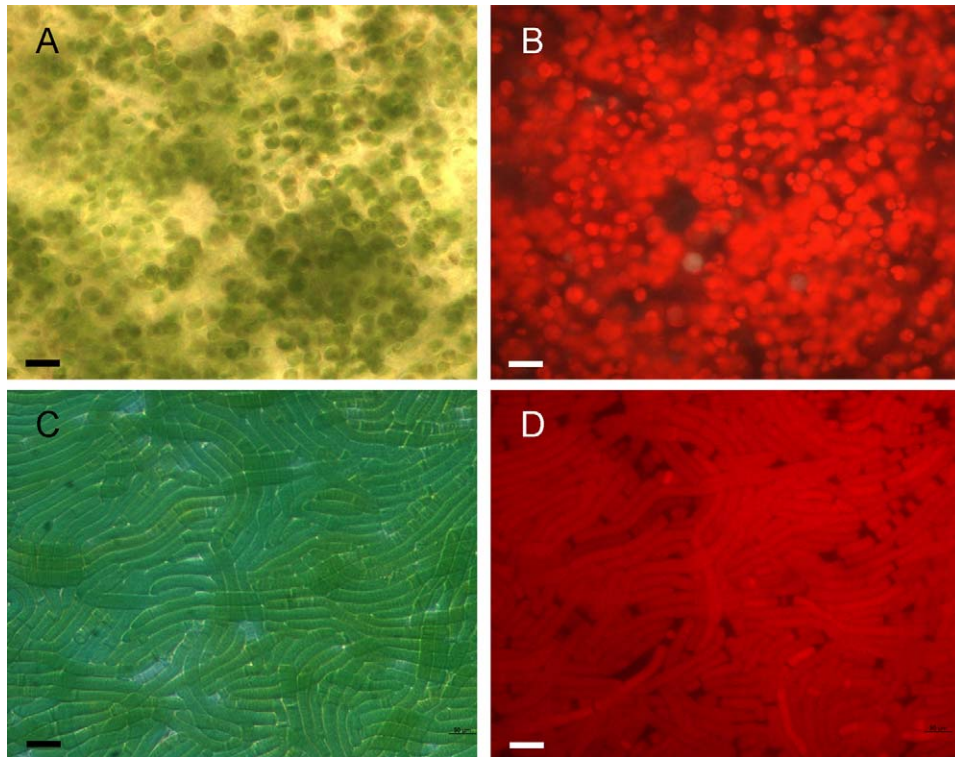
Fig. 3. Examples of *Chlorella* (A, B) and *Oscillatoria* (C, D) cells visualized under phase-contrast microscopy (A, C) and under epifluorescence microscopy (B, D) using blue excitation light. In (B) and (D), the red color of the emitted fluorescence can be observed allowing a sensitive detection of these cells. Bars represent 10 μm .

The use of specific photosynthetic microorganisms presents a clear advantage against heterotrophic microorganisms due to the possibility of detecting the autofluorescence of chlorophyll²⁰ when illuminating phototrophs with blue light (Fig. 3). The use of fluorescence allows for a higher sensitivity in the detection of the colonizing microorganisms even at early stages of colonization.¹⁷ Thus, using fluorescence from the chlorophyll contained in the phototrophic microorganisms, colonization can be detected in base to a relatively low number of cells. This implies a significant reduction of the time required to detect a colonization process during bioreceptivity tests.

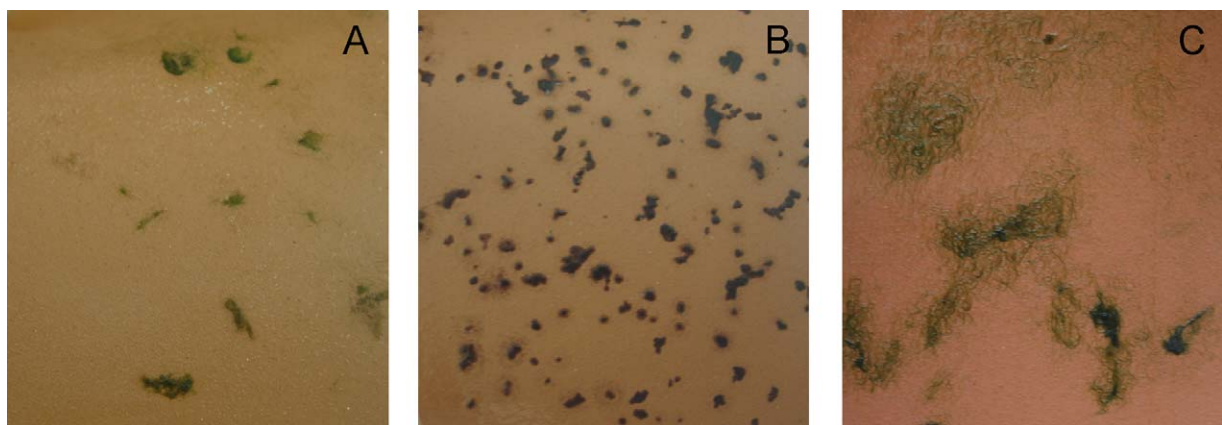
Fig. 4. Examples of biofilms formed by the growth of *Chlorella* (A), *Nostoc* (B) and *Oscillatoria* (C) on unglazed roofing tiles. The case of *Leptolyngbya* is not shown since it did not form visible biofilms.

As potential models of photosynthetic microorganisms for assays of bioreceptivity of ceramic roofing tiles, four strains were tested (Fig. 4). The eukaryote *Chlorella* showed slow and poor growth on the coupons forming a heterogeneous distribution. The Cyanobacteria *Leptolyngbya* was unable to clearly develop on the roofing tiles under the provided conditions. The sheath-forming Cyanobacteria *Nostoc* showed slow

growth although clearly visible, but presented a highly heterogeneous distribution forming clumps unable to spread over the tile surface throughout time and covering only small portions of the coupon area. Thus, the patches of the Cyanobacteria *Nostoc* and the alga *Chlorella* growing on roofing tiles makes difficult the assessment and quantification of the colonization process since they did not meet a requirement for an homogeneous colonization.¹⁷ *Oscillatoria* showed the fastest growth, forming significant biofilms on the roofing tile coupons. Besides, *Oscillatoria* presented a clear trend to grow spreading all over the tile surface which was progressively and homogeneously covered by the filaments. The Cyanobacteria

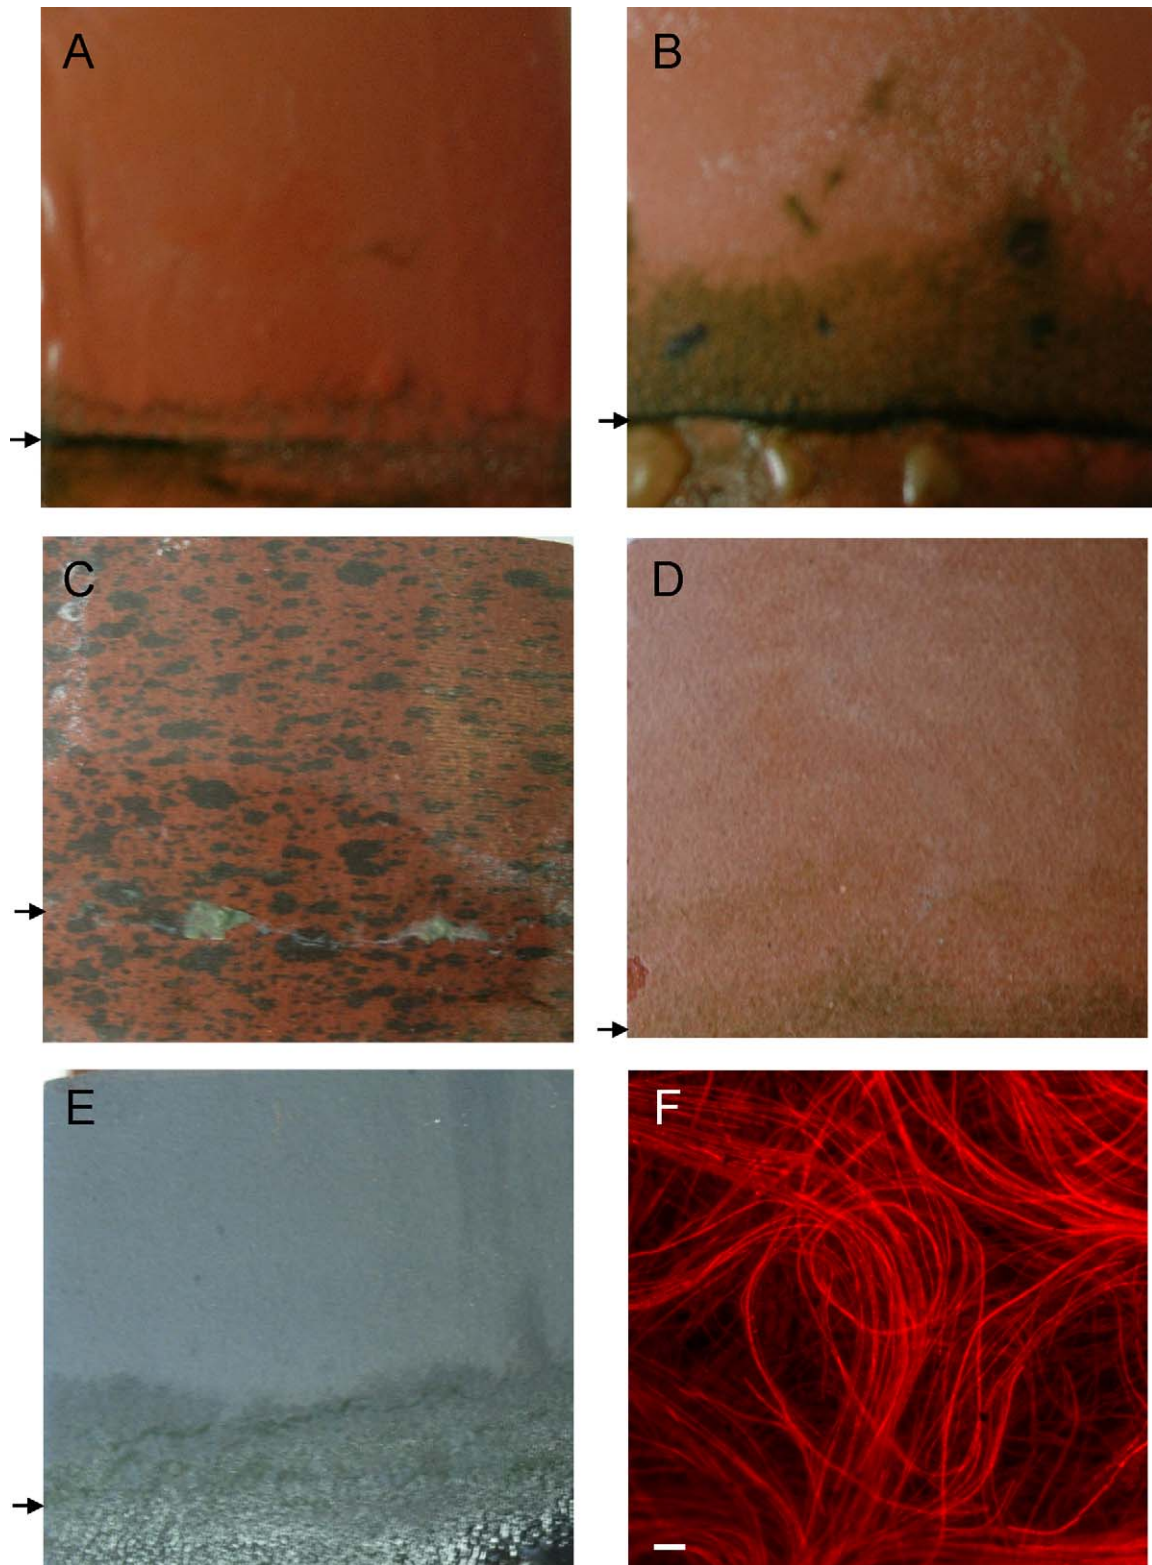
Fig. 5. Biofilm formation of *Oscillatoria* on roofing tile coupons during bioreceptivity tests comparing glazed (A) and unglazed (B) roofing tiles, as well as three different commercial types 1 (C), 2 (D), and 3 (E). Incubation time was one month. Arrows indicate the level reached by the surface of the culture medium. (F) A microphotograph of the *Oscillatoria* cells colonizing an unglazed roofing tile (A) by fluorescence microscopy under blue excitation light. Bar (F) indicates 20 μm .

which spreads upwards over time as a result of the growth of *Oscillatoria* filaments along the surface of the coupons and this development was dependent on the material under evaluation (Fig. 5).

The three commercial roofing tiles showed lower bioreceptivity than the unglazed tile due to the effect of their proprietary coatings to provide different aesthetic aspects to these ceramics (Fig. 5). For instance, the commercial type 1 showed scarce colonization (average 0.5 cm; standard deviation 0.1). Commercial type 2 presented an intermediate (average 3.3 cm; standard deviation 0.6) bioreceptivity between the types 1 and 3. The third type of commercial roofing tile showed the highest observed colonization (average 7.8 cm; standard deviation 0.7) among the three coated ceramic roofing tiles of commercial origin (Table 4). Commercial types 1 and 3 have a dark coating which might preclude the visualization of early stage colonization. However, the use of a fluorescent detection method of the chlorophyll content in the proposed cyanobacterium overlooks that potential problem because autofluorescence measurements are not affected by the coloration of the tile surface. Besides, the proposed procedure has resulted in the ability to statistically distinguish ceramic roofing tiles in base to the bioreceptivity (i.e., in terms of biological colonization) of these ceramics.

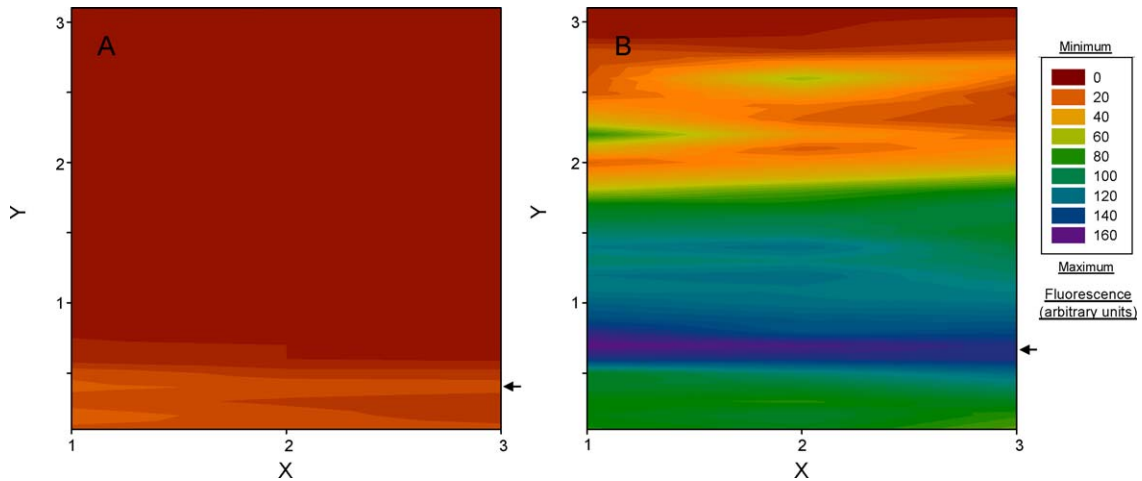
Fig. 6. Graphical representation of the 2D measurements of fluorescence from the growth of *Oscillatoria* biofilms during the bioreceptivity test of the glazed (A) and unglazed (B) roofing tiles shown in Fig. 5. Arrows indicate the location of the surface of the culture medium. A colored scale is shown corresponding to fluorescence intensity. X and Y axes represent width and height, respectively, of the scanned area of ceramic roofing tile coupons.

Experiments were carried out for the comparative analysis of the bioreceptivity of different roofing tiles and the level of colonization was evaluated by an increase of the intensity of chlorophyll autofluorescence as well as the distance or height colonized by *Oscillatoria* during its growth on different roofing tiles. An example of this colonization is shown in Fig. 5. Fig. 6 shows the quantification of fluorescence intensity over the surface of two roofing tiles. Previous analyses have reported a direct relationship between chlorophyll content and fluorescence measurements using pulse-amplitude modulated fluorimeters.¹⁷ Herein, the procedure provided with quantitative information on the development of the Cyanobacteria *Oscillatoria* growing on ceramic roofing tiles (Fig. 6) although it is also

useful to assess differences in bioreceptivity between a variety of materials. In order to quantify and compare the bioreceptivity of different materials two parameters can be utilized: fluorescence intensity (i.e., scale of colors in Fig. 6) and growth distance or height (Y axes in Fig. 6). Fig. 7 schematically shows the estimation of the colonization distance on a roofing tile. In the examples of Fig. 6, one can easily observe differences in both parameters useful for the comparison of two different roofing tiles. The unglazed roofing tile coupon allowed a much more intense colonization as judged by the higher levels of fluorescence than in the glazed coupon. The glazed coupon presented low bioreceptivity as shown by the poor growth of *Oscillatoria* (average height, 3 mm; standard deviation 0.4). The colonization by *Oscillatoria* on the unglazed coupon covered over a centimeter (average 18.5 mm; standard deviation 0.5) (Table 2) showing a relatively high bioreceptivity and presenting chlorophyll flu-

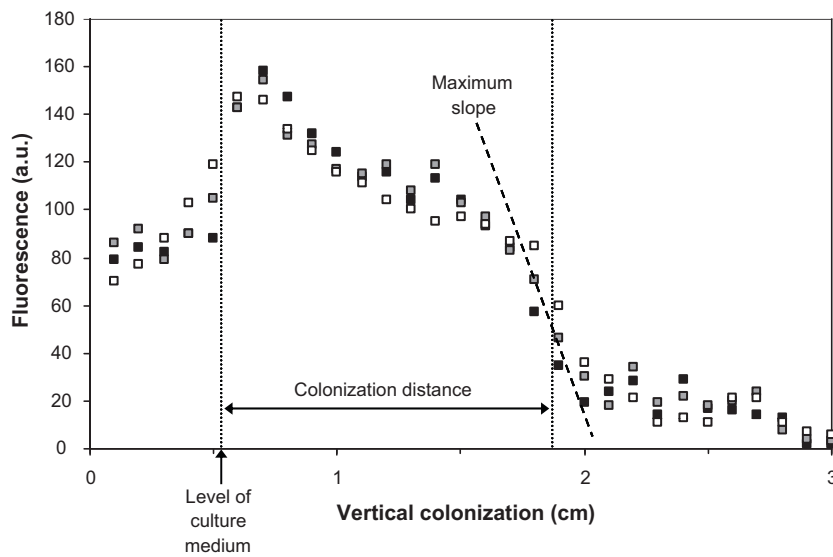
Fig. 7. Example of fluorescence intensity along the vertical position of an unglazed roofing tile colonized by *Oscillatoria* during the experiments described in this study. The position of the level of medium in the experiment is shown and the maximum negative slope is used to locate the end of the colonized area and to estimate the colonization distance for this example. Data points correspond to three different measurements along a y-axis.
