## A Safer Debonding/Debanding Technique

Most orthodontists remove the wires and attachments separately. The present article describes a debonding/debanding technique that eliminates the possibility of swallowing or inhalation of attachments, yet requires no more chairtime than conventional methods.

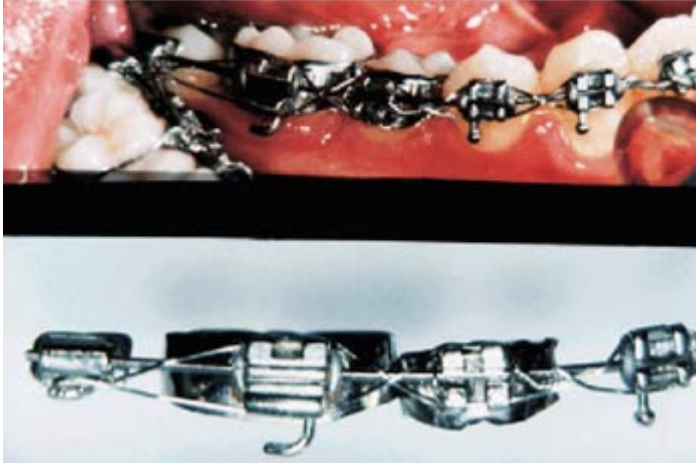
**Fig. 1** Bands and brackets tied together with figure-8 ligature wire.

- 1. Tie a ligature wire over the archwire and around all the attachments, from one end to the other, in a figure-8 pattern (Fig. 1).
- 2. Ask the patient to bite down firmly on a cotton roll, then break each bond at the bracket-enamel interface with a debonding plier (Fig. 2).
- 3. Use a debanding plier to dislodge each band, working from mesial to distal (Fig. 3). At this point, all brackets and bands should be detached from the teeth.
- 4. Remove the entire assembly of brackets, bands, and archwire (Fig. 4).
- 5. Clean off any remaining adhesive, and polish all tooth surfaces.

If the archwire is long enough, it can be cinched back to the distal attachments at both ends. The figure-8 ligature wire will then not be needed to hold all the attachments together.

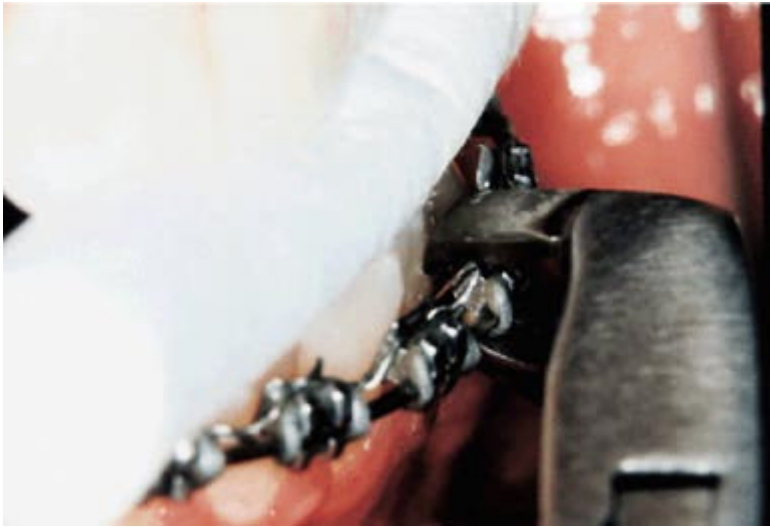
**Fig. 2** Patient bites down on cotton roll while brackets are removed with debonding plier.

Having the patient bite down on a cotton roll will reduce any discomfort or pain caused by the pressure of the pliers, especially on mobile teeth. □

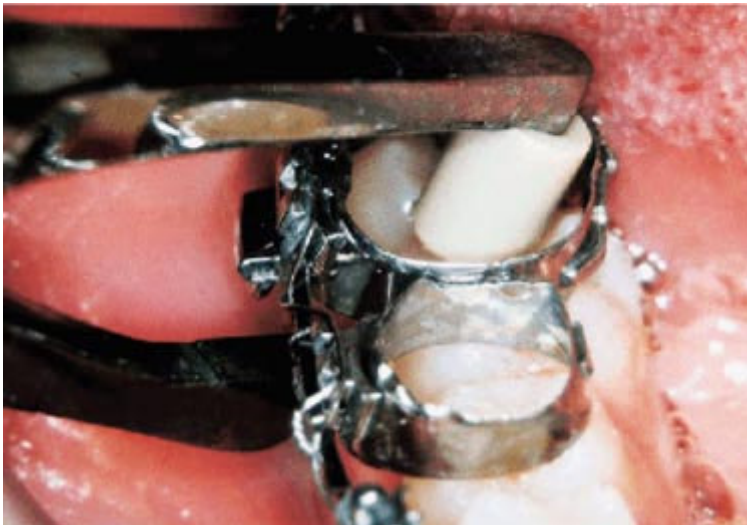
**Fig. 3** Bands dislodged with debanding plier.

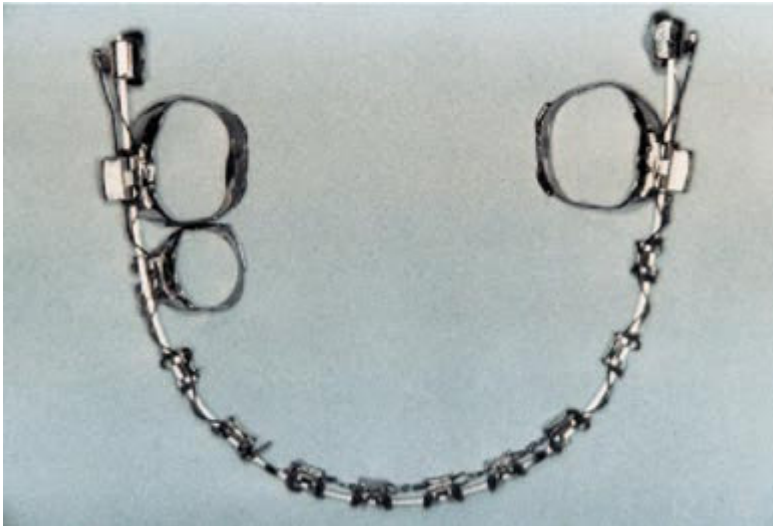
**Fig. 4** Bands, brackets, and archwire after removal.
