No corrosion of 304 stainless steel implant after 40 years of service

When exposed to 0.9% NaCl type 304 stainless steel undergoes severe pitting corrosion within a matter of days. However, a Sherman plate fabricated from type 304 stainless steel remained inside a patient's arm for almost 40 years without any visible indications of corrosion. Given the previous understanding of the pathological environments this was considered quite remarkable. It is proposed that the low dissolved oxygen levels found in human-body fluids makes the long-term *in vivo* environment much more benign than would be anticipated from *in vitro* experiments. Furthermore, it is proposed that previous cases of localized pitting corrosion on stainless steel implants most likely arose due to the development of short-term aggressive conditions due to pathological changes in the surrounding tissue as a result of the trauma of the implant procedure. In the present case the Sherman plate was sufficiently small that the surrounding tissue was not aggravated sufficiently to lead to the development of such an environment aggressive. The conclusion that surgical implants are at most risk during the first few weeks of

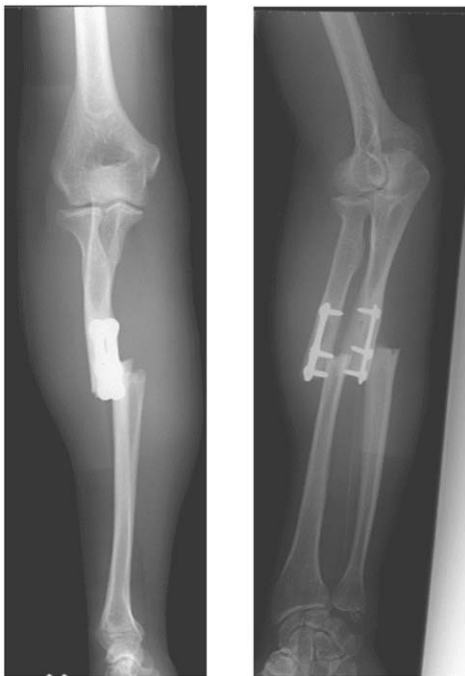
Figure 1 Radiograph showing fractures of both forearm bones, at the distal screws of the plate fixation.

This was in about 1960, where both fractures were reduced with bone plates and screws. He was 13 years old then. In 1998, he again fractured his right radius and ulna in another road traffic accident. Both fractures were at the distal screws of the plate fixation (Fig. 1). There was minimal bone growth over the proximal part of one plate, but there was no evidence of growth over the majority of the plates' surfaces or the screws, such growth, if it had existed, could have protected the implant from corrosion (Fig. 2). The old plates were removed, after being *in situ* for about 38 years, and the fracture reduced with two new plate implants. No inflammation or black material in the soft tissue surrounding the original implant was noted. The implants were 4-cm three-hole bone plates, each with three 3-mm diameter screws, 14-mm in length. Both plates and their respective screws were removed intact. The condition of the plates were remarkably good, with just a few scratches which were obtained during retrieval and the

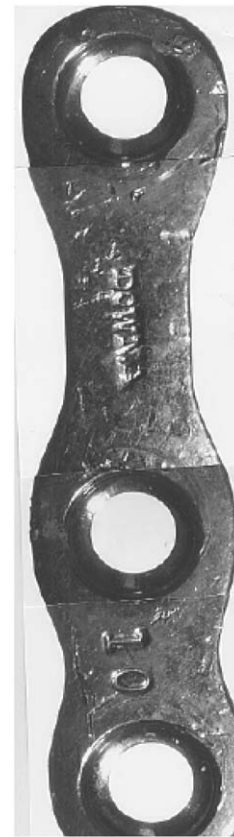
Figure 3 Close-up of the removed plate, showing that no corrosion appeared on the plate. The manufacturer's name "DOWN.A" was still clearly readable.

manufacturer's name "DOWN.A" was still clearly visible (Fig. 3). The surgeon who removed the plate and screws was sufficiently impressed to enquire why it was that not all implants were made of such highly corrosion resistant alloys.
