A mechanical study of the deterioration of coconut leaf thatch under natural and accelerated environmental conditions

C. K. S. PILLAI, M. A. VENKATASWAMY, K. G. SATYANARAYANA
V. P. SREEDHARAN, C. INDIRA, P. K. ROHATGI
Regional Research Laboratory (CSIR), Trivandrum-695 019, Kerala, India

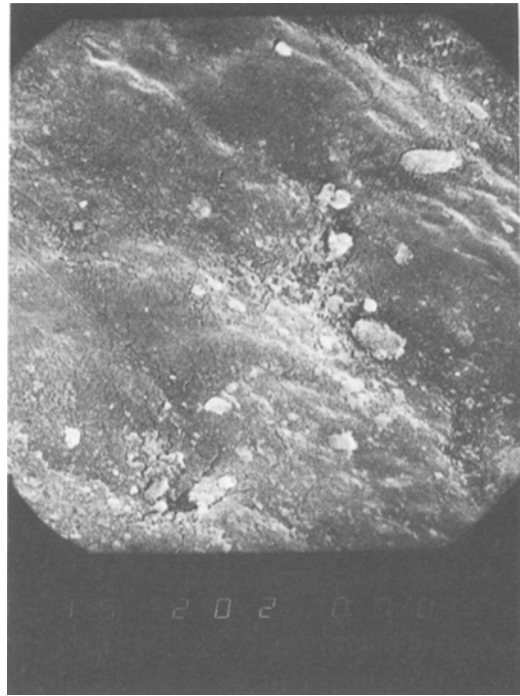
Figure 7 Scanning electron micrograph of the upper surface of green coconut leaf, $\times 2375$.

Considerable changes were also observed on the surface of the leaf during deterioration. The colour of the leaf underwent a change from pale brown to brown grey, greyish black and finally almost to black. Figs 7–10 show SEMs of the surface fractures of green, dry and deteriorated leaves. The green leaf showed almost a smooth surface whereas in the dry leaf, the cuticular wax on the surface of the leaf appeared flaky (possibly due to escape of moisture during drying). Extensive surface damage is indicated in Fig. 9 even after a few months' exposure to natural weathering. The cuticular surface layer seems to have been eroded due to wear or leaching by rain. As deterioration proceeds, the upper surface layers are worn off

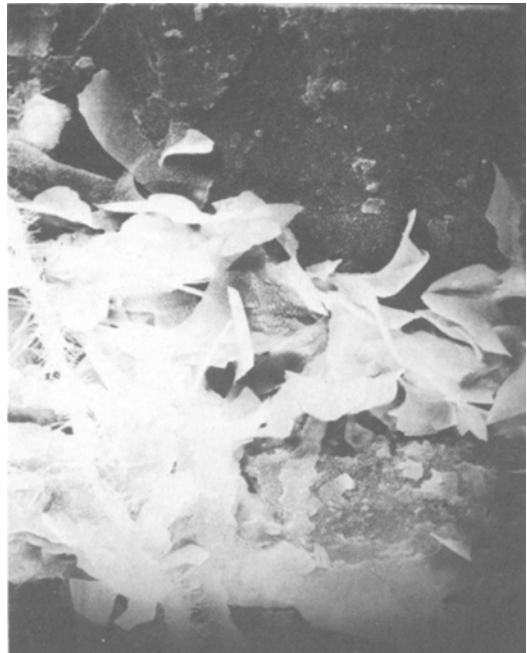
Figure 8 SEM of the upper surface of dry coconut leaf showing flakes of cuticular wax, $\times 2375$.

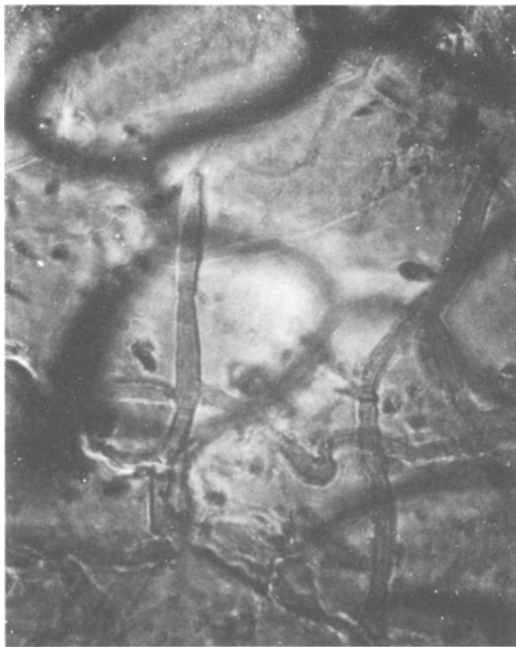
Figure 12 Surface preparation of dry coconut leaf showing growth of mycelium, $\times 150$.

growth. Fig. 12 is a picture of mycelium growing on the surface of the leaf and Fig. 13 indicates that the entry of the fungus into the leaf possibly takes place through the stomatal openings on the lower surface of the leaf. Fig. 14 shows the fracture surface of the coconut leaf after fungal attack indicating that apart from a few cells around the vascular bundles, the system as a whole seems to have lost its regular arrangements of cells. They appear to be a mass of amorphous material (rich in lignin which is shown to be increased in content by alkali solubility tests [6]) loosely packed with discontinuity of cell structure which enhances the brittle nature of the system.
