Corrosion of cordierite ceramics by sodium sulphate at 1000° C

ROBERT BIANCO*, NATHAN JACOBSON
NASA Lewis Research Center, Cleveland, Ohio 44135, USA

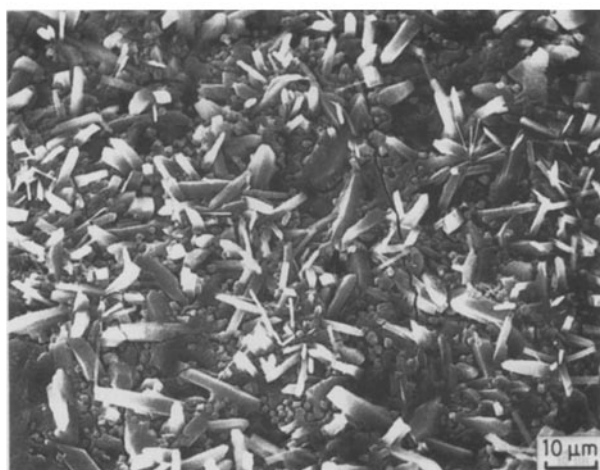
Figure 5 Surface view – cordierite + Na₂SO₄:O₂, 24 h.

As the reaction continued, the Na₂SO₄(l) was less prevalent on the surface and the crystallites became more dominant as shown in Fig. 5. Fig. 6 shows a polished cross section with associated X-ray dot maps after 72 h of reaction. The large crystallites of

Next, consider the physical changes induced by corrosion. In all the microstructures examined, there was evidence of cracking (Figs 4 to 6). The polished cross-section (Fig. 6) suggests that these cracks extend below the corrosion product scale and into the cordierite substrate. Fig. 7 is a surface view of the material corroded for 24 h after the corrosion scale had been removed by the HCl treatment. The clear presence of substrate cracks indicates that they result from the corrosion process. The physical mechanism by which

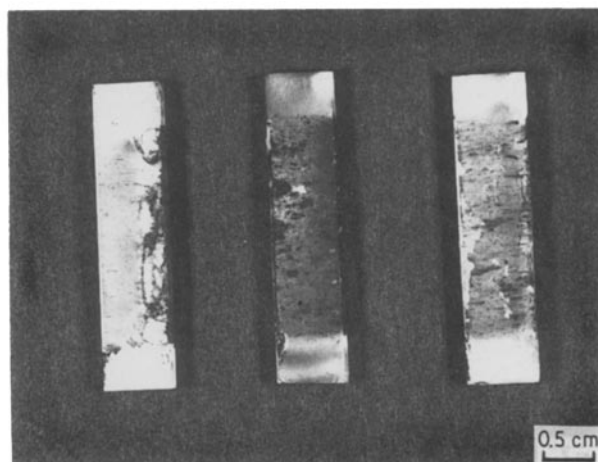
Figure 11 Cordierite corroded in a 4 atm burner rig for 40 h at 1000°C .

in a burner rig under the conditions discussed previously. The specimens seen in Fig. 11 clearly show a deposit and possible corrosion product. Chemical analyses of these deposits (Table I) indicated the presence of Na_2SO_4 and other compounds with generally the same composition found in the furnace tests. A polished cross-section (Fig. 12) shows the same features as observed in the furnace tests with $\text{Na}_2\text{SO}_4/\text{O}_2$ (Fig. 6). The layer on the top appears to be Mg_2SiO_4 , with larger underlying regions of NaAlSiO_4 . The calculated $P(\text{SO}_2)$ in this case is 3.9×10^{-4} atm [19], indicating Reaction 4 would be favourable.
