Damage in carbon fibre composites due to repetitive low-velocity impact loads

The effect of repetitive impacting with increasing impact energy on unsupported thermoset matrix and thermoplastic matrix carbon fibre laminates was studied. In the case of the thermoset laminates, there were two abrupt losses in stiffness, the first corresponding to through-the-thickness damage and the second to the damage extending to the specimen edges. The thermoplastic matrix laminates exhibited a continuous decline in stiffness but again the damage sequence was through-the-thickness followed by extension to the specimen edges. Static bend testing of these composites resulted in the same type and extent of damage as was observed for impact loading. The effect of increasing the unsupported area and laminate thickness were investigated. Impacting with increasing impact energy was compared to repetitive impacting at a constant impact energy.

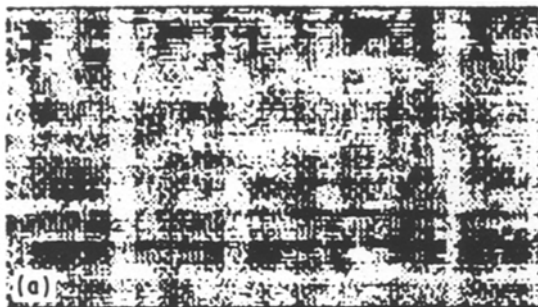
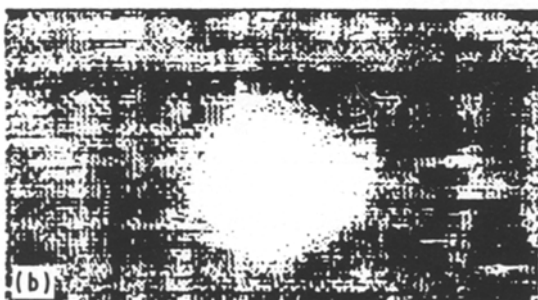
Figure 5 C-scans of impact damage of AS4/3501-6 (0/90)_{8s} after cumulative impact energies (Σ IE) of (a) 10 J, (b) 80 J and (c) 170 J.

C-scans were taken of specimens that had been impacted to about the mid-point of each of the three stages of stiffness shown in Fig. 3. These same specimens were then sectioned and damage maps generated. The C-scans are shown in Fig. 5 and the damage maps in Fig. 6. After a cumulative impact energy of 10 J the C-scan indicated only a narrow damage area (Fig. 5a) and from Fig. 6a the damage was limited to

the first few top plys. After 80 J cumulative impact energy, which is beyond the first drop in stiffness (Fig. 3), the C-scan indicated a wider damage area (Fig. 5b) that, extended through the thickness of the laminate (Fig. 6b). After 170 J cumulative impact energy, the C-scan (Fig. 5c) and the damage map (Fig. 6c) indicated that damage had extended to the edges of the laminate.

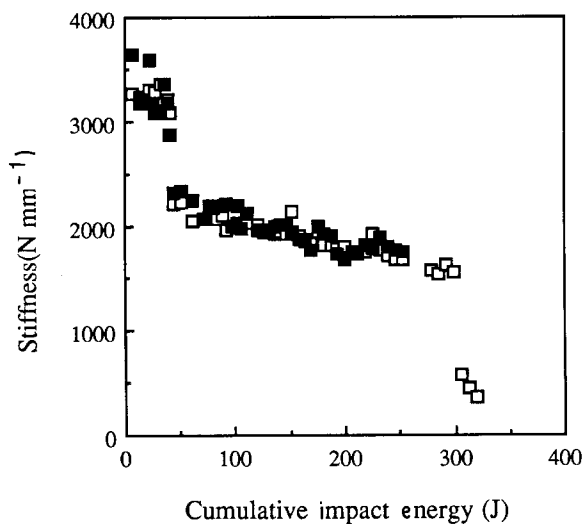
Figure 7 Stiffness versus cumulative impact energy AS4/4 (±45)_{8s}.

The impact response of laminates with fibre orientations of $\pm 45^\circ$ in the 3501-6 matrix were similar to the observations with the $0^\circ/90^\circ$ fibre orientation. As shown in Fig. 7, three regions of relatively constant stiffness were found and the transferred energy exhibited a spike at the transition between the first drop off in stiffness and erratic behaviour after the second transition (Fig. 8). The only differences between the 0/90 and the ± 45 laminates was that the second stage of stiffness versus cumulative energy extended to higher energies for the ± 45 laminate and the third stage was not as clearly defined as in the case of the 0/90 laminate.

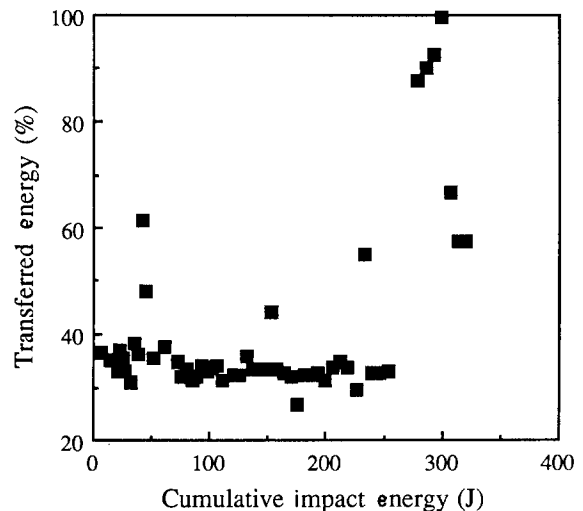
Figure 8 Per cent transferred energy versus cumulative impact energy, AS4/3501-6 (±45)_{8s}.

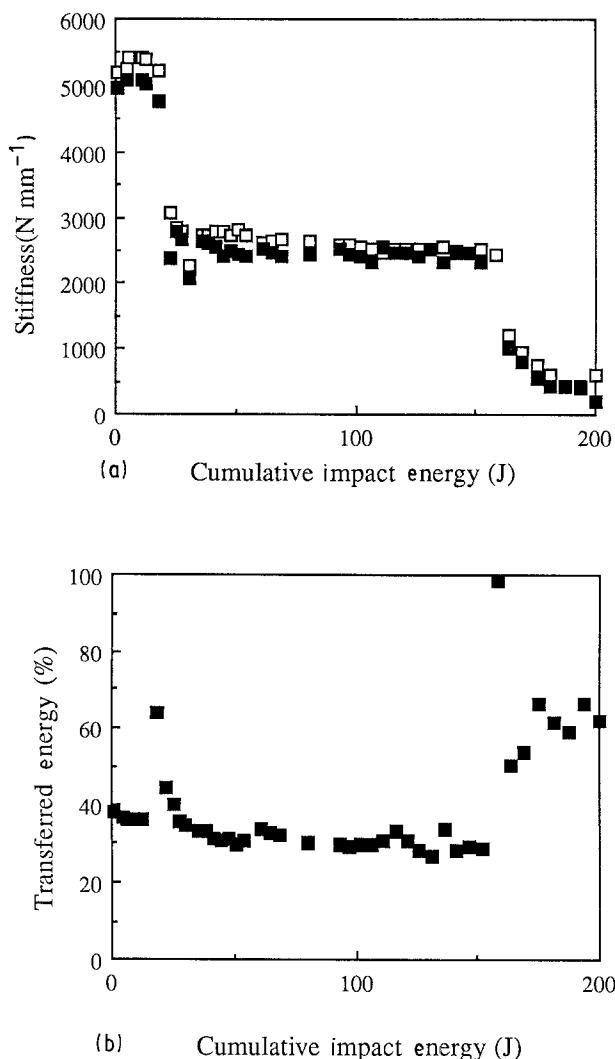
Figure 10 (a) Stiffness and (b) per cent transferred energy versus cumulative impact energy for IM6/3501-6 (0/90)_{8s}.

The stiffness and per cent transferred energy versus cumulative impact energy for IM6/3501-6 (0/90) and IM6/3501-6 (± 45) are presented in Figs 10 and 11, respectively. Three distinct slopes were observed in the stiffness plots for the IM6/3501-6 (0/90) laminate (Fig. 10a) and, as with the AS4 laminates, the second and third stage correspond to through-the-thickness damage and extension of the damage to the edges of the sample as indicated in the damage maps presented in Fig. 12.

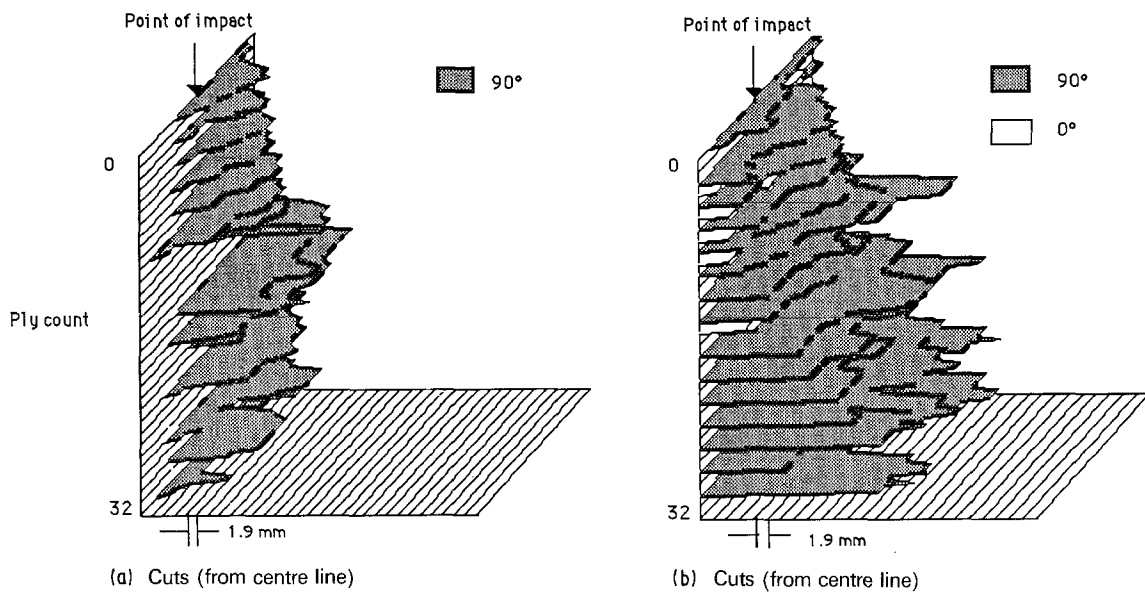
Figure 12 Damage maps for IM7/3501-6 (0/90)_{8s} after Σ IE of (a) 110 J and (b) 190 J.

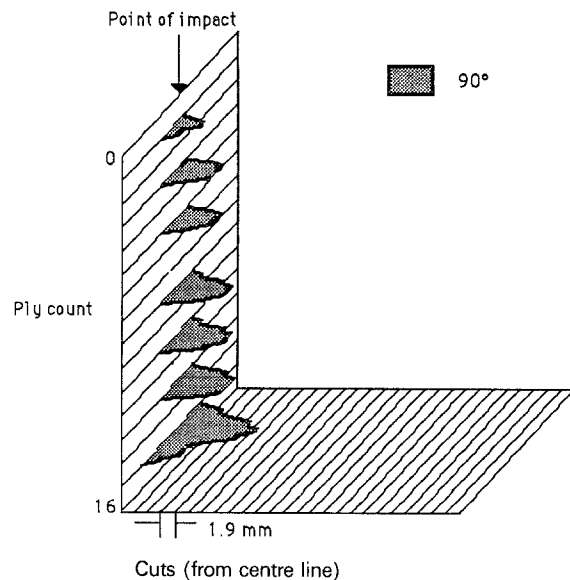
Figure 23 Damage map for AS4/3501-6 (90/0)_{4s} at Σ IE of 10 J.

Decreasing the laminate thickness resulted in the onset of damage at a lower cumulative impact energy. As shown in Fig. 22, the 16-ply laminate of AS4/3501-6 exhibited an initial drop in modulus after the first impact (1.5 J) and then at about 25 J. The first drop in stiffness for the 32-ply laminate was at about 50 J. A damage map for the 16-ply laminate after a cumulative impact energy of 10 J is shown in Fig. 23 and it is evident that damage had extended through the laminate thickness.

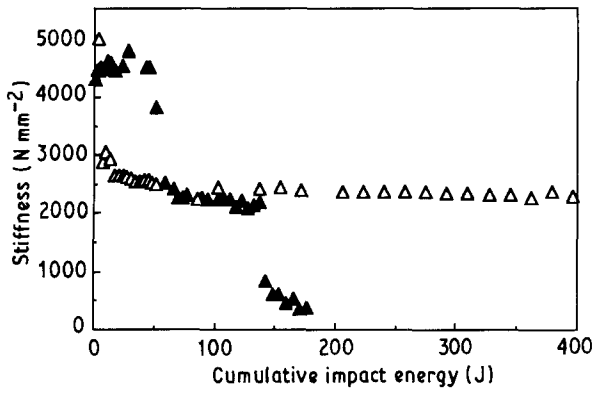
Figure 24 Comparison of the change in stiffness versus cumulative impact energy for fatigue loading at (Δ) constant and (\blacktriangle) increasing impact energy for AS4/3501-6 (0/90)_{8s}.

“conventional” fatigue mode where the specimens were repetitively impacted at a constant impact load. The results are compared with impacting with increasing impact load in Fig. 24. In the fatigue mode there is an initial drop in stiffness but with no subsequent change even up to a cumulative impact energy of 400 J. The repetitive impacting with increasing impact

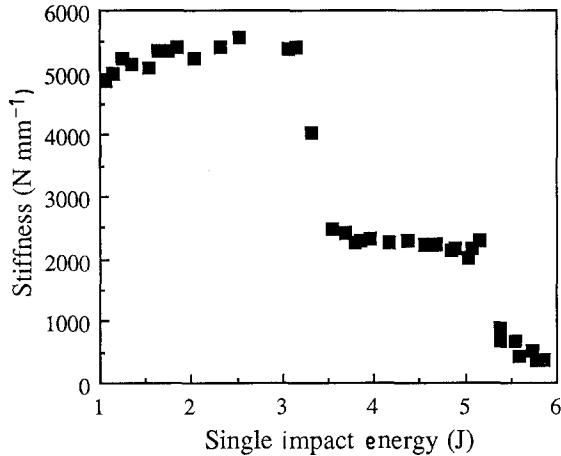
Figure 25 Stiffness versus single impact energy for AS4/3501-6, (0/90)_{8s}.

These data for increasing impact energy are presented in terms of the actual impact energy rather than the cumulative impact energy in Fig. 25. The initial drop in stiffness occurs at about 3 J. In Fig. 24, the initial drop in stiffness for impacting at constant en-

Continuing the fatigue test at a constant 3 J for each impact resulted in no further change in stiffness. On the other hand, continuation of the RIIE test, results in a second change in stiffness at about 5 J (Fig. 25). Here again, a change in the extent of damage, through-the-thickness to extension to the laminate edges, depends on the level of impact loading rather than the cumulative impact energy.
