Cyclic hot corrosion of Haynes 230 alloy

FEN-REN CHIEN*, RICHARD BROWN

Materials Laboratory in the Department of Chemical Engineering, University of Rhode Island, Kingston, RI 02881, USA

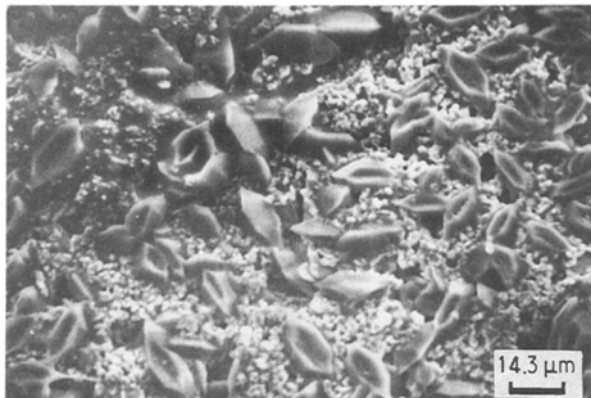
Figure 3 Surface microstructure after 150h cyclic exposure at 871 °C.

After 150 h thermal treatment, the surface microstructure was as shown in Fig. 3. The large crystals were Na_2SO_4 which recrystallized under high-temperature ageing. The porous agglomerations were chromium-rich with nickel oxides. EDS analysis for the average surface composition is shown below in Fig. 5b.

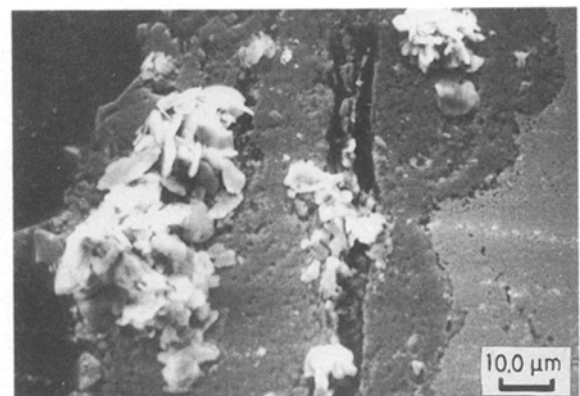
Figure 9 The microstructure after 16 h cyclic exposure at 1093 °C: the melt within the scale absorbed water from humid air to recrystallize. The crystal morphology is subject to change with time.

There was some indirect evidence to show that Na_2CrO_4 and Na_2WO_4 actually existed in the scales, which is present in the structure shown in Fig. 9. Na_2CrO_4 and Na_2WO_4 are soluble and can absorb humidity from the air to recrystallize. Therefore, these chromate and tungstenate crystal shapes were subject to change with exposed time in air. It is interesting

that the compositions of the crystals were not the same everywhere. In Fig. 9, the plate-like crystals growing at the outer layer have a higher concentration of Na_2CrO_4 . Meanwhile, the crystals growing near the matrix have a higher concentration of Na_2WO_4 . These results possibly may be evidence that the accumulation of WO_4^{2-} played a major role in the mechanism of the hot corrosion in this study. The presence of liquid phases might provide short-circuit paths for either oxygen or sulphur, and accelerate cracking as well. Because the liquid was developed in the attacked region and it provided the accelerated path for the diffusion of oxygen or sulphur, chromium was prevented from diffusing outward to form the protective film.

In this study, evidence, i.e. Figs 6 and 9, indicated that the appearance of sulphur below the surface prevents chromium from diffusing outward to form a protective film. However, it is very likely that the reaction occurs due to the sulphur diffusing into the substrate, probably because sulphur has higher penetration ability than oxygen. Therefore, a nickel-rich region (chromium-depleted region) was maintained after an initially short stage of selective oxidation of chromium, as shown in Fig. 7. Overall, at this stage, consumption of oxygen ions predominates the fluxing, which creates chromate and tungstenate, resulting in an acidic environment.
