Fatigue-induced damage mechanisms in carbon fibre-reinforced plastic composites

A. S. CHEN, B. HARRIS[†]

School of Materials Science, University of Bath, Bath, BA2 7BY, UK

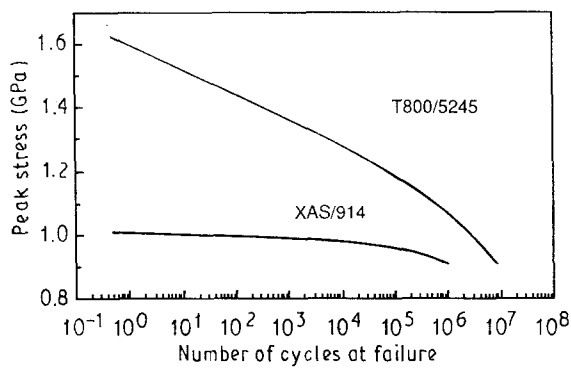
Figure 1 $S/\log N$ curves for XAS/914 and T800/5245 $[(\pm 45, 0_2)_2]_s$ laminates, $R = 0.1$.

Results of fatigue life tests for all three laminates are presented in Fig. 1 as fatigue peak stress/log life curves ($S/\log N$). Apart from the differences in the ultimate strengths, the $S/\log N$ curve for the XAS/914 system is

much flatter than that for the T800/5245 system. All the curves have shown a tendency to tail off after about 10^5 cycles. The following mechanisms investigation has been carried out in the stress/life range within the $S/\log N$ curves indicated for the individual material systems.

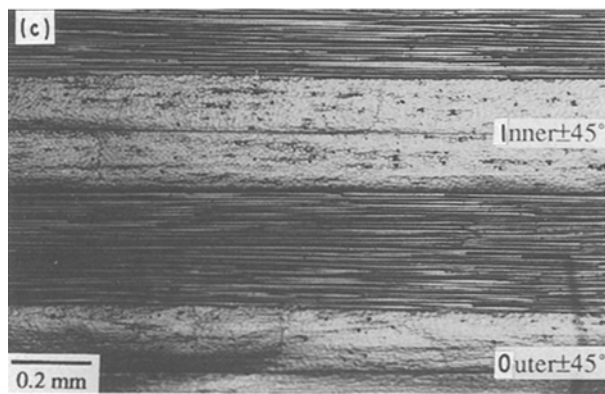
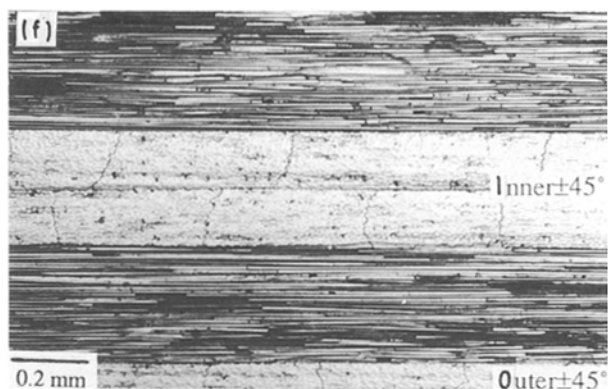
Figure 2 Damage conditions at the edge of an XAS/914 [$(\pm 45, 0_2)_2$]_s specimen subjected to fatigue at a maximum stress of 94% of the strength. (a) Matrix crack in outer 45° plies, $N = 301$. (b) Fibre breakage in 0° plies, $N = 301$. (c) Matrix cracking in inner 45° plies, $N = 2512$. (d) Fibres in 0° plies drop out from edge of sample, $N = 6846$. (e) Detail of fibre drop-out from edges, $N = 6846$. (f) Delamination between $\pm 45^\circ$ plies start from all sample edge, $N = 13000$. (g) Delamination between 0° and 45° plies, $N = 80012$. (h) Formation of small edge delamination between 0° and 45° plies, $N = 80012$. (i) Some fibre fractures in a 0° ply are triggered by an approaching matrix crack in a neighbouring 45° ply, $N = 80012$. (j) The last replica of this specimen after 554 440 cycles.

Fig. 2a–k show typical damage development recorded by edge replicas in a test coupon which was fatigued at a maximum stress equal to 94% of the monotonic ultimate strength. At a very early stage, after only 301 cycles, the first signs of damage, namely matrix cracks, appeared in an outer 45° ply (skin layer; Fig. 2a). At about the same time, fibre breakage in the 0° plies was observed (Fig. 2b). When the specimen was fatigued to 2512 cycles, matrix cracks occurred in the inner $\pm 45^\circ$ plies (Fig. 2c), the number of matrix cracks continuing to increase in the outer 45° plies. After about 6800 cycles, fibre breakage spread throughout the 0° plies, and some broken fibre ends dropped out of the sample (Fig. 2d) from the edge of the specimen. Fig. 2e shows this at higher magnification. With further fatigue, the number of matrix cracks in the 45° plies increased, and edge delamination between two adjacent $\pm 45^\circ$ plies appeared in all pairs of $\pm 45^\circ$ plies (Fig. 2f). Although this edge delamination damage occurs along the whole boundary length at this stage, it started much earlier as several separate small edge delaminations as an appropriate stress condition was built up as a consequence of the presence of two matrix cracks in adjacent 45° plies (see Fig. 2c). The last damage mechanism which was observed in the edge replicas is delamination between the 0° and the 45° plies (Fig. 2g). This delamination could also start from approaching matrix cracks in adjacent 45° plies (Fig. 2h). In a few cases

the opening matrix crack in a 45° ply could introduce a sufficiently high local normal stress concentration in the crack direction in the neighbouring 0° ply to trigger some fibre fractures as a continuation of the crack across the boundary into the 0° layer (Fig. 2i). This kind of crack will then be prevented from further growth by the formation of new matrix cracks between the fibres and parallel to the boundary. Fig. 2j is a picture of the last replica taken from this specimen which then failed after a further 542 cycles in the fatigue test.

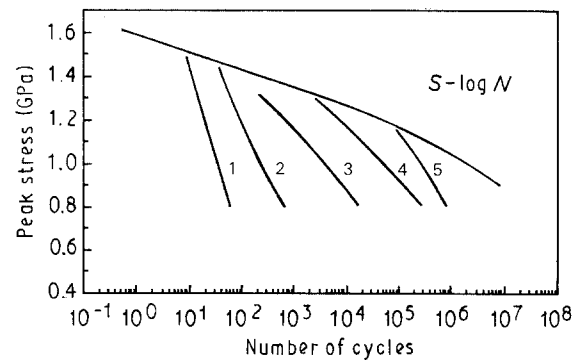
Figure 11 A schematic map of the fatigue-induced damage mechanisms for T800/5245 $[(\pm 45, 0_2)_2]_s$ laminate, $R = 0.1$. 1, Fibre fracture; 2, outer matrix crack; 3, fibre drop-out; 4, inner matrix crack; 5, delamination between 45° and 0° .

50–60 cycles, the numbers of fibre fractures are clearly greater at higher stress levels. Given that we have relatively little accurate information about the threshold for fibre fracture, because no replicas could be taken within the first few tens of cycles, the damage curve for fibre fracture in Fig. 11 could reasonably be corrected to a position given by the line furthest to the left.

It is noted that fibre drop-out from edges occurs in a particular range of the fatigue life at different cyclic load levels for both laminates (Figs 4 and 11), so that it has been identified as a specific fatigue damage mechanism. The fibre drop-out could be the physical consequence of a piece of fibre or a group of fibres being isolated by the combined effects of a fibre fracture and subsequent splitting between fibres. When the laminate samples are subjected to a uniform axial tensile stress, it is expected that fibre breakage will readily spread into all 0° plies [36]. The transverse and shear stress concentrations near the tip of a fibre break would initiate a split in the plies along the direction of the fibre orientation [37], following which, the isolated fragment could peel away from the edge surface as schematically illustrated in Fig. 16. With further cyclic loading, fibres will continue to peel away from the newly exposed edge surface in this fashion. Because fibre breakage can occur anywhere in the load-bearing 0° plies, fibre drop-outs are expected to be observed in any exposed layer parallel to the fibre orientation in the 0° plies. The observation of fibre drop-out in the sectioned surfaces of some XAS/914 specimens provides strong evidence (Fig. 7a and b) that the drop-out phenomenon is a bulk failure mechanism, not merely a free-edge effect. The splitting parallel to the fibre orientation would not necessarily be a result of debonding between the fibres and the surrounding matrix resin. This interfibre fracture could well be a matrix crack parallel to the fibre orientation direction if the bond strength between
