# Fracture and fatigue performance of textile commingled yarn composites

The response to mechanical loads of unidirectional commingled warp knitted and woven glass fibre reinforced polyethylene terephthalate laminates has been characterized. The mechanical properties of the two materials were determined under tension, in-plane shear and flexure. The flexural fatigue properties were determined for the woven laminates by means of three-point bending tests with a loading ratio of  $R = 0.1$  at stress levels of 50–90% of the ultimate static strength. The Mode I, Mode II and mixed mode (Mode I:II ratios 4:1, 1:1 and 1:4) interlaminar fracture toughnesses of the laminates were determined by means of the double cantilever beam and mixed mode bending tests, respectively. The main fractographic features, as determined by a scanning electron microscopy examination, of the Mode I dominated failures were a brittle matrix failure and larger amounts of fibre pull-out. As the Mode II loading component increased, the amount of fibre pull-out was reduced and the features of the matrix appeared to be more sheared. Cusps were found on the fracture surfaces of specimens tested in pure Mode II and mi

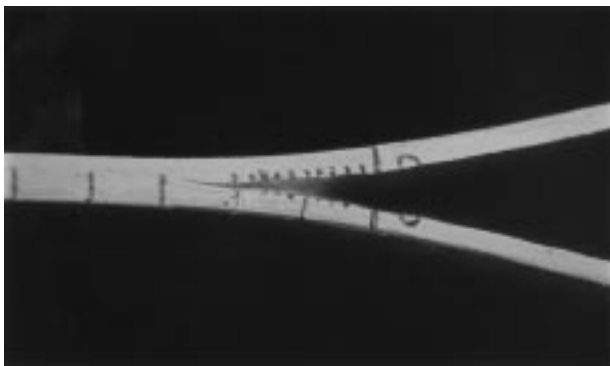
Figure 4 Fibre bridging during a Mode I test. The crack front is seen to be slightly bent out of plane and crack propagation followed the undulated paths of the warp yarns.

fibre pull-out was seen during testing and this was responsible for both the resistance curve effect in the fracture toughness and the unstable crack growth. In the woven laminates the crack followed the undulation of the warp yarns as the cracks propagated from the end of the non-adhesive insert, Fig. 4.

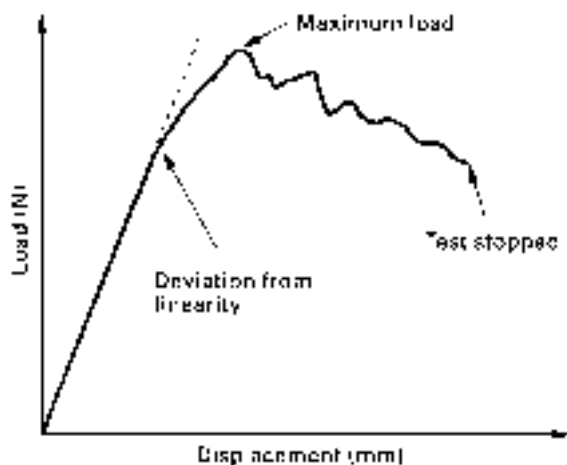
Figure 5 The schematic load–displacement curve of a double cantilever beam (DCB) test. The fracture toughness initiation values were calculated from the conditions at the onset of non-linearity.

The initiation values of fracture toughness were calculated at the point where the load–deflection curve deviated from linearity as shown schematically in Fig. 5. The propagation values of fracture toughness were calculated from the conditions of steady state crack growth. No significant difference was detected between the toughness of the annealed woven laminate and those of the ordinary woven laminate. The fracture toughness of the warp knitted laminates was lower than for the woven laminates and this was due to the weft yarns in the woven laminates, which made interlaminar crack propagation more difficult. The scatter in the fracture toughness data was greater for the mixed mode fractures in the cases of all three materials.

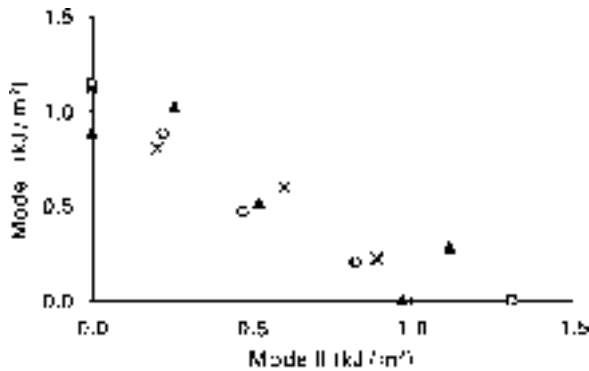
Figure 12 The experimentally determined initiation fracture toughness values for the three different material: (▲) warp knitted; (×) woven; (□) woven, annealed.

large deflections. Stable mixed mode crack growth was seen in most cases for both the warp knitted and woven laminates. Figs 12 and 13 show the experimentally determined failure loci for the three different materials in terms of both initiation and propagation fracture energies.

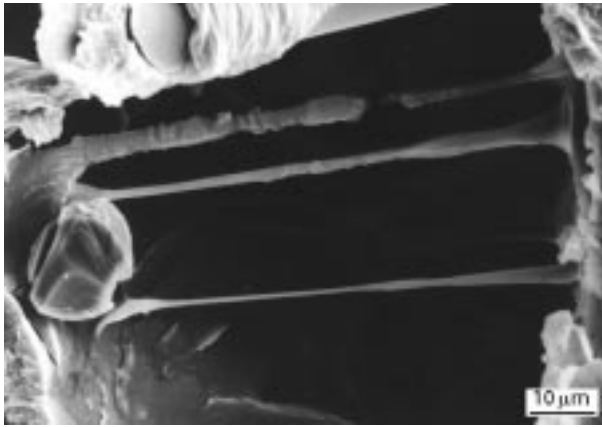
Figure 24 Fibrils bridging a matrix crack close to the location of the primary compressive damage.
