# Characteristics of rolling contact fatigue of steels produced by thermomechanical processing

0.27C-1.97Cr-1.65Mn-0.30Mo-0.21Ni steels produced by thermomechanical processing were rolling contact fatigue tested in the elastohydrodynamic lubricating condition at the rotating speed of 8,000 rpm under the applied load in the range of 25–100 kgf. A mixture of lower bainite and martensite was formed during thermomechanical processing, and it was found in transmission electron microscopy that fine lower bainite was formed by splitting in two after formation of martensite. The zone of maximum shear stress was found to be 195.0–339.3  $\mu\text{m}$  in depth from the contact surface by comparing the regions of hardness increase, microstructural change and the contact width during rolling contact fatigue. Resistance to crack initiation during rolling contact fatigue is the main reason for improved fatigue life. This is confirmed from the result that the shortest fatigue life was shown in the specimen with the largest crack length and crack depth.

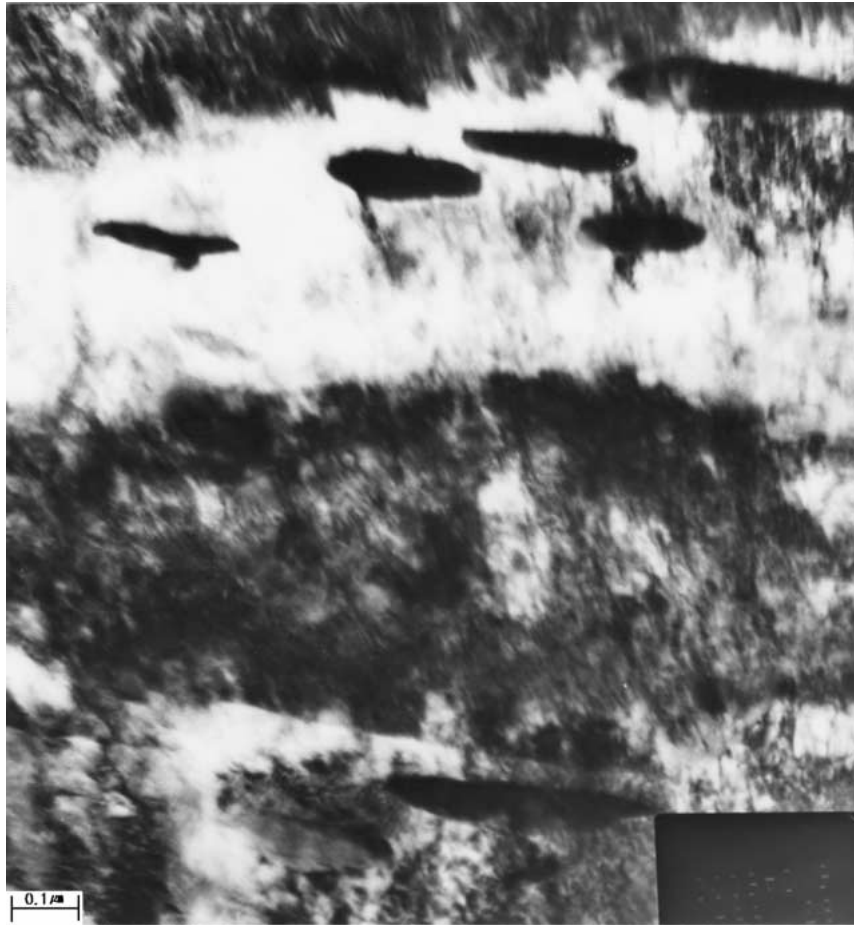
Figure 4 TEM micrograph showing bainitic carbides and martensite in the thermomechanically processed steel.

micrograph revealed that the bainitic carbides were formed along a certain orientation in bainitic ferrite, and that the tangled dislocations were formed in the martensite just below the bainite, bainitic carbide also formed underneath the lath boundaries in lower region as shown in Fig. 4.

Martensite was formed at the surface region during rapid cooling of water spraying stage and lower bainite or type III bainite was formed because of difference in cooling rate along the depth from the surface and heat transfer [7–9]. Fig. 4 shows the formation of fine lower bainite through separation of lower bainite by martensite with tangled dislocations. X-ray diffraction analysis using Mo  $K_{\alpha}$  radiation did not reveal the trace of retained austenite, which is thought to come from precipitation of bainitic carbides [10] caused by carbon enrichment in untransformed austenite through atomic diffusion of interstitial carbon, not reaching chemical stability of austenite [11].

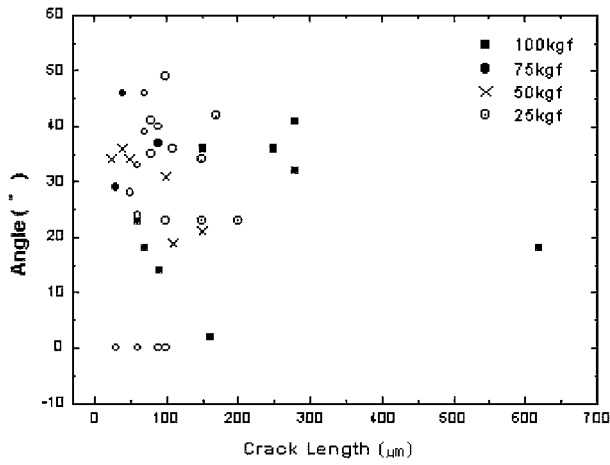
Figure 13 Relationship between crack length and crack angle during rolling contact fatigue.

Depth, length and propagation angle were measured for many cracks observed depending on the applied load, and these are plotted in Figs 12 and 13. Cracks with maximum depth or maximum length were observed in the specimens subjected to loading of 100 kgf. But Fig. 7 shows these specimens have the minimum fatigue life in spite of the maximum crack length or crack

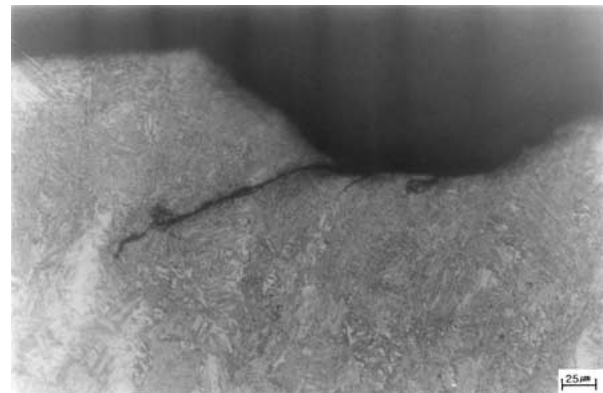
Figure 16 Optical micrograph showing subsurface cracks to flaking in the rolling contact fatigue test under applied load of 50 kgf.

Fatigue crack was observed as shown in Fig. 14 to propagate in the direction of main shear [16] along the white etching band under the raceway in a specimen under 100 kgf loading. Under the same load many cracks were formed in the white etching bands and propagated towards the surface leading to surface failure by flaking as shown in Fig. 15. Fig. 16 shows the initiation and propagation behavior of fatigue cracks observed in the specimen subjected to 50 kgf of loading, and less white etching bands were formed than that of 100 kgf of loading as shown in Figs 14 and 15. Fatigue crack length was shorter but fatigue life was longer than those under 100 kgf of loading as shown in Fig. 7, which indicates
