Recycling of a plastic car component having a multilayer structure: Morphological and mechanical analysis

The recycling of two types of dashboards having a multilayer structure presently available on the market and hence on the scrap cars has been extensively investigated. In both the cases the recycled material showed a strong worsening in the mechanical and impact properties. This effect was attributed to the incompatibility of the different materials constituting the item and to the occurrence of degradation phenomena taking place during processing. To overcome these limitations suitable polymeric additives were added during the recycling. By this procedure materials with improved mechanical properties able to be reused for the same or for similar applications within the car have been obtained.

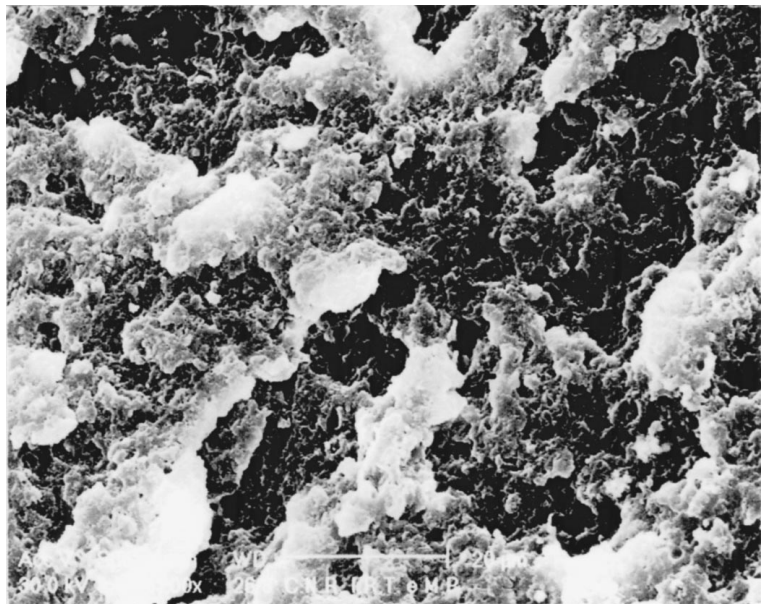
Figure 6 SEM micrographs of the tensile fractured surfaces of the two layers dashboard: A, unmodified dashboard; B, dashboard with 30 wt % of ABS; C, dashboard with 50 wt % of ABS.

This improvement in the mechanical behaviour was confirmed by a morphological analysis performed by SEM on the tensile fractured surfaces. In Fig. 6 are shown the SEM micrographs of the recycled dashboard (Fig. 6A) and of the same material containing 30 and 50 wt % of ABS (Fig. 6B and C respectively). Although the morphology of the recycled item appears quite homogeneous, features distinctive of a plastic deformation mechanism are scarcely visible. When virgin ABS is added, a stress whitening during the tensile deformation process is generally observed. This phenomenon is clearly shown in the corresponding fracture surfaces in which plasticity and tearing are evident. The extent of such an effect increases with enhancing the ABS content (see Fig. 6B and C). The above observations account for the improved tensile mechanical properties and, at the same time, give further evidence that the shear yielding is the dominant deformation mechanism.

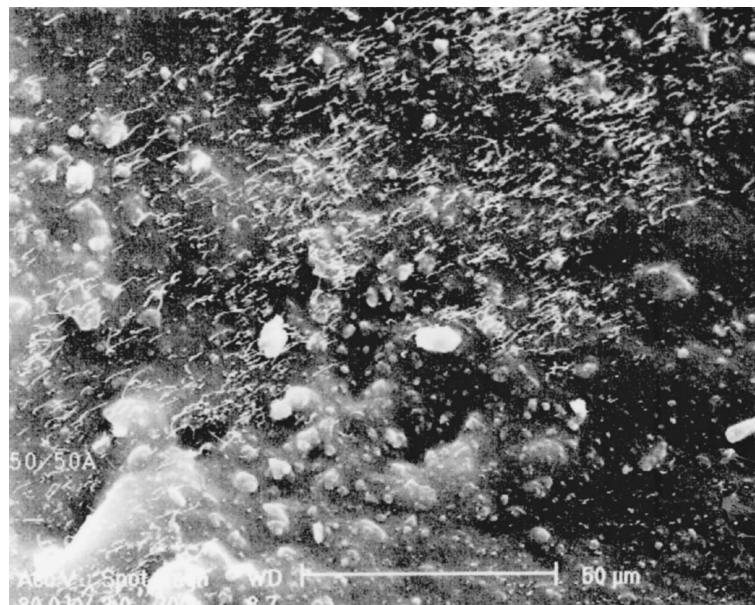
Figure 8 SEM micrographs of the impact fractured surfaces of the two layers dashboard: A, unmodified dashboard; B, dashboard with 50 wt % of ABS.

A SEM examination of the fracture surfaces (see Fig. 8A and B) reveals a morphology quite different from that observed in tensile tested samples, although the fractographic analysis has been conducted at lower magnification. In particular, at higher deformation rate the fractured surfaces appear smoother and the shear

yielding mechanism seems to be partially suppressed and replaced by crazing. In fact, as shown in Fig. 8B, the plastic deformation features visible on the fracture surface of the recycled dashboard containing 50 wt % of ABS are probably due to the occurrence of craze formation during the fracture process. This mechanism is completely absent for the unmodified dashboard (Fig. 8A) which exhibits the fracture morphology of a brittle material.

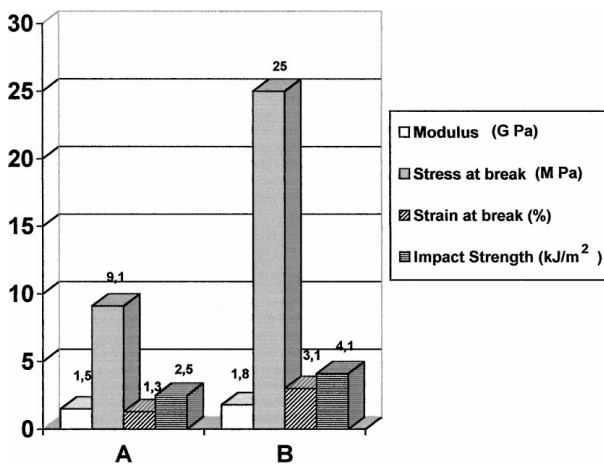
Figure 12 Bar-graph of the tensile and impact parameters of the three layers dashboard: A, dashboard recycled in presence of the PU layer; B, dashboard recycled in absence of the PU layer.

The results of the tensile and impact tests are reported in the bar-graph of Fig. 12 and are compared with those of the dashboard processed in presence of the PU layer. This comparison shows that, in absence of PU, a material with satisfactory mechanical properties can be obtained. In fact, the modulus increases by about 20%, the stress and the elongation at break increase by about 175% and 130% respectively and the impact strength increases by more than 60%.

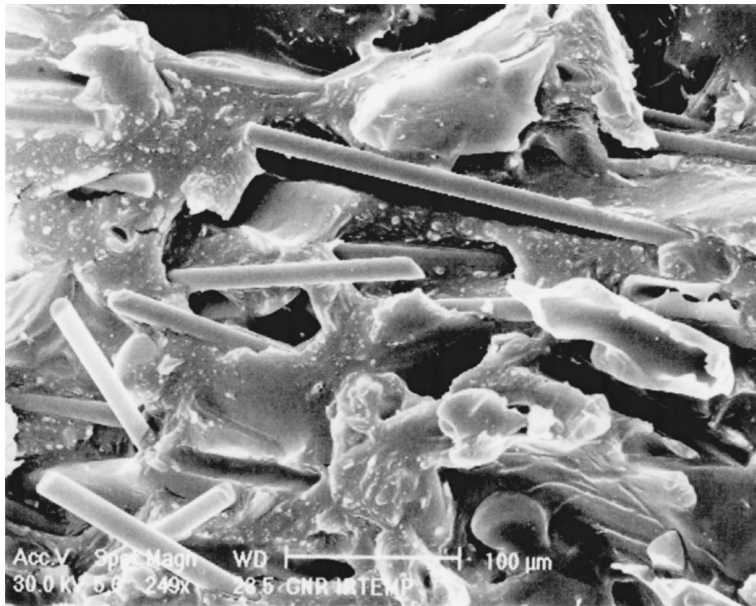
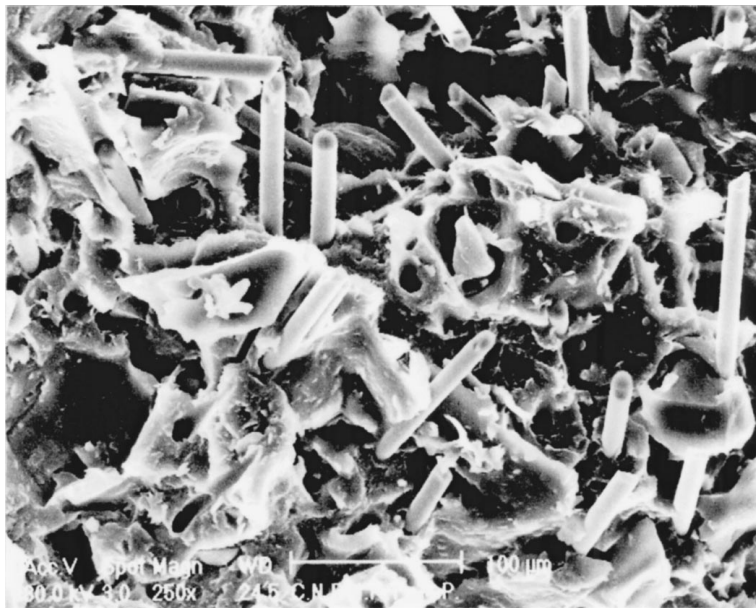
Figure 14 SEM micrographs of the impact fractured surfaces of the three layers dashboard: A, unmodified dashboard; B, dashboard with 10 wt % of ABS; C, dashboard with 20 wt % of ABS.

Quantitatively the addition of 20 wt% of ABS increases the stress and the elongation at break of about 150% and 75% respectively and the impact strength of about 110%. These results are in good agreement with the fractographic analysis performed by SEM on such materials. In Fig. 14 the SEM micrographs after impact tests of the unmodified and the modified dashboard containing 10 wt% and 20 wt% of ABS are reported. For the unmodified resin (Fig. 14 A), besides the already noted presence of PU particles, the fracture surface exhibits

a brittle morphology without any evidence of plastic flow, in accordance with its poor mechanical properties. The addition of ABS (Fig. 14 B and C) changes substantially the fracture morphology which shows features of plastic deformation whose extent increases with enhancing the amount of ABS in the formulation. Most probably the observed plastic deformation may be ascribed to a shear yielding mechanism which represents the main source of energy dissipation before fracture.
